> PHASE I ENVIRONMENTAL SITE ASSESSMENT (Site Visit: June 27, 2018) 6939 KING STRET CALEDON, ONTARIO, CANADA

ENVIROVISION INC. JULY 2018

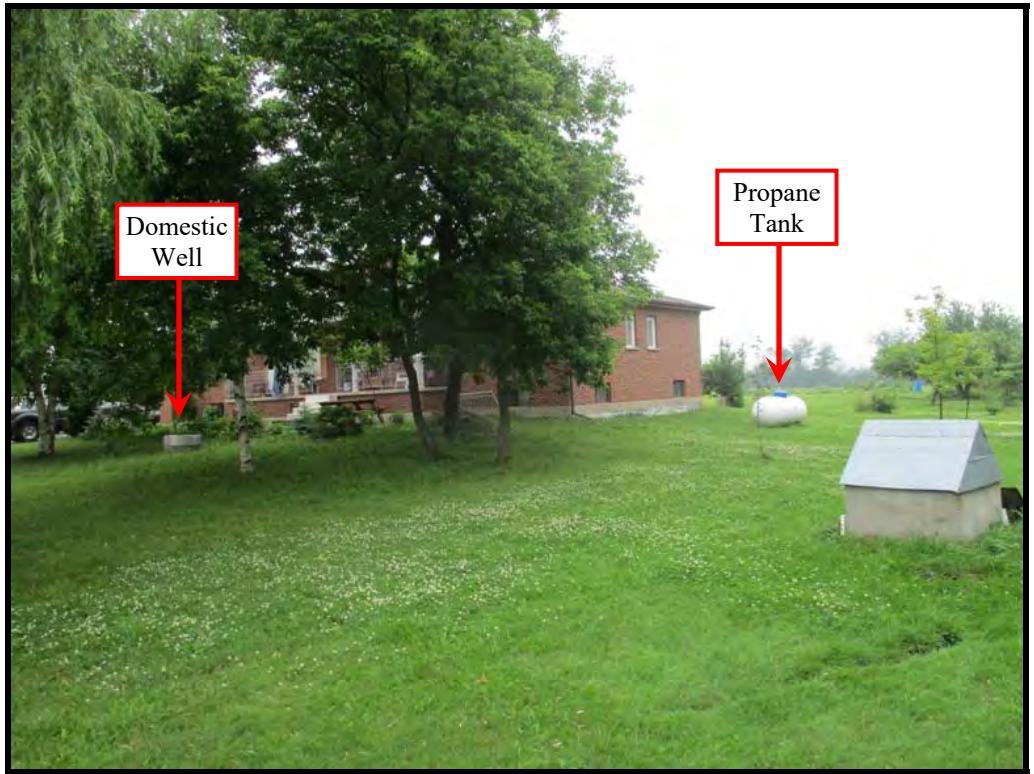
Photograph 2. View of the north and west sides of the Site Building. A domestic well (north side) and a propane tank (west side) are present in the immediate vicinity of the structure.

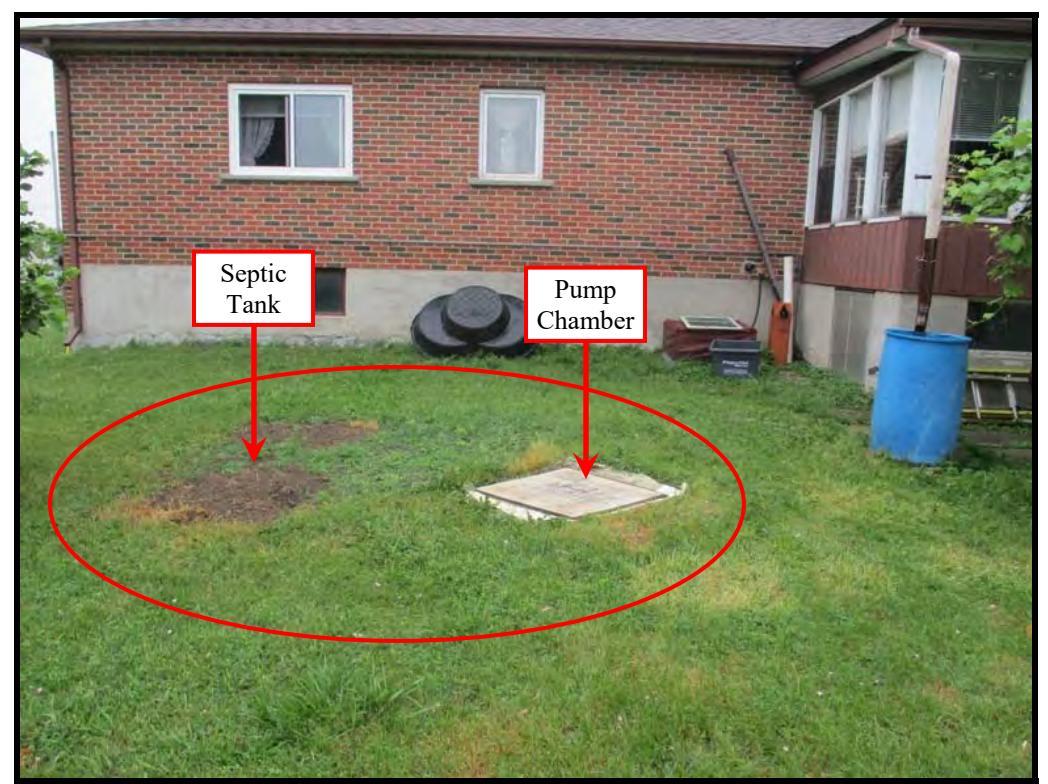
Photograph 4. View of the septic tank area located in the back of the Site Building.

No industrial wastewater generating activities were observed on the Site during the site visit. Wastewater from the septic tank is discharged to the leaching field to the south of the Site Building as required.

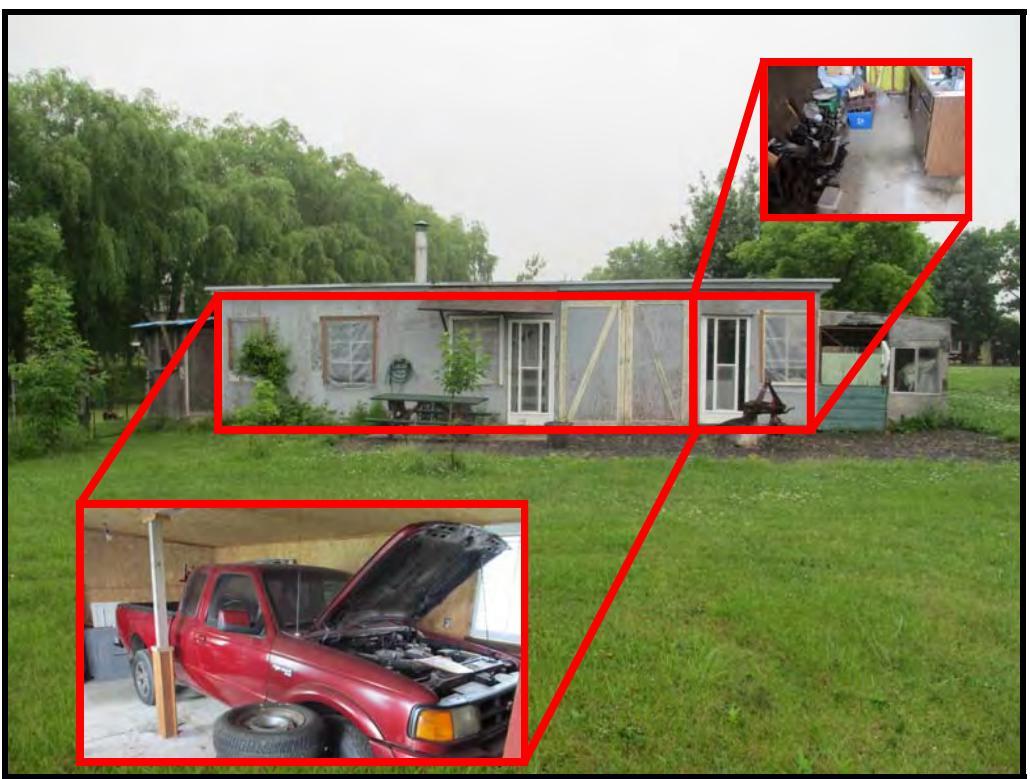
Photograph 5. View of the South Shed located on the Site.

No significant amounts of hazardous/regulated materials/chemicals were observed on the Site. One tractor, a pick-up truck and grass cutting equipment are stored inside the South Shed. A dismantled engine was also observed inside this shed. Materials consisting of wood and metal were observed inside the North Shed.

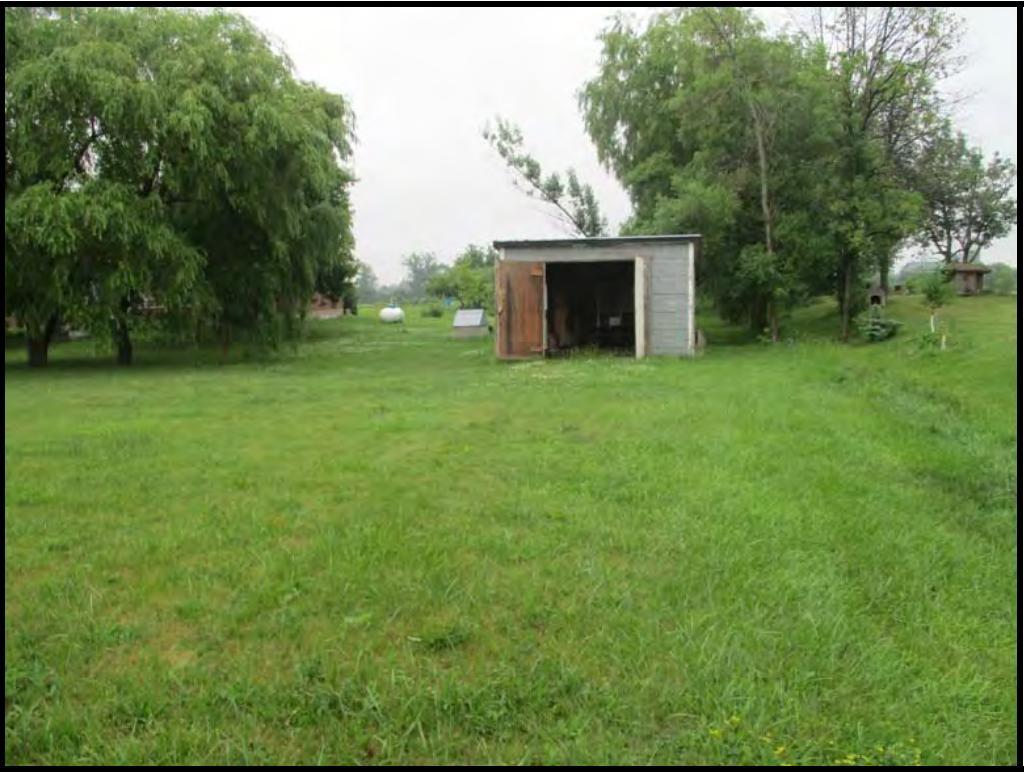
Photograph 7. View of the North Shed located on the Site.

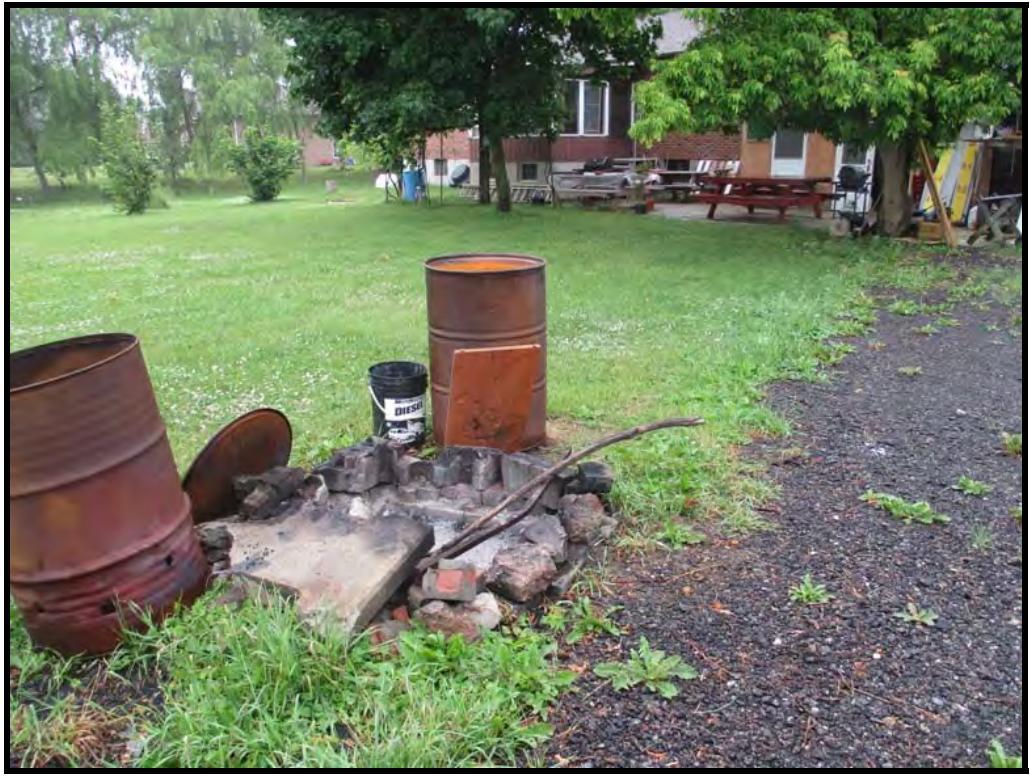
Photograph 8. View of a fire pit located to the south of the Site Building.

No fill piles or debris materials were identified on the Site at the time of the site visit. A fire pit was observed to the south of the Site Building.

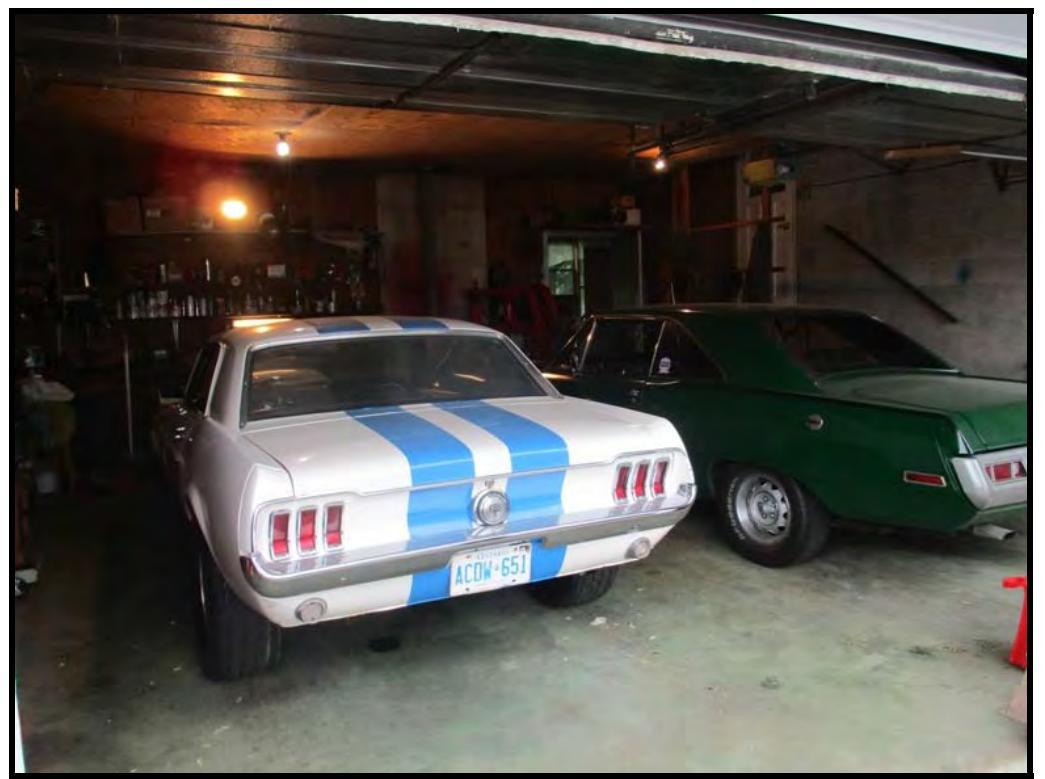
Photograph 11. View inside the front garage located within the Site Building.

Two cars were observed inside the garage attached to the front of the Site Building. Boxes with various parts, tools and paint cans are present on the floor and shelves within the garage. Three tractors were present in the garage attached to the back of the Site Building. Several small plastic containers (up to 5 litres each) containing waste motor oil were observed inside both

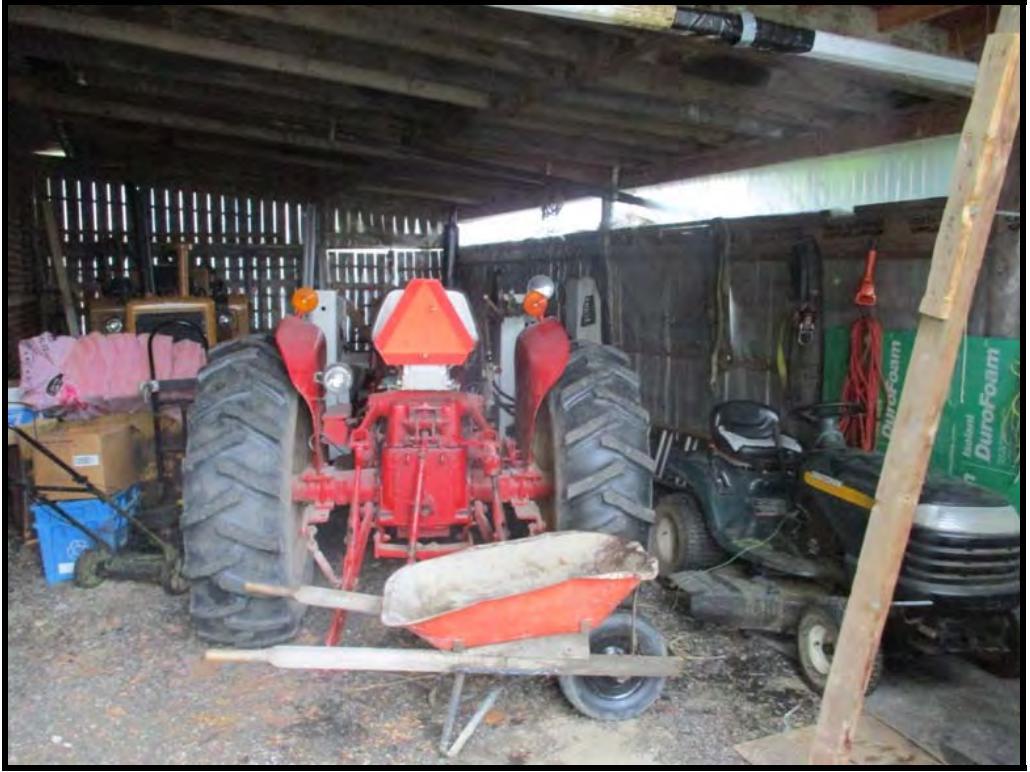
Photograph 12. View inside the back garage located on the east end of the Site Building.

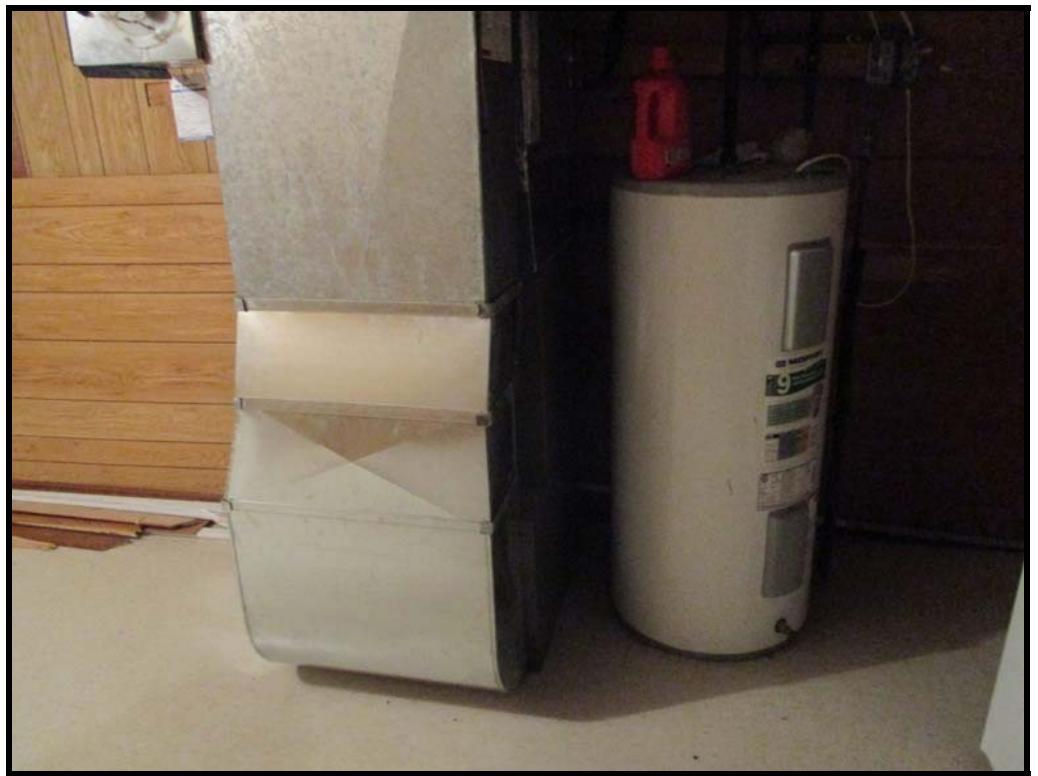
Photograph 14. View of the furnace and hot water tank situated in the Site Building's basement area.

Propane-burning emissions are released to the atmosphere from the Site Building's furnace.

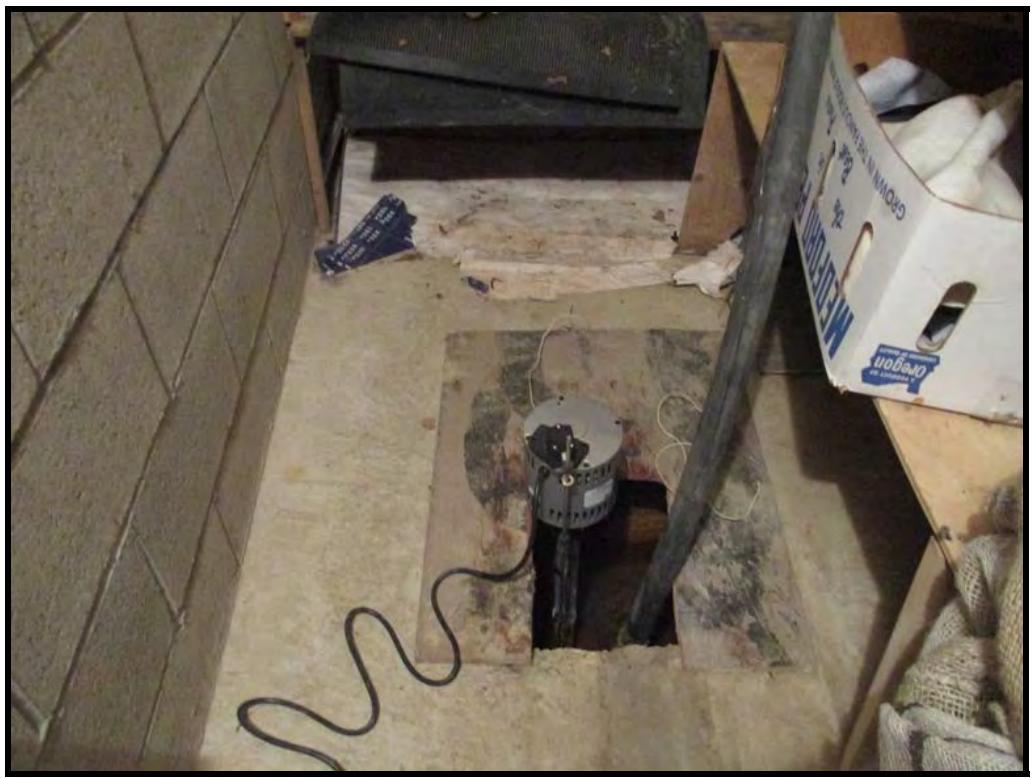
Photograph 15. View of sump located inside the Site Building's basement area.

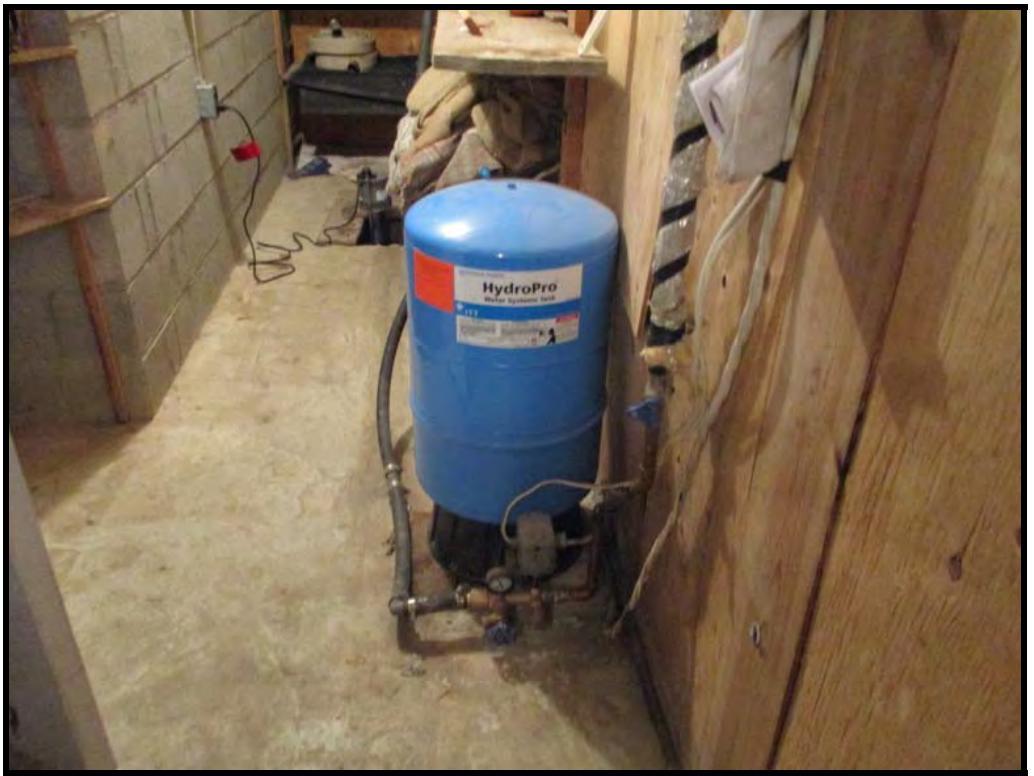
Photograph 16. View of domestic water pressure tank located inside the Site Building's basement area.

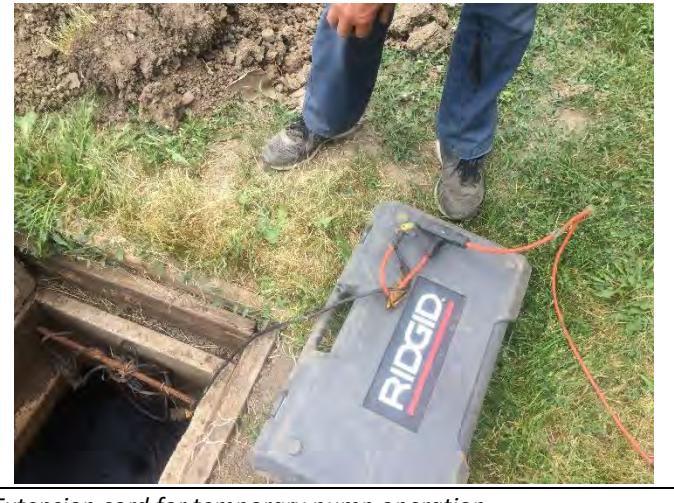
- The original, trenched electrical connection serving the chamber is inoperative, and was replaced by a temporary extension cord
 - Retain a certified electrician to diagnose and repair or replace the permanent electrical line to ensure long-term reliability

Extension cord for temporary pump operation

- New electrical connections should be placed in a sealed electrical junction box outside the pump chamber
- 5. The effluent pump can only be activated by manually plugging in the temporary extension cord. At the time of repair to the permanent electrical supply, equip the pump with a control switch for automatic operation;

- Install an outlet baffle to prevent floating solids from entering the leaching field (±\$200++ depending on outlet accessibility by repair technician);
- Retain a certified electrician to repair or replace the permanent electrical connection to the pump chamber, as described above.
