Comprehensive Environmental Impact Study and Management Plan (CEISMP) Snell's Hollow East Secondary Plan

Part A – Existing Baseline Conditions & Characterization Part B – Land Use Evaluation & Impact Assessment

August 2021 300051670.0000

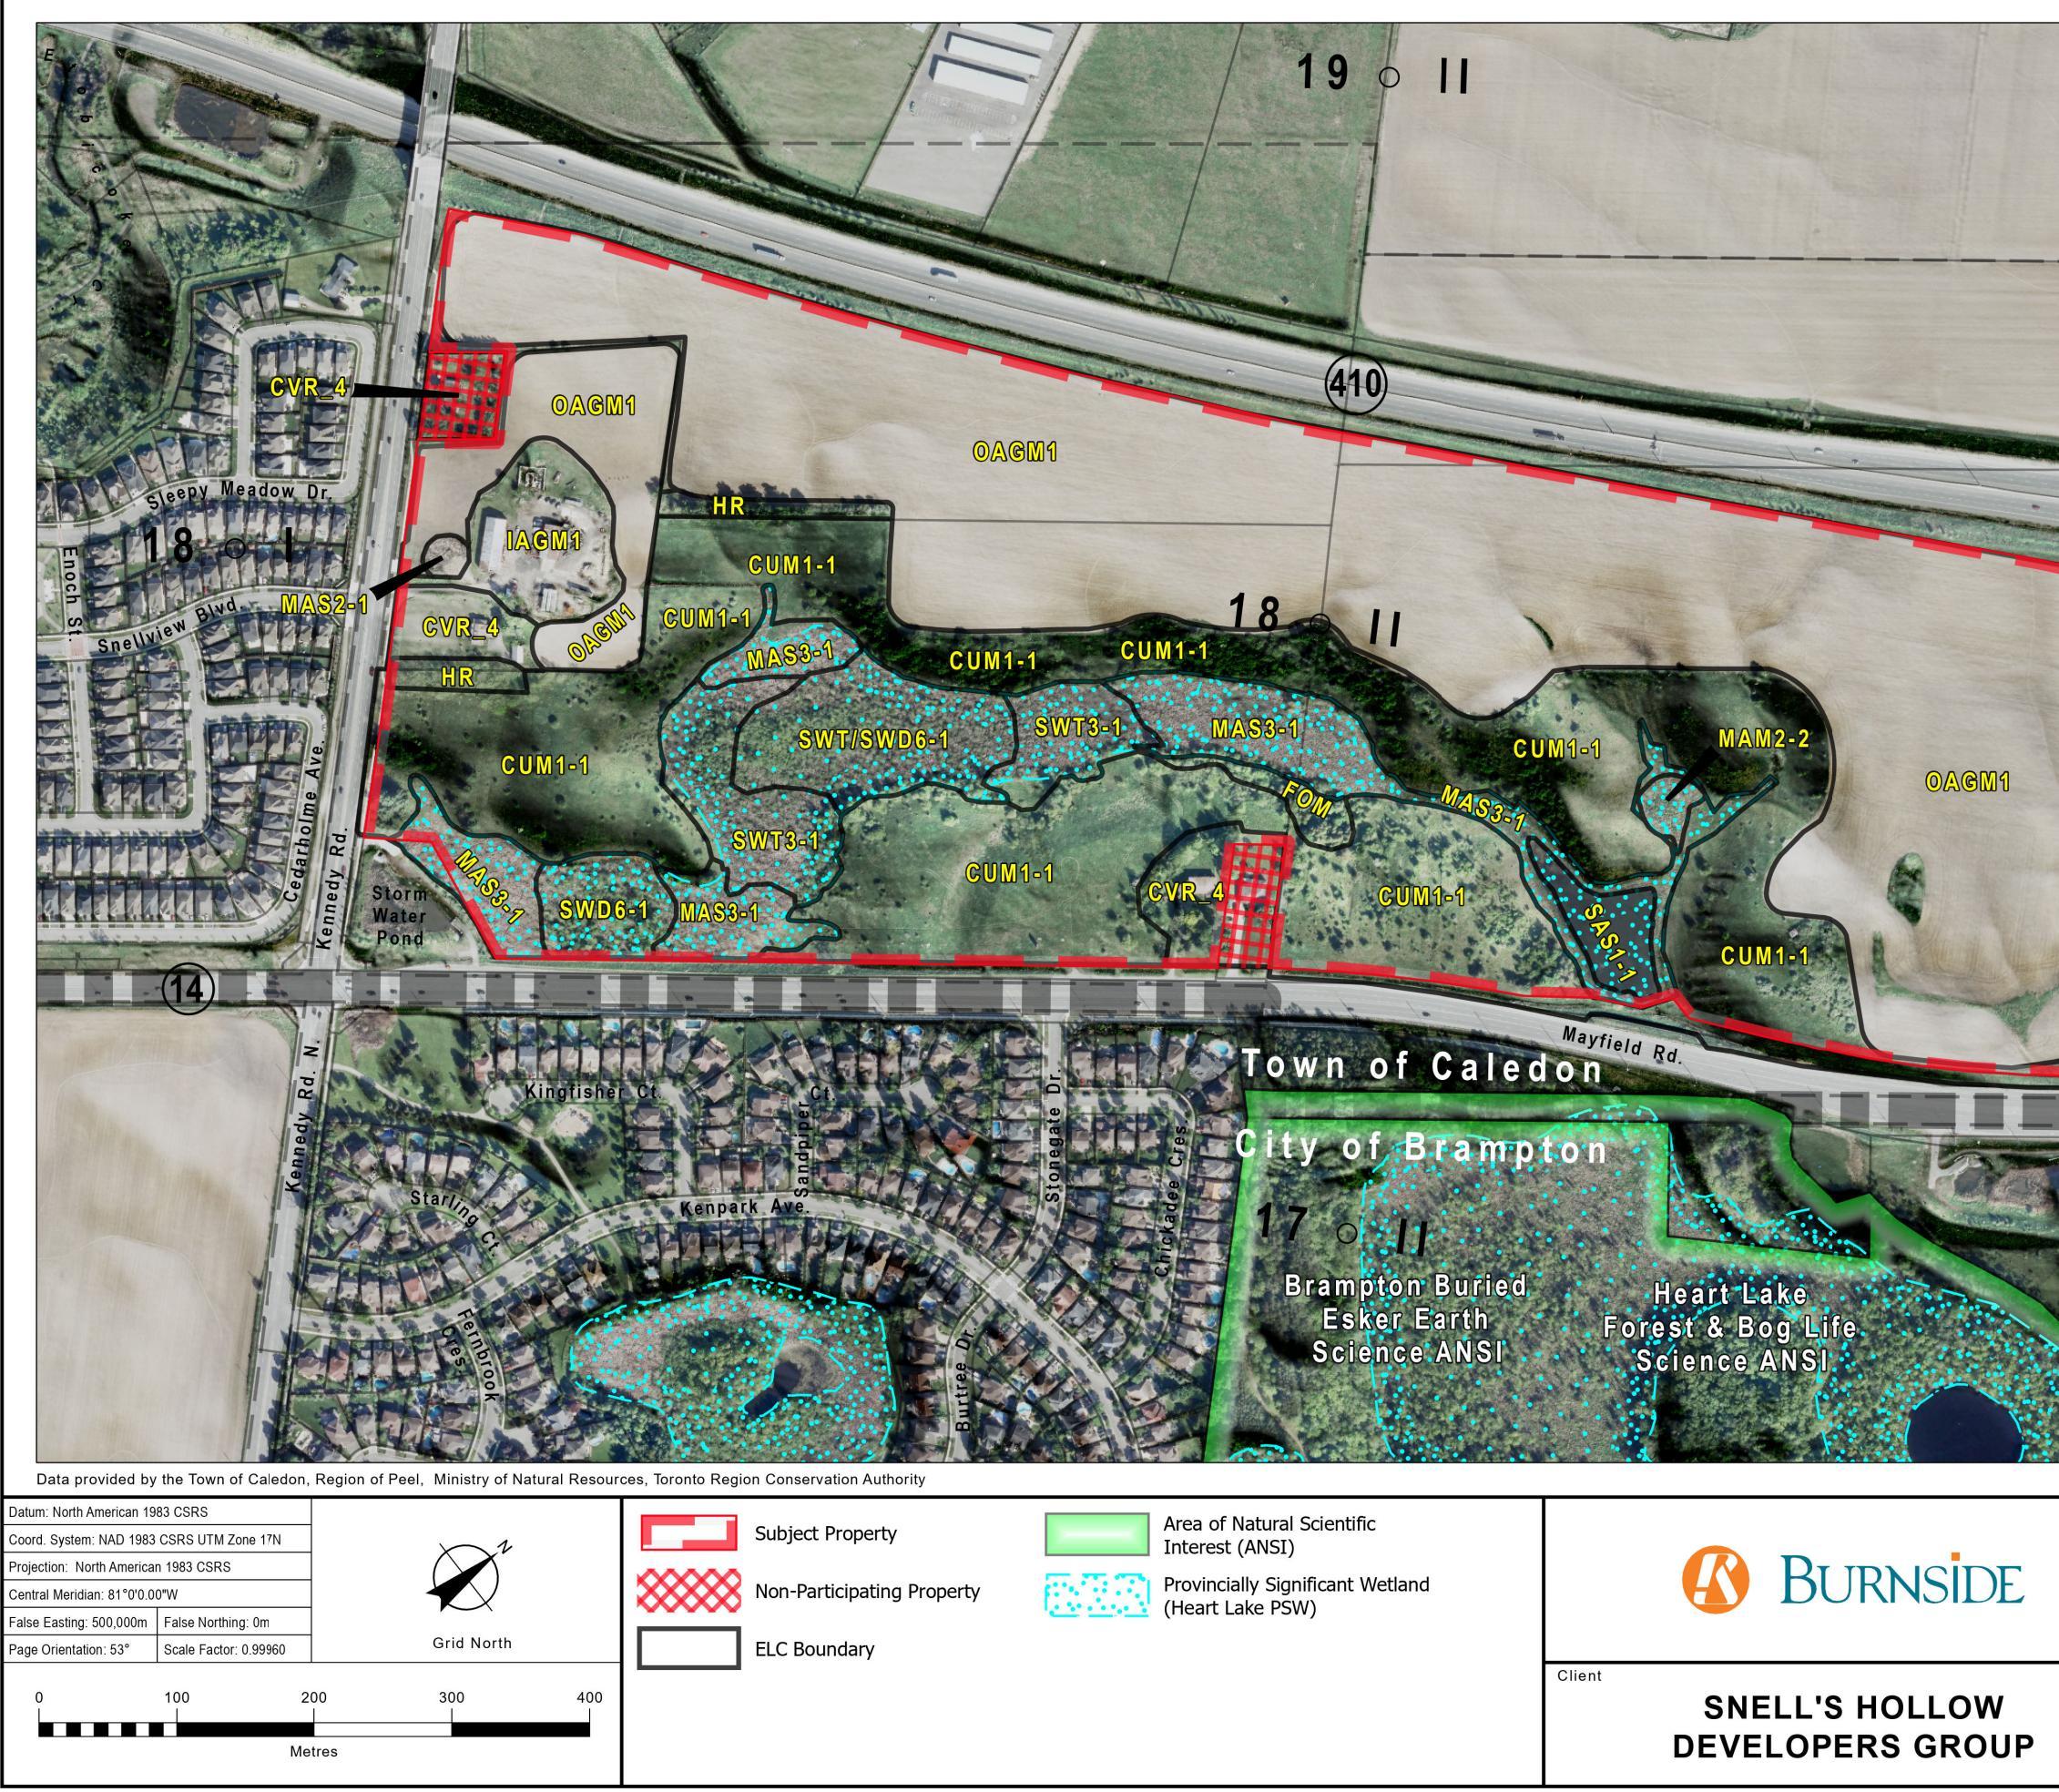
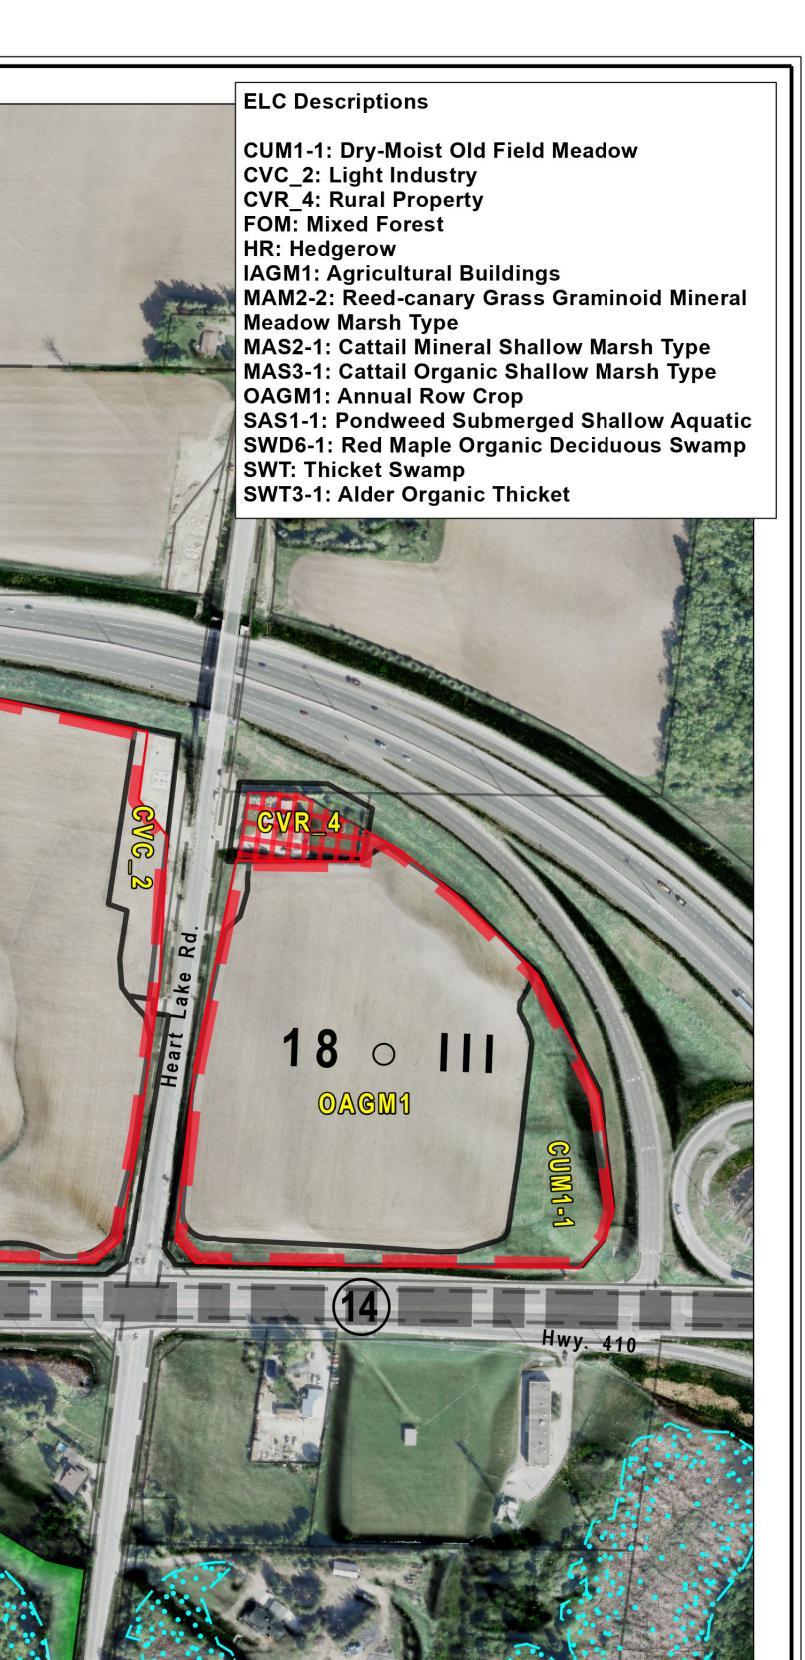
Figure Title			
ECO	SNELL SEC	'S HOLLOW E ONDARY PLA	AST N FICATION
Drawn	Checked	Date	Figure No.
PS	НМ	2021/08/05	2
Scale		Project No.	2
1:5,000		300051670

ELC Classification		
Cultural / Anthropogenic		
CUM1-1: Dry-Moist Old Field Meadow		
Commercial and Institutional		
CVC_2: Light Industrial		
Residential		
CVR_4: Rural Property		
Agricultural Infrastructure		
IAGM_1: Agricultural Buildings		
Open Agriculture		
OAGM1: Annual Row Crop		
Forest		
Mixed Forest		
FOM: Mixed Forest		
Thicket		
Deciduous Thicket		
HR: Hedgerow

ELC Classification		
Wetland		
Meadow Marsh		
MAM2-2: Reed Canary Grass Graminoid Mineral Marsh		
Shallow Marsh		
MAS2-1: Cattail Mineral Shallow Marsh		
MAS3-1: Cattail Organic Shallow Marsh		
Submerged Shallow Aquatic		
SAS1-1: Pondweed Submerged Shallow Aquatic		
Deciduous Swamp		
SWD6-1: Red Maple Organic Deciduous Swamp		
Thicket Swamp		
SWT: Thicket Swamp		
SWT3-1: Alder Organic Swamp

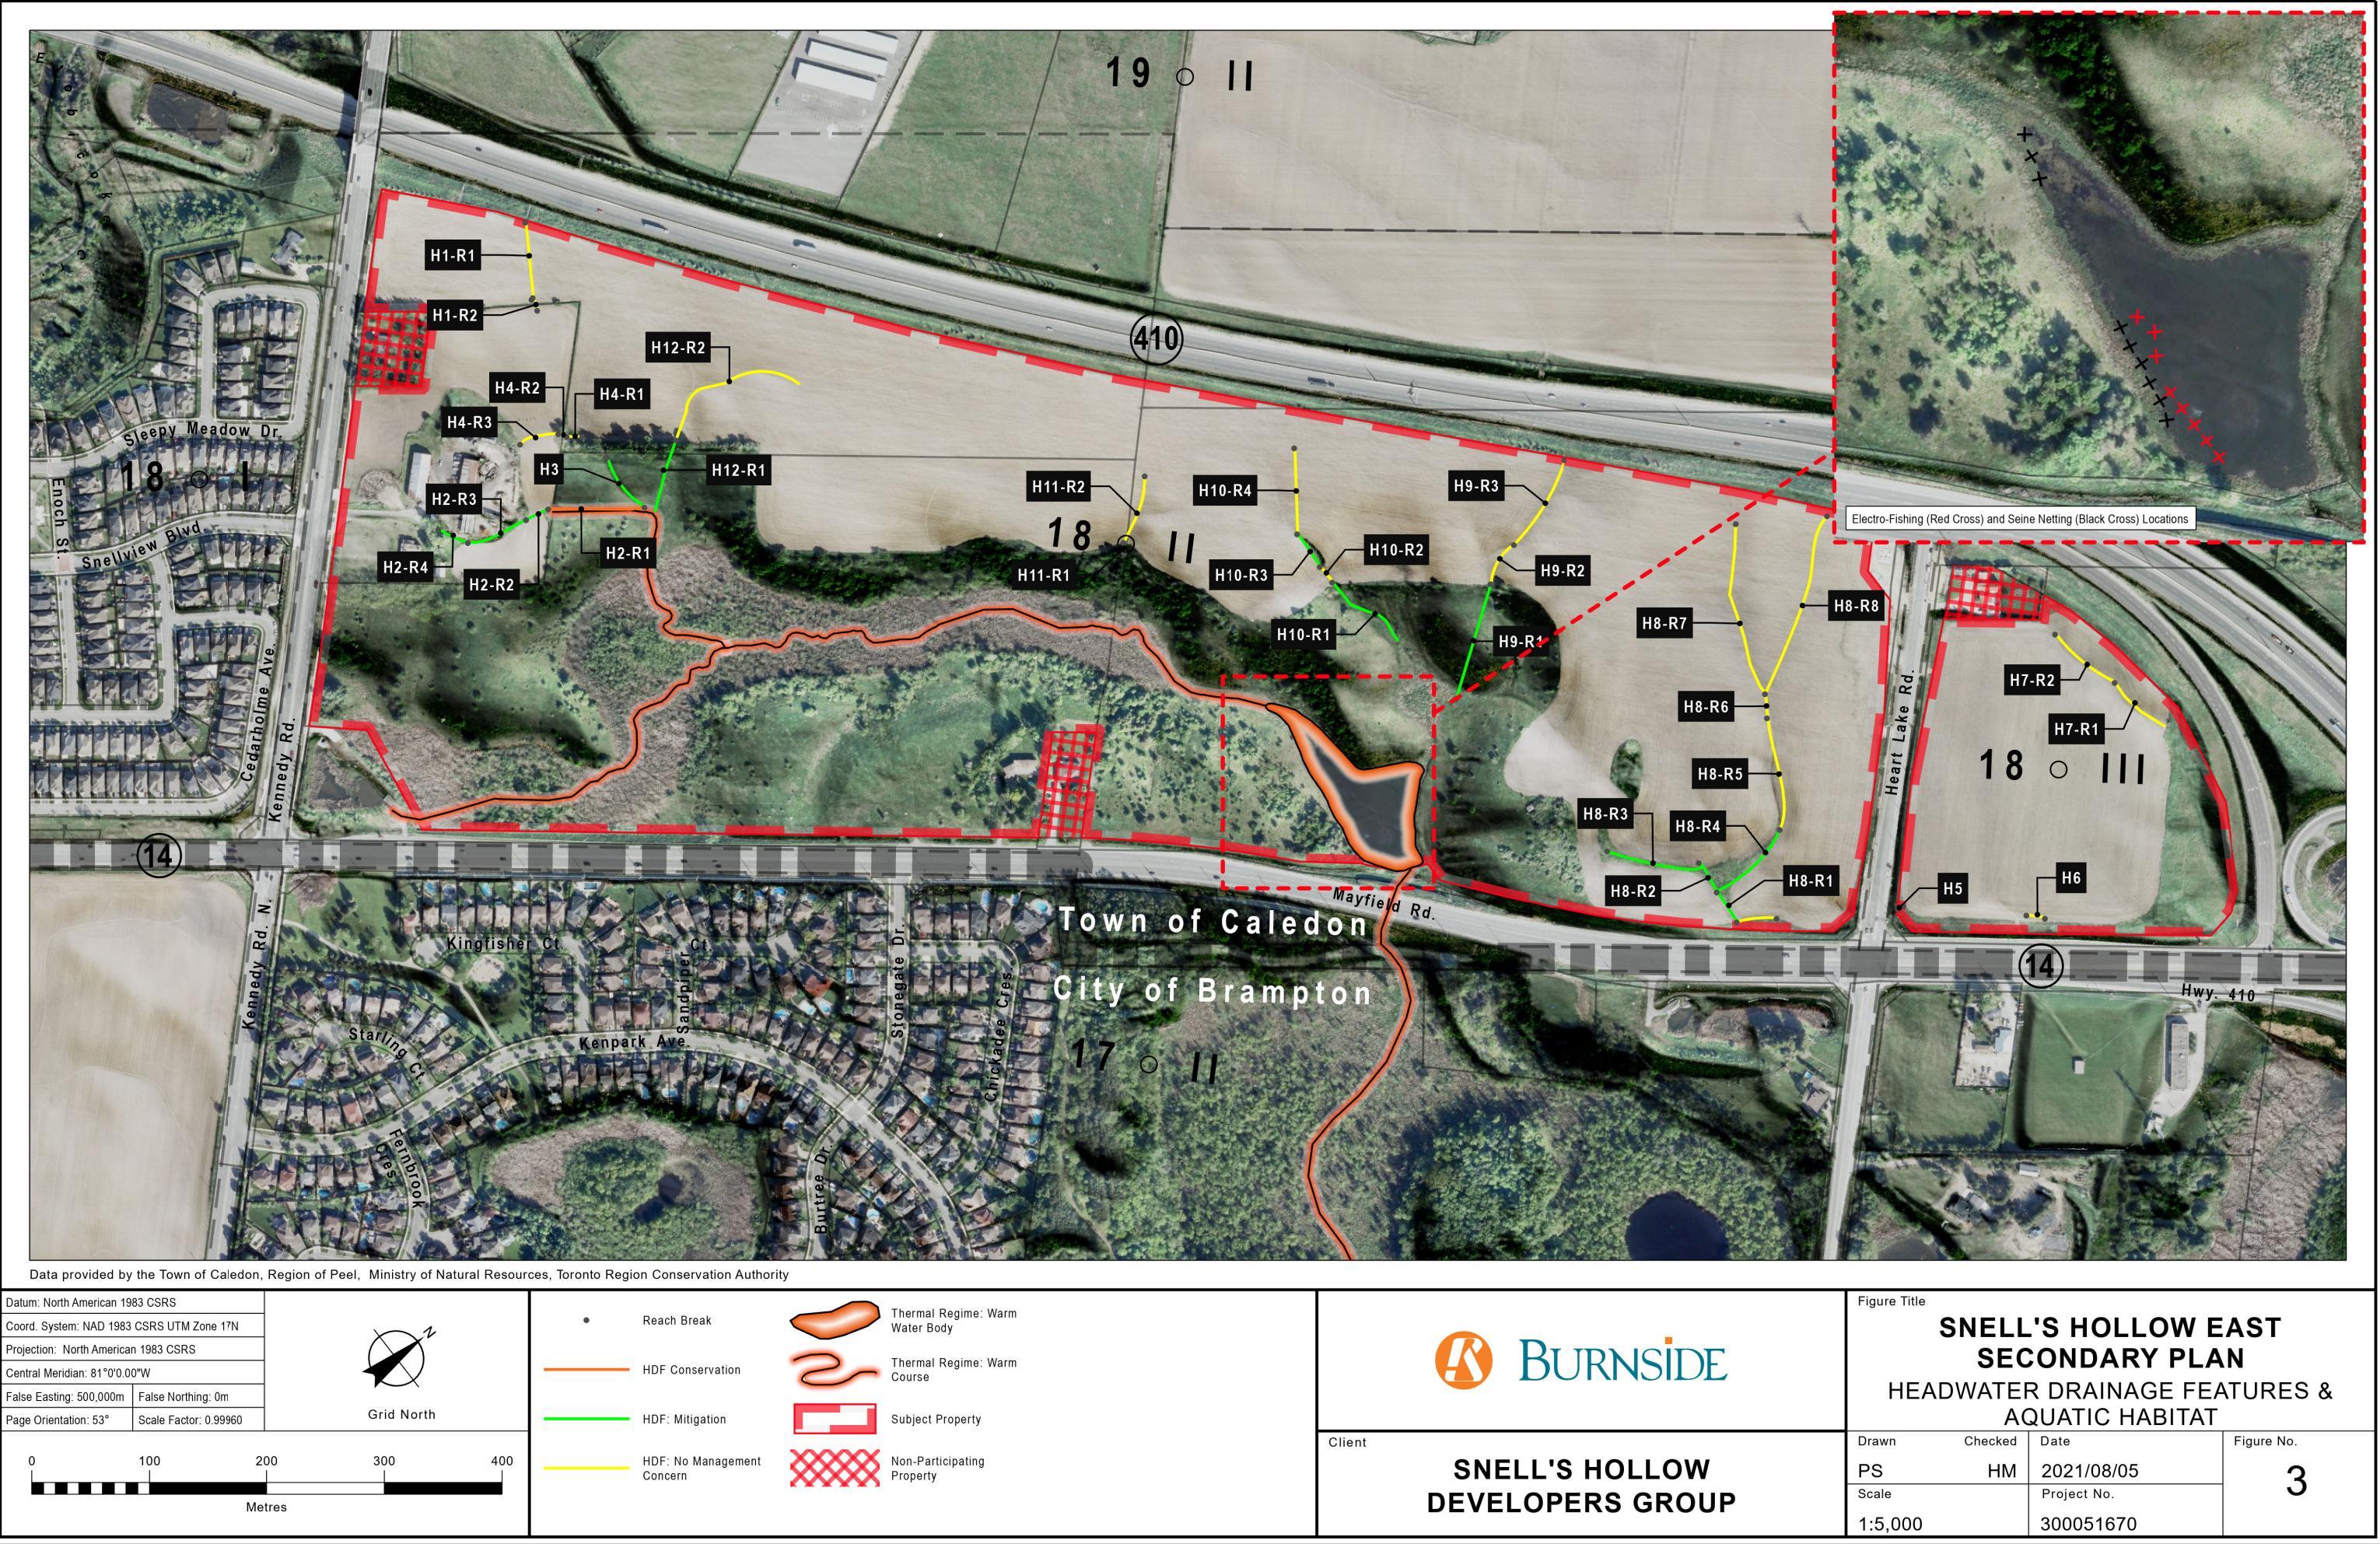
Figure Title	SNELL SEC	'S HOLLOW E ONDARY PLA	AST N
HEA	DWATER AC	R DRAINAGE FEA QUATIC HABITAT	TURES &
Drawn	Checked	Date	Figure No.
PS	HM	2021/08/05	3
Scale		Project No.	5
1:5,000		300051670

The majority of features on the subject property were found in actively tilled agricultural fields, with poor definition and lacking natural channel vegetation. Overall, 12 potential drainage networks were investigated (H1 to H12) throughout the subject property (Figure 3 of this report). All the drainage networks, except for H3, flow, partially or wholly, through cultivated agricultural fields. Of the 33 reaches within these networks, 20 were classified as 'No Management Concern', 12 as 'Mitigation' and one as 'Conservation', based on the management decision matrix provided in Figure 2 of The Guideline.

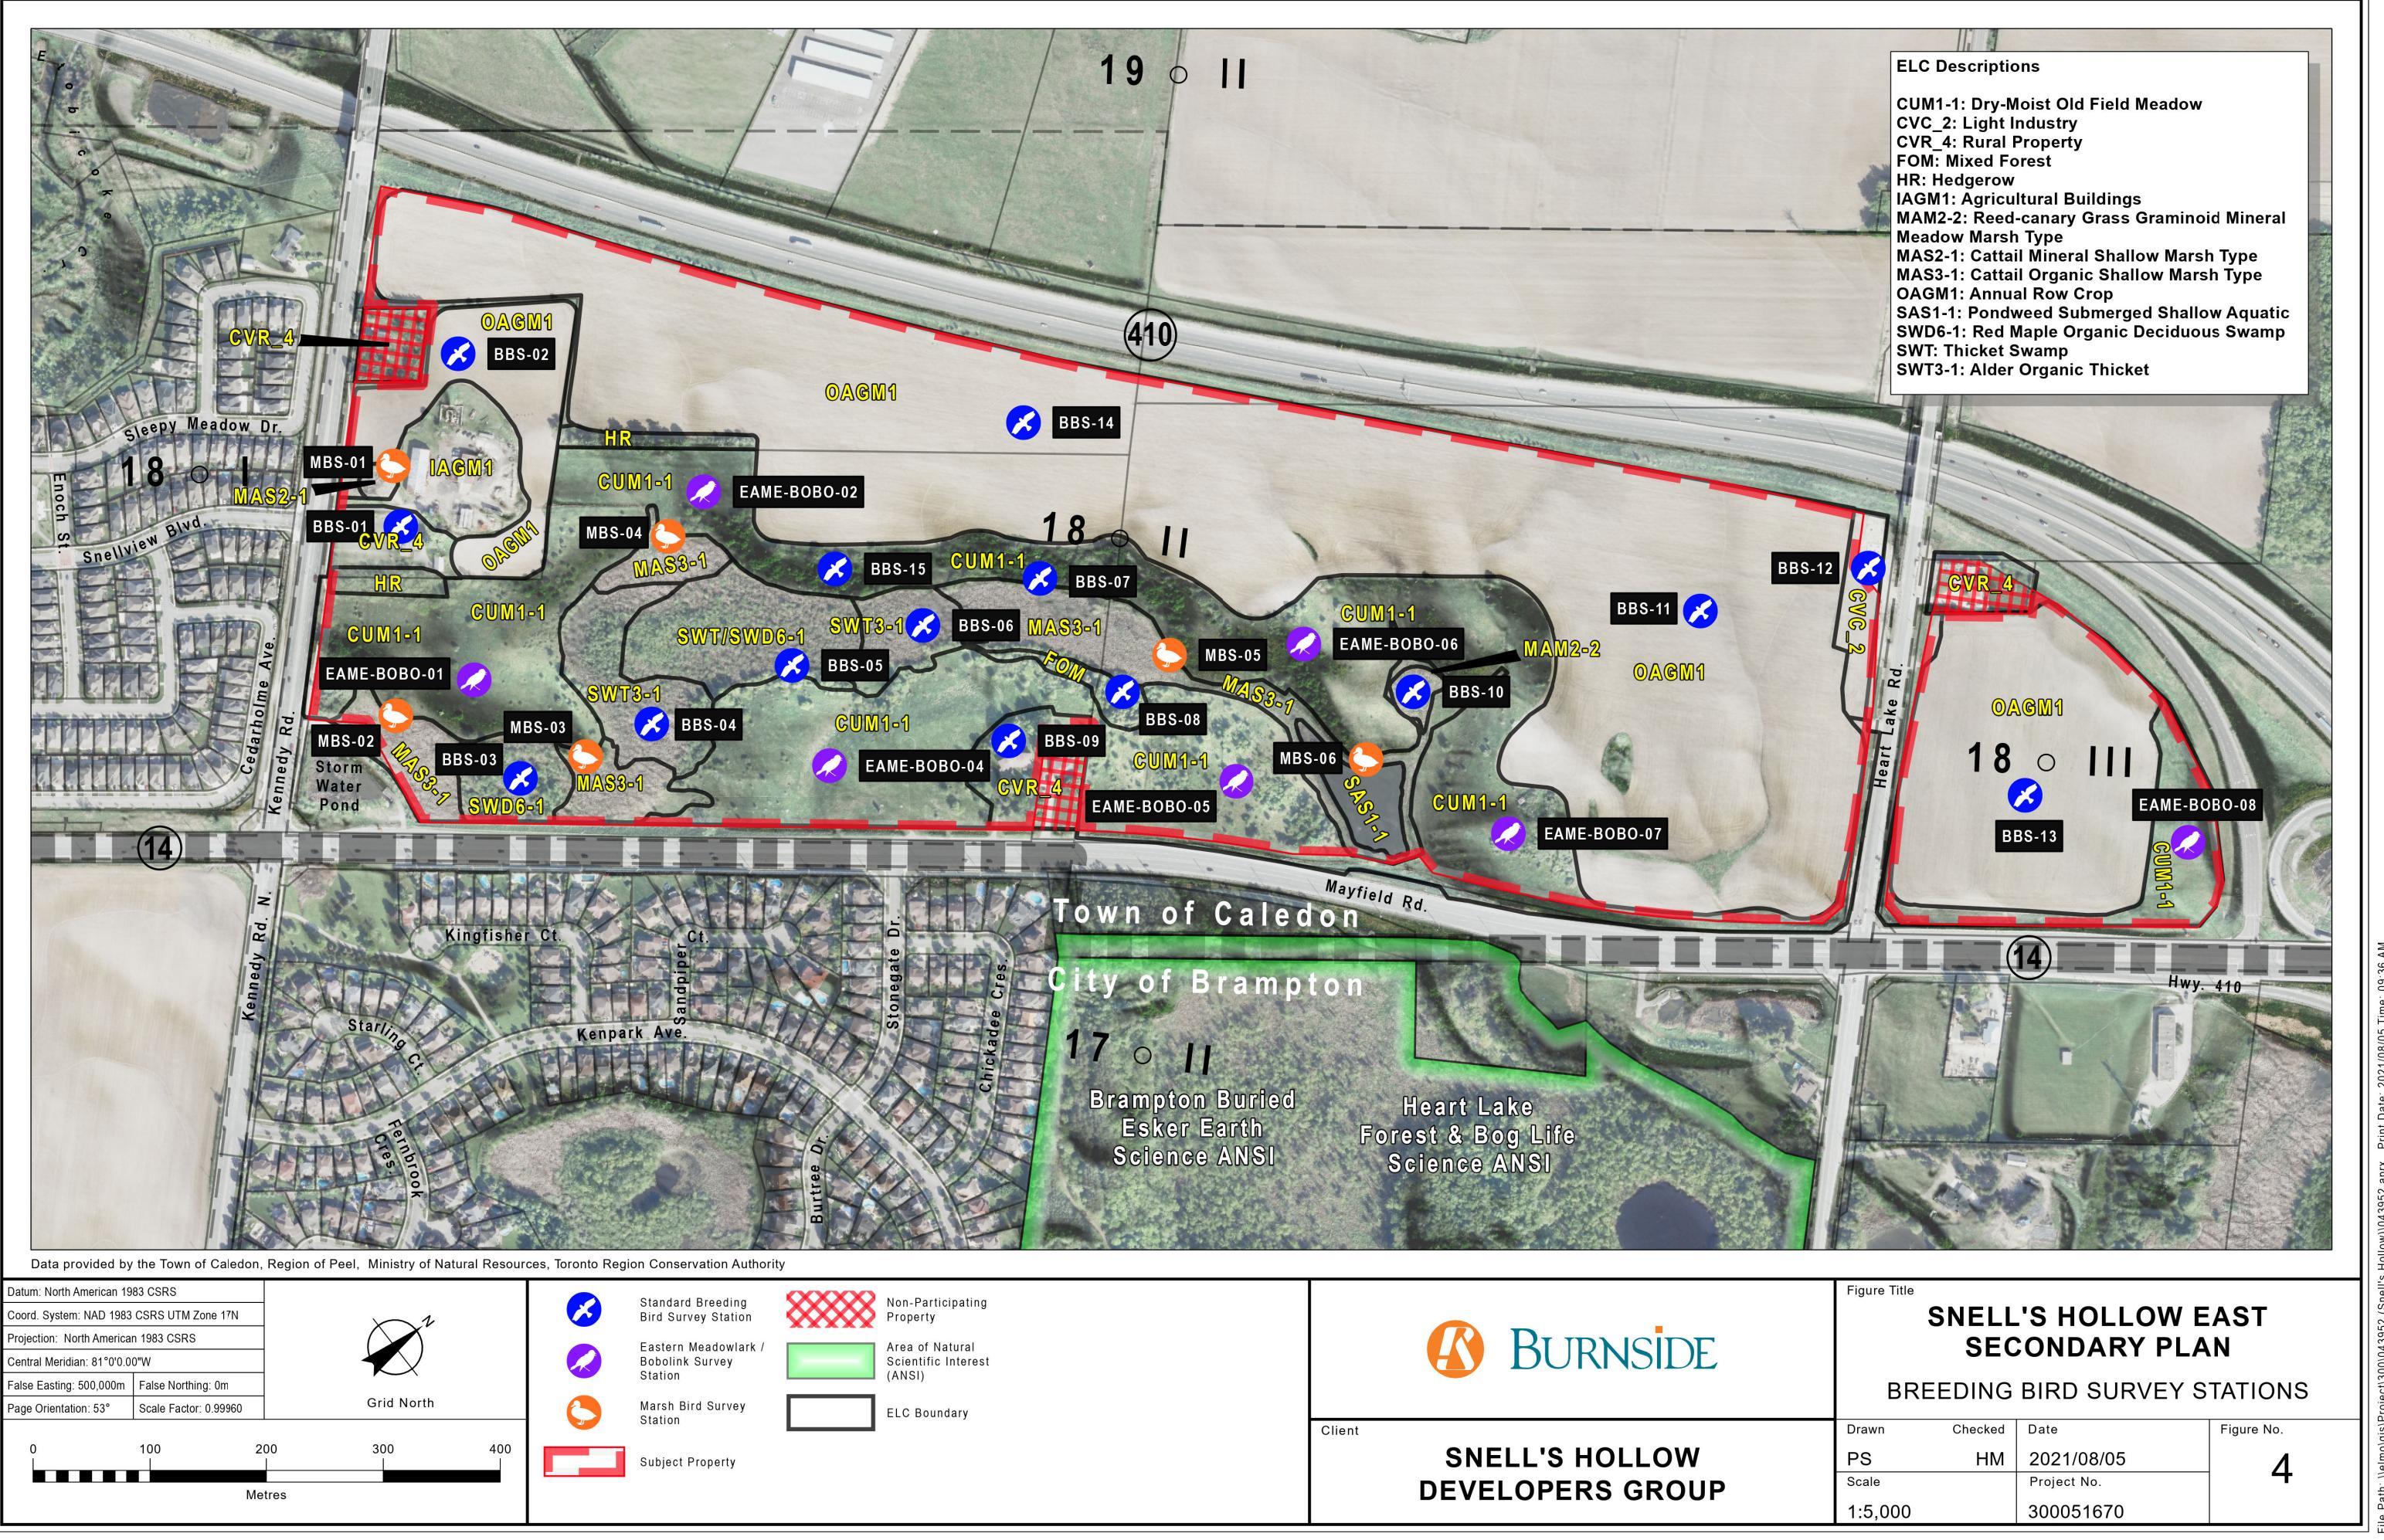
Figure Title	SNELL SEC	'S HOLLOW E ONDARY PLA	AST N
BRE	EEDING	BIRD SURVEY S	TATIONS
Drawn	Checked	Date	Figure No.
PS	НМ	2021/08/05	Λ
Scale		Project No.	-
1:5,000		300051670

Marsh bird survey stations were established at certain locations around the perimeter of the wetlands, based on suitable habitat and background records indicating the potential presence of marsh birds.

Each EAME/BOBO point count location was chosen based on good visibility of the surrounding fields/open areas. Per the protocol, the surveyor completed 10 minutes of passive observation and recorded all species observed or heard.

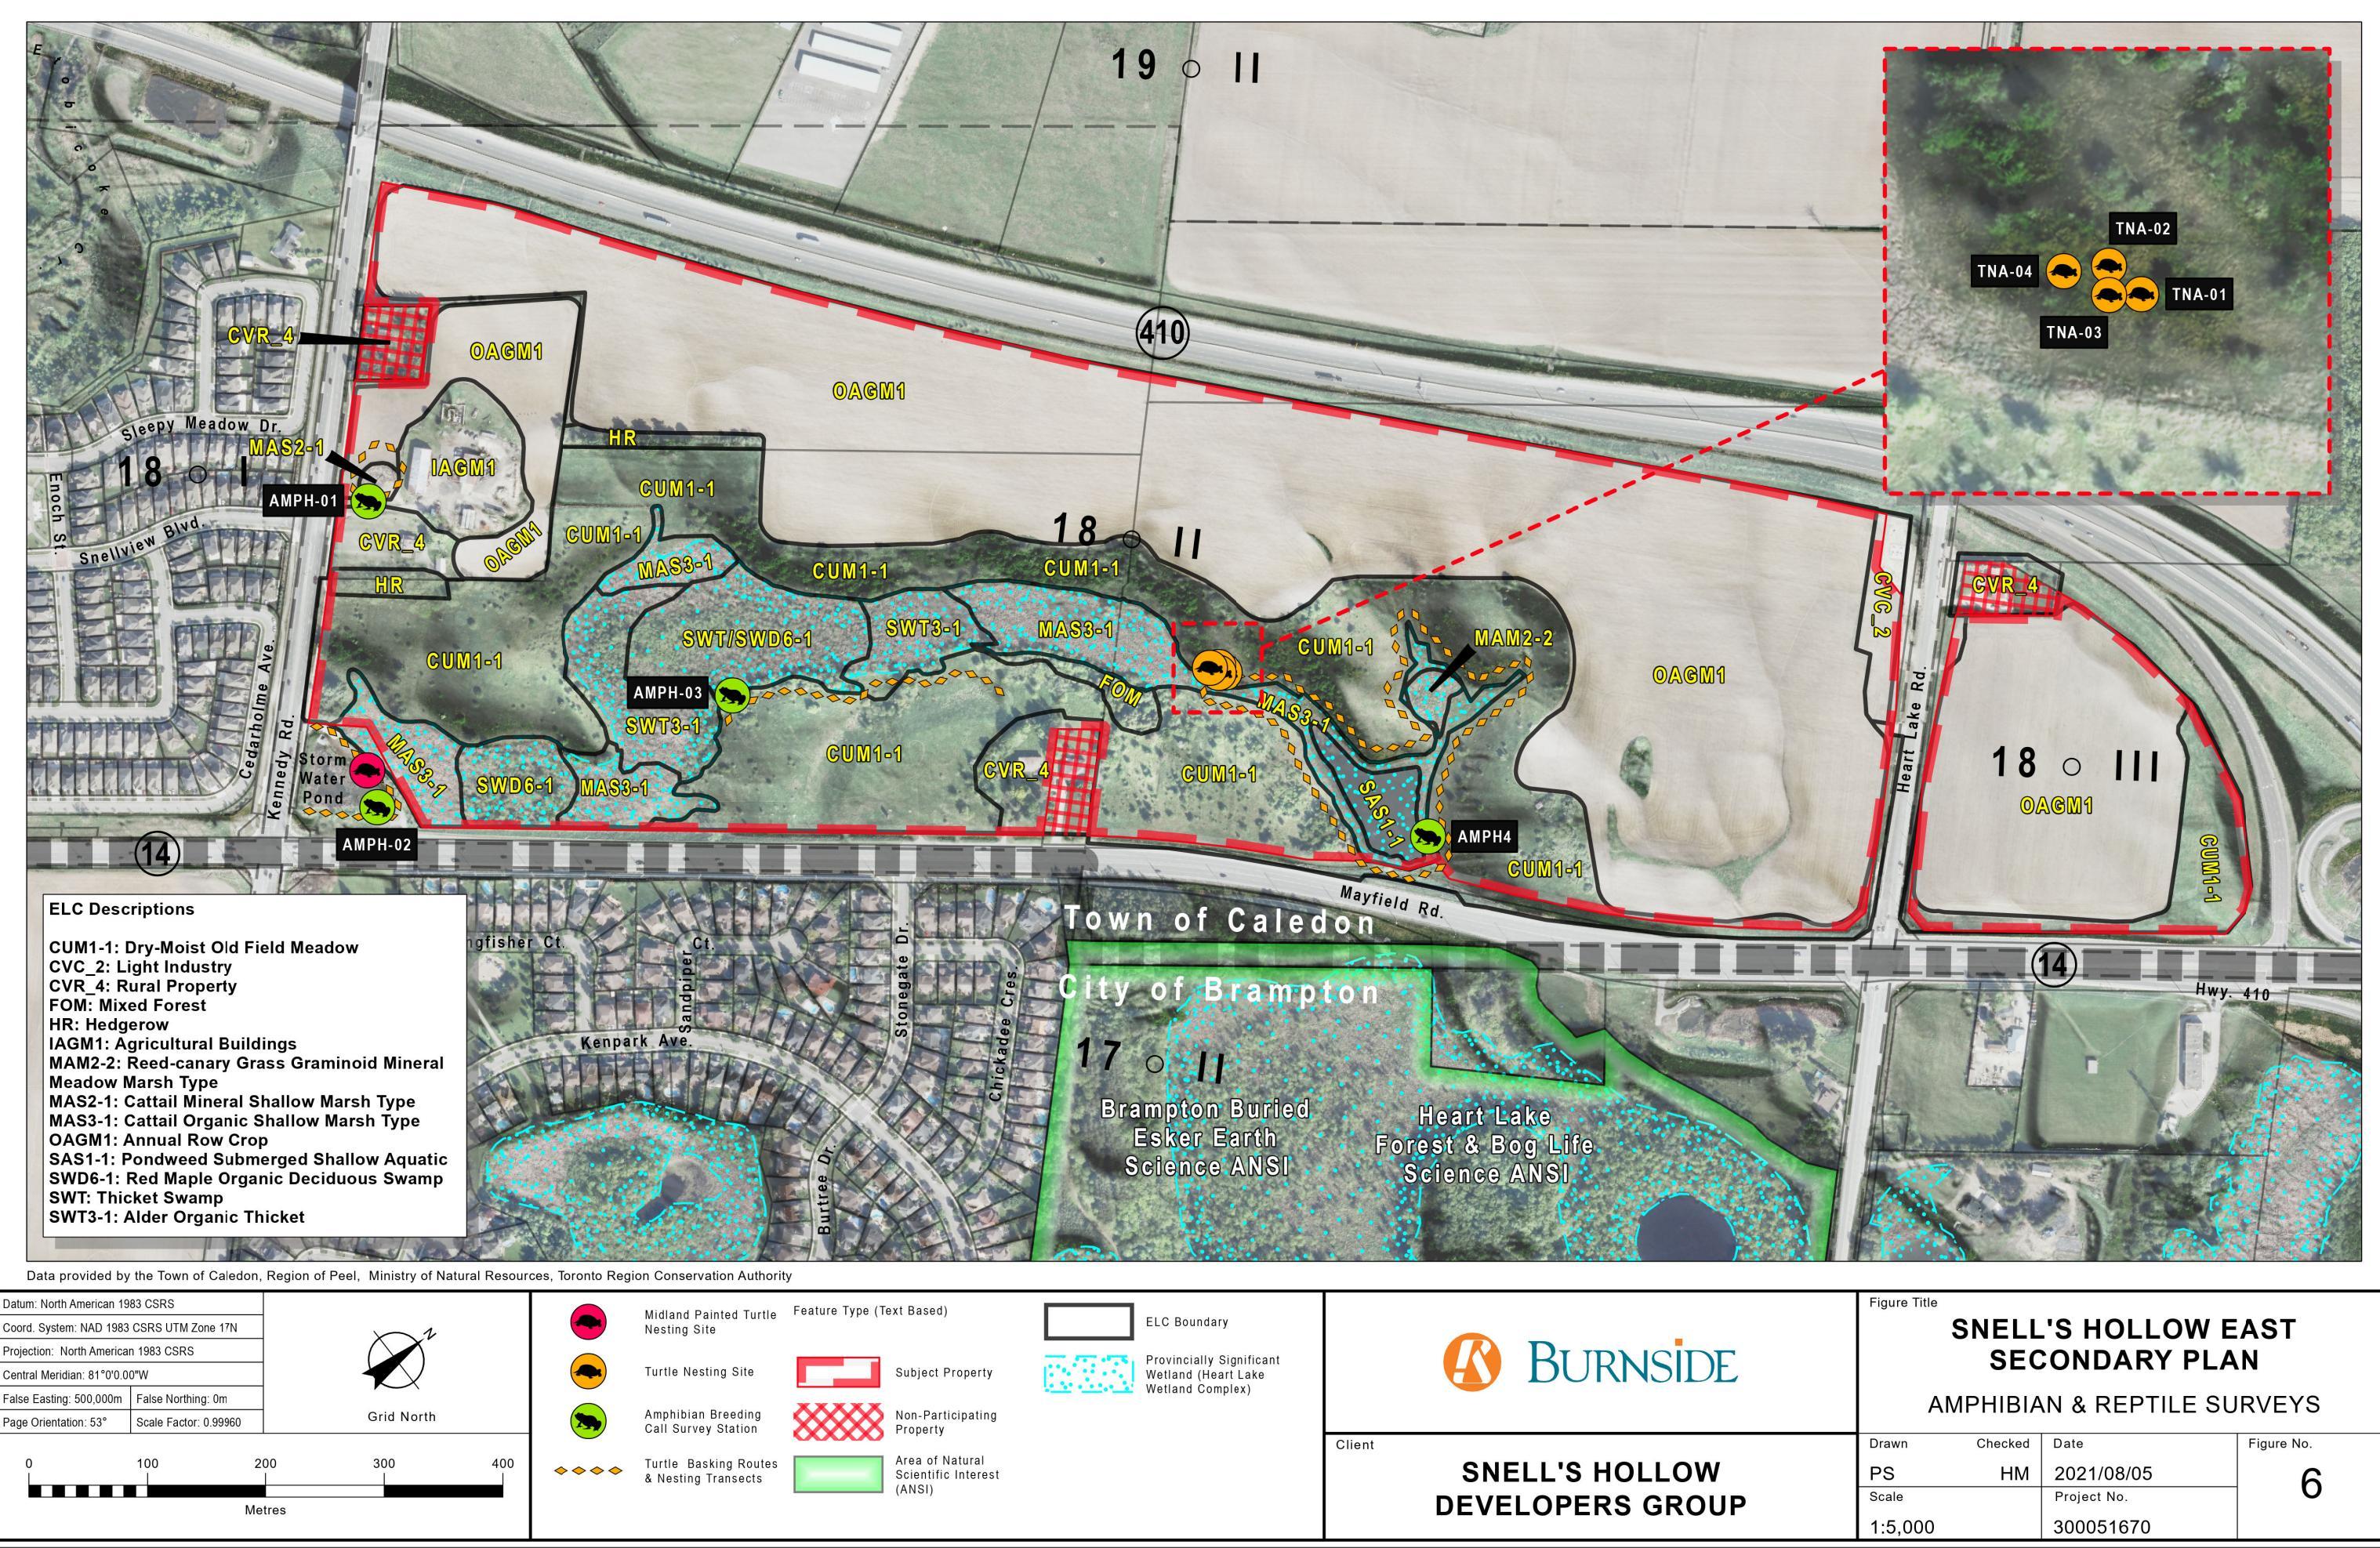
Figure Titl	SNELL	'S HOLLOW E	AST
	SEC	ONDARY PLA	Ν
	AMPHIBIA	N & REPTILE SU	RVEYS
Drawn	Checked	Date	Figure No.
PS	НМ	2021/08/05	6
Scale		Project No.	0
1:5,000)	300051670

Four survey stations were chosen to provide information on potential amphibian breeding sites within representative wetland communities, located throughout the subject property. While outside of the subject property limits, one of the stations was located at the existing SWM pond as a control site. Stations are depicted on Figure 6.

Visual encounter surveys for turtles were conducted in the spring, based on the MNRF's *Survey Protocol for Blanding's Turtle in Ontario* (MNRF, 2015), tailored to the needs of this project. While Blanding's Turtle is not expected for this area, this protocol provides a comprehensive method for surveying generally for turtle overwintering/basking habitat for species expected in this location (i.e., Midland Painted Turtle (*Chrysemys picta marginata*) and Snapping Turtle (*Chelydra serpentina*). Three main survey stations were established where open water was present: Station 1 (SWM pond control site), Station 2 (south side of wetland) and Station 3 (shallow aquatic open water pond). It was assumed that any turtles observed at the control site may also be using the adjacent wetland habitats during their life cycle. Burnside staff also walked the perimeter of the wetlands and pond where suitable. See Figure 6.

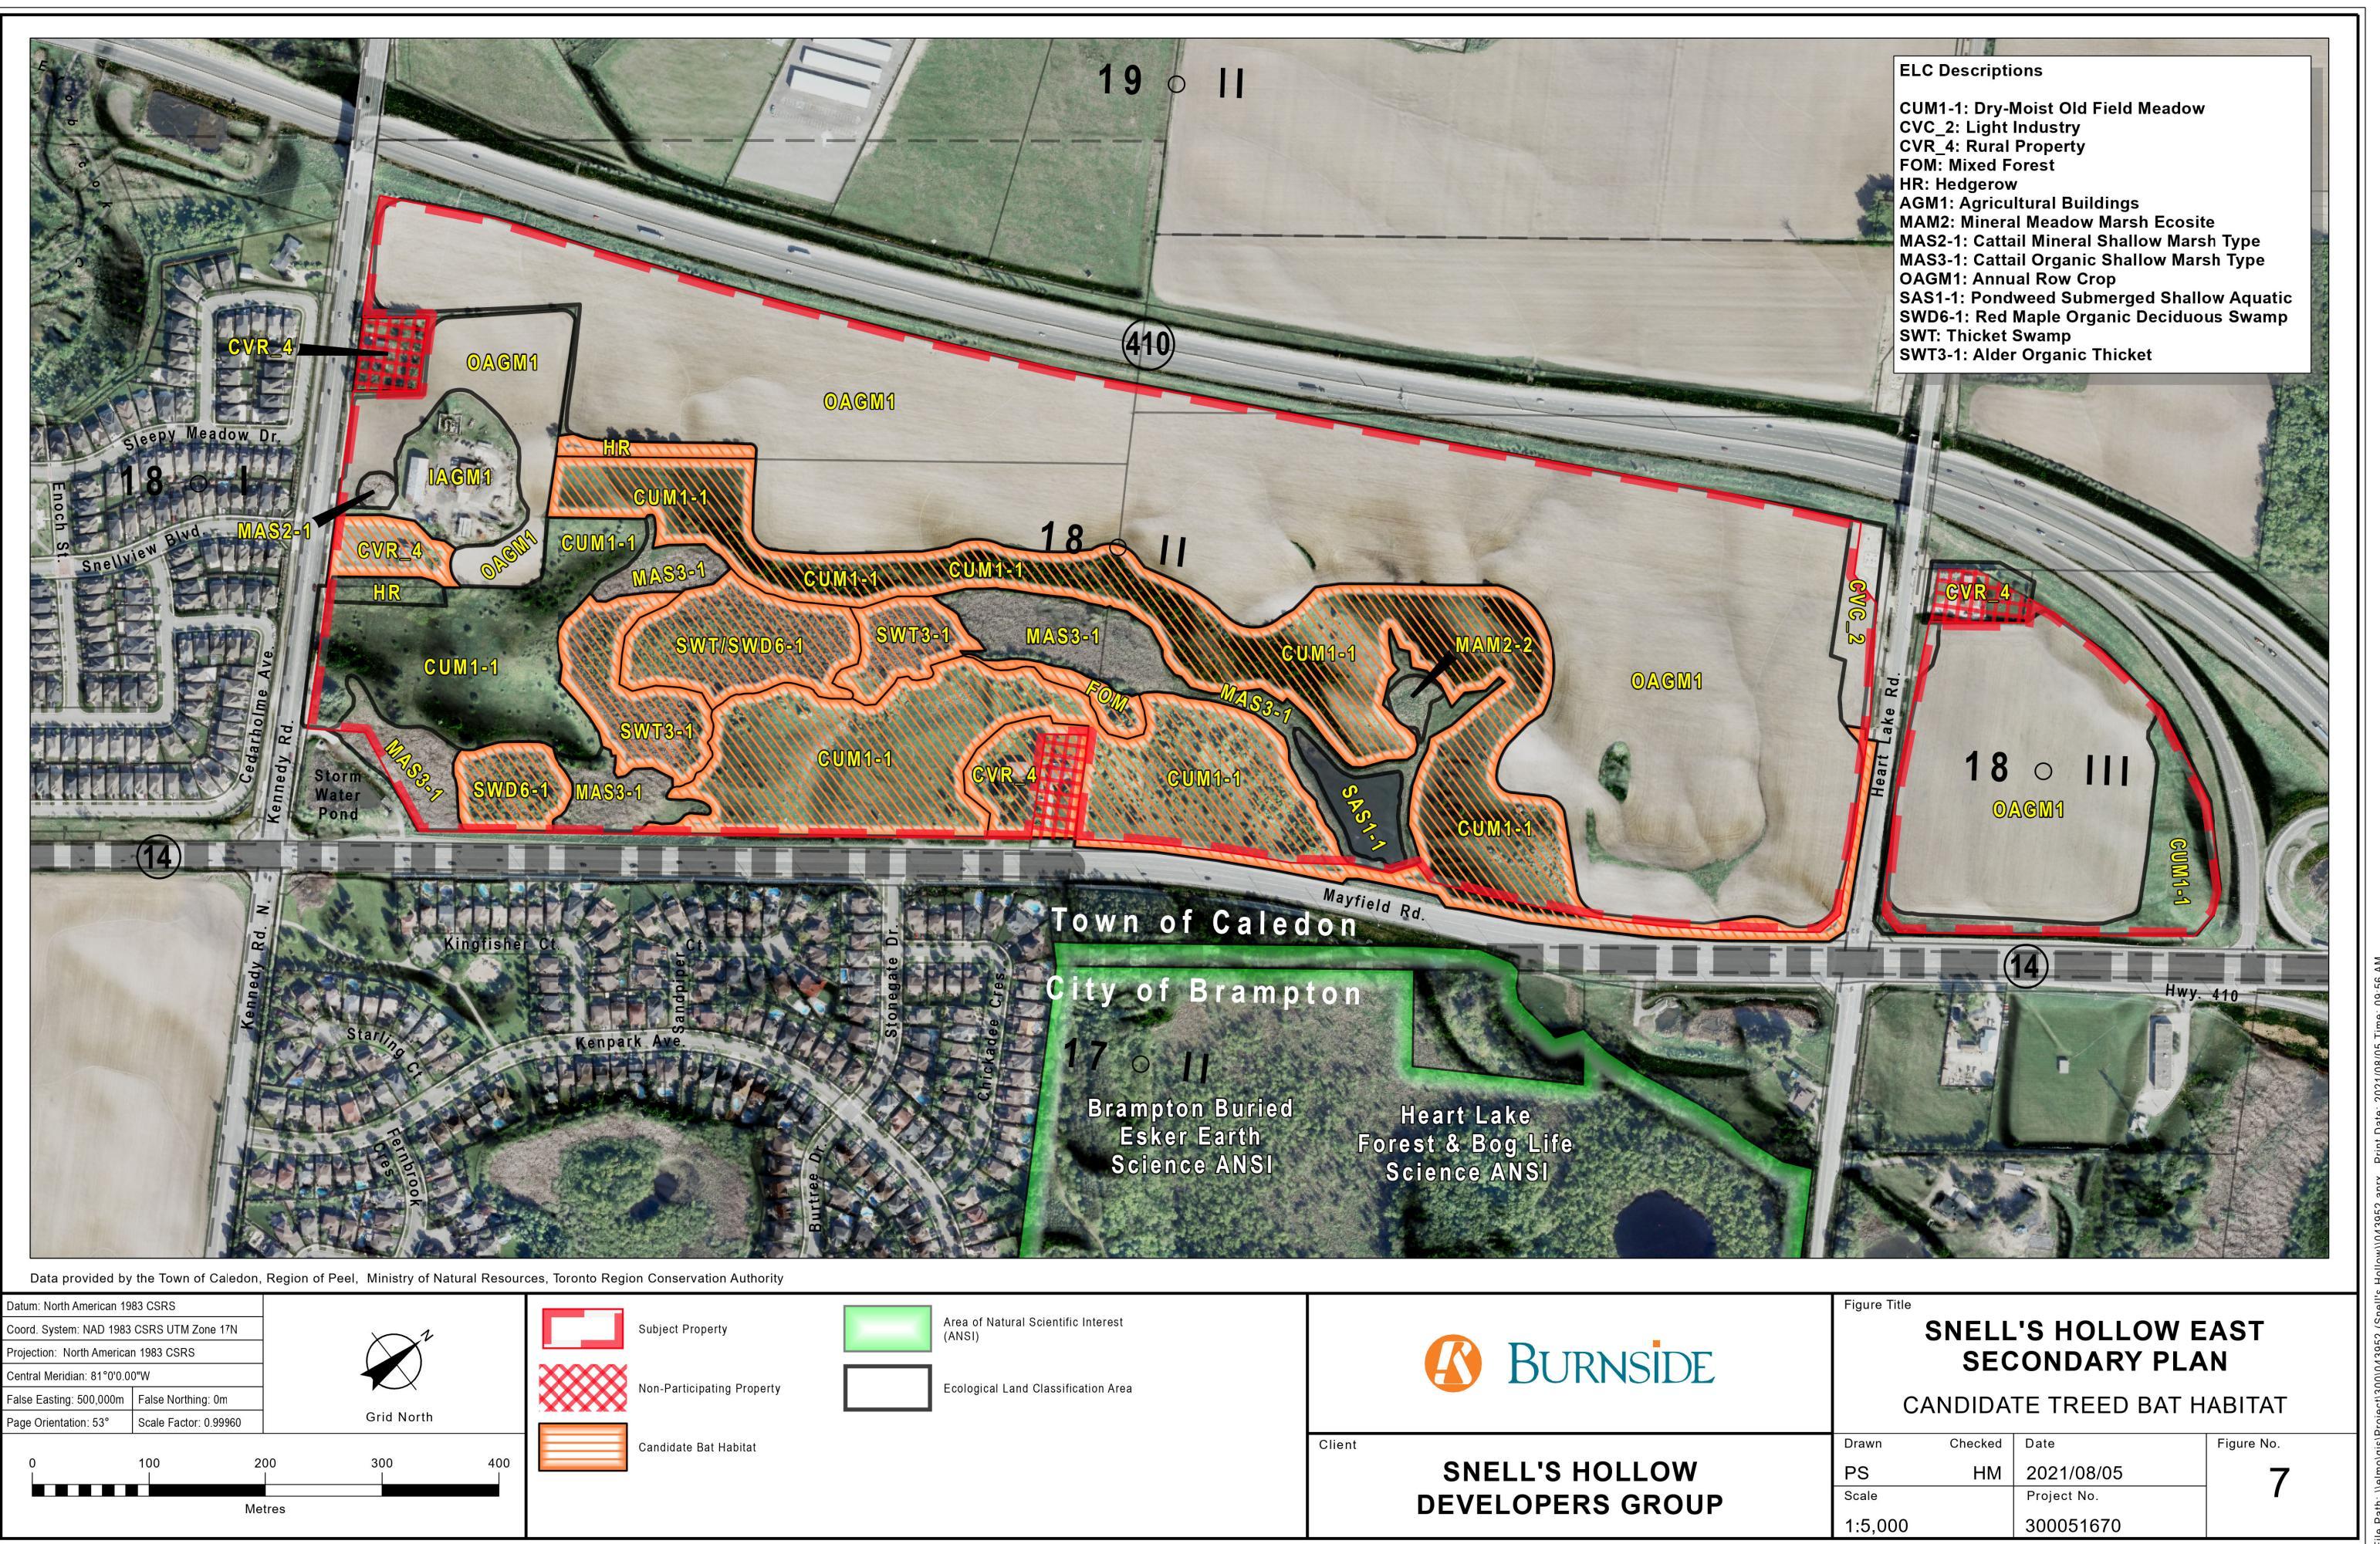
Figure Title	SNELL SEC	'S HOLLOW E ONDARY PLA	AST N
C	ANDIDA	TE TREED BAT H	ABITAT
Drawn	Checked	Date	Figure No.
PS	НМ	2021/08/05	7
Scale		Project No.	
1:5,000		300051670

Furthermore, small habitat communities (<10 ha) require a comprehensive walkthrough of the ecosite to look for snag trees, as opposed to larger sites where subsamples and snag density surveys are more appropriate. Most of the subject property is comprised of agricultural and meadow habitats; however, there are a few smaller treed communities identified. Surveys were completed in the following treed and cultural communities: FOM, SWD6-1, HR, and CUM1-1, as well as residential areas and the boulevard trees surrounding the residential properties, along Kennedy Road and Mayfield Road. Comprehensive walkthrough surveys of these communities were completed during both leaf-off and leaf-on surveys and are depicted on Figure 7. Surveys were not completed within the treed communities of the PSW. This feature is part of the NHS. Currently, no development is proposed within the PSW; if future intrusions are proposed in the wetland and trees will be impacted, further studies would be required. The treed communities located in the PSW are assumed candidate habitat for SAR bats, as shown on Figure 7.
