Comprehensive Environmental Impact Study and Management Plan (CEISMP) Snell's Hollow East Secondary Plan

Part A – Existing Baseline Conditions & Characterization Part B – Land Use Evaluation & Impact Assessment

August 2021 300051670.0000

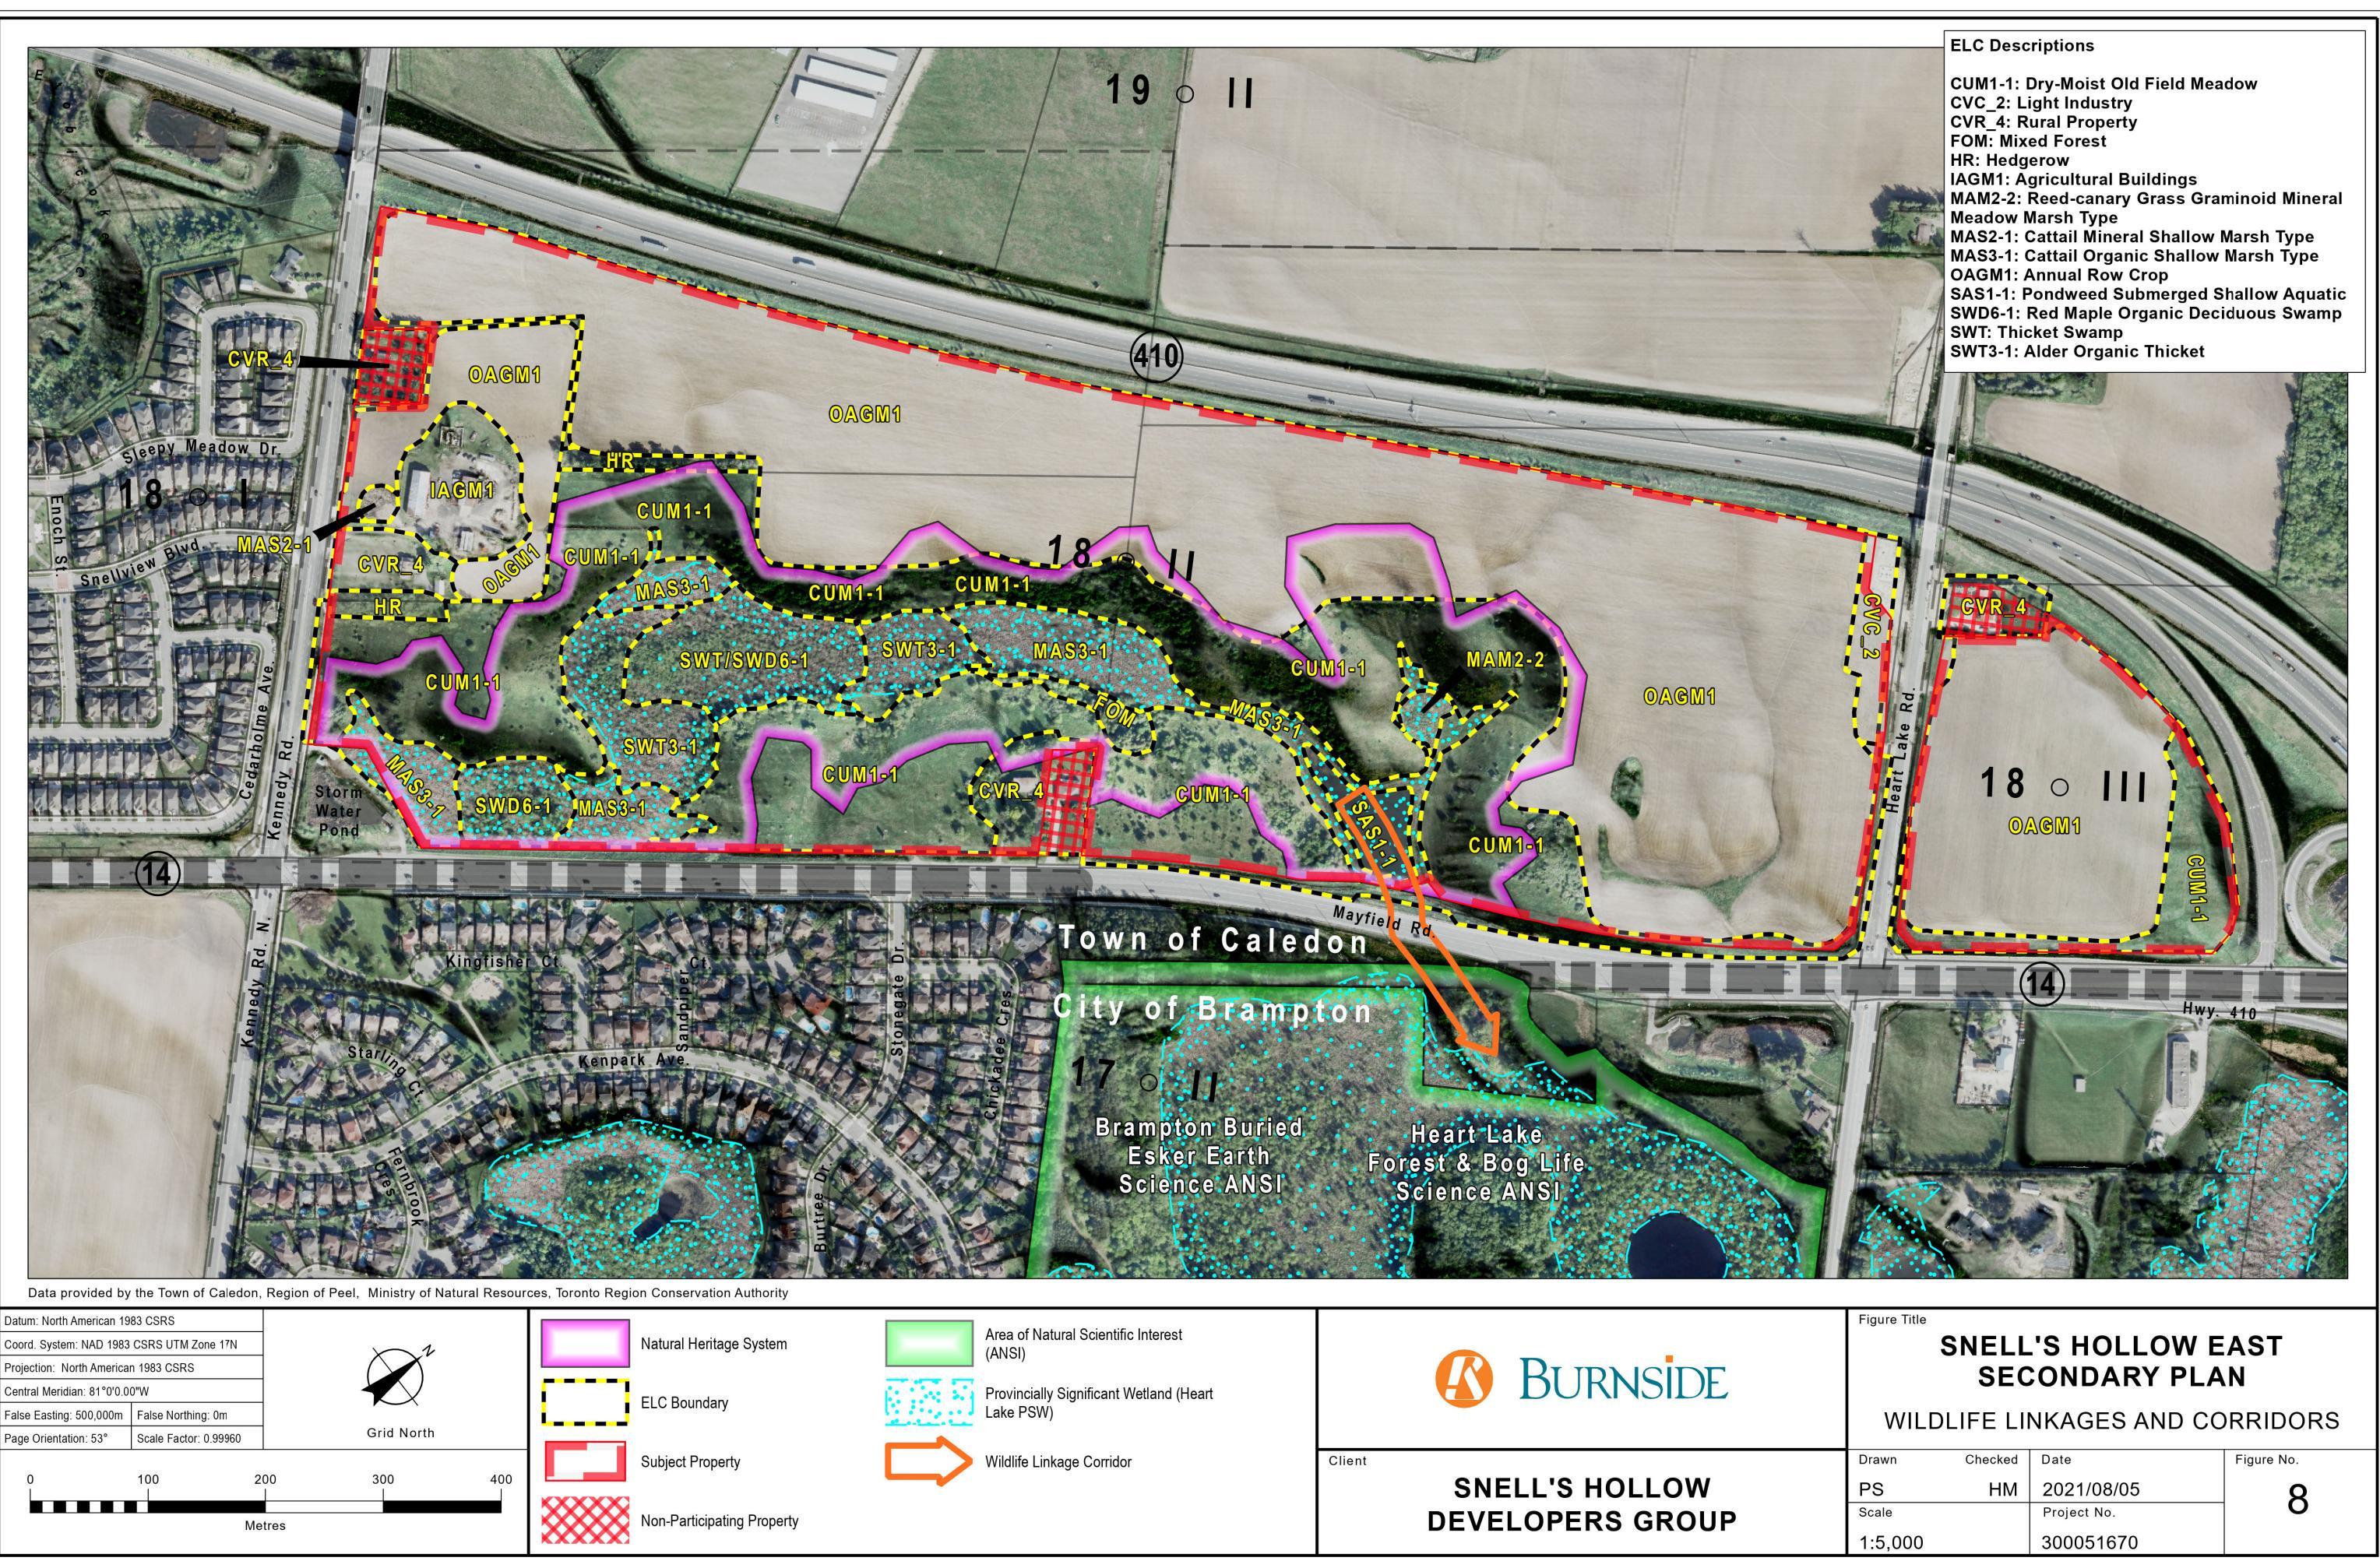
Figure Title SNELL'S HOLLOW EAST SECONDARY PLAN						
	WILDLIFE LINKAGES AND CORRIDORS					
	Drawn	Checked	Date	Figure No.		
	PS	НМ	2021/08/05	8		
	Scale		Project No.	0		
	1:5,000		300051670

At the risk of Wetland No. 1 becoming more isolated due to adjacent development, the existing wildlife linkage at the existing culvert crossing described in Section 7.4 at Mayfield Road should be maintained between these two natural areas for safe wildlife movement. As per the NAI (Volume 3, April 2014), this connectivity will help to maintain ecosystem resilience and the health of this natural area, particularly for the wetland communities. This culvert is a smooth wall steel pipe culvert that is embedded and is 1,050 mm in diameter. Currently, the culvert conveys limited seasonal flow downstream of Mayfield Road and appears to remain mostly dry much of the year. While connectivity with respect to fish passage is not available through this culvert, some native substrate material such as rocks and cobblestone is present (see image below). Based on the size and conditions of the culvert, it is expected that small-sized mammals, as well as amphibians and turtles, may utilize the feature for passage under existing conditions.

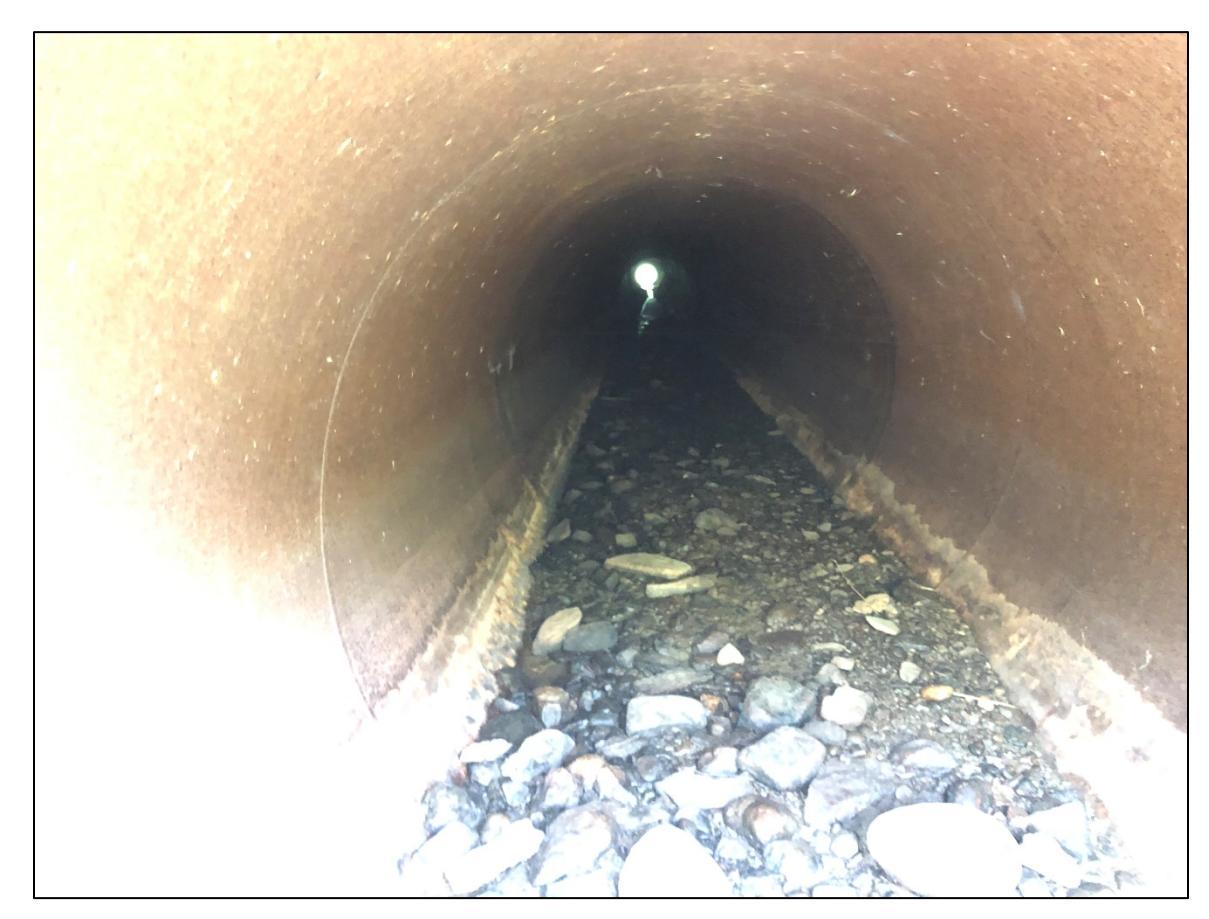
Interior View of Crossing Under Mayfield Road (Photo taken July 2020)
