PHASE TWO ENVIRONMENTAL SITE ASSESSMENT

2256 MAYFIELD ROAD, CALEDON, ONTARIO

WSP Project No. 161-08392-00

September 13, 2016

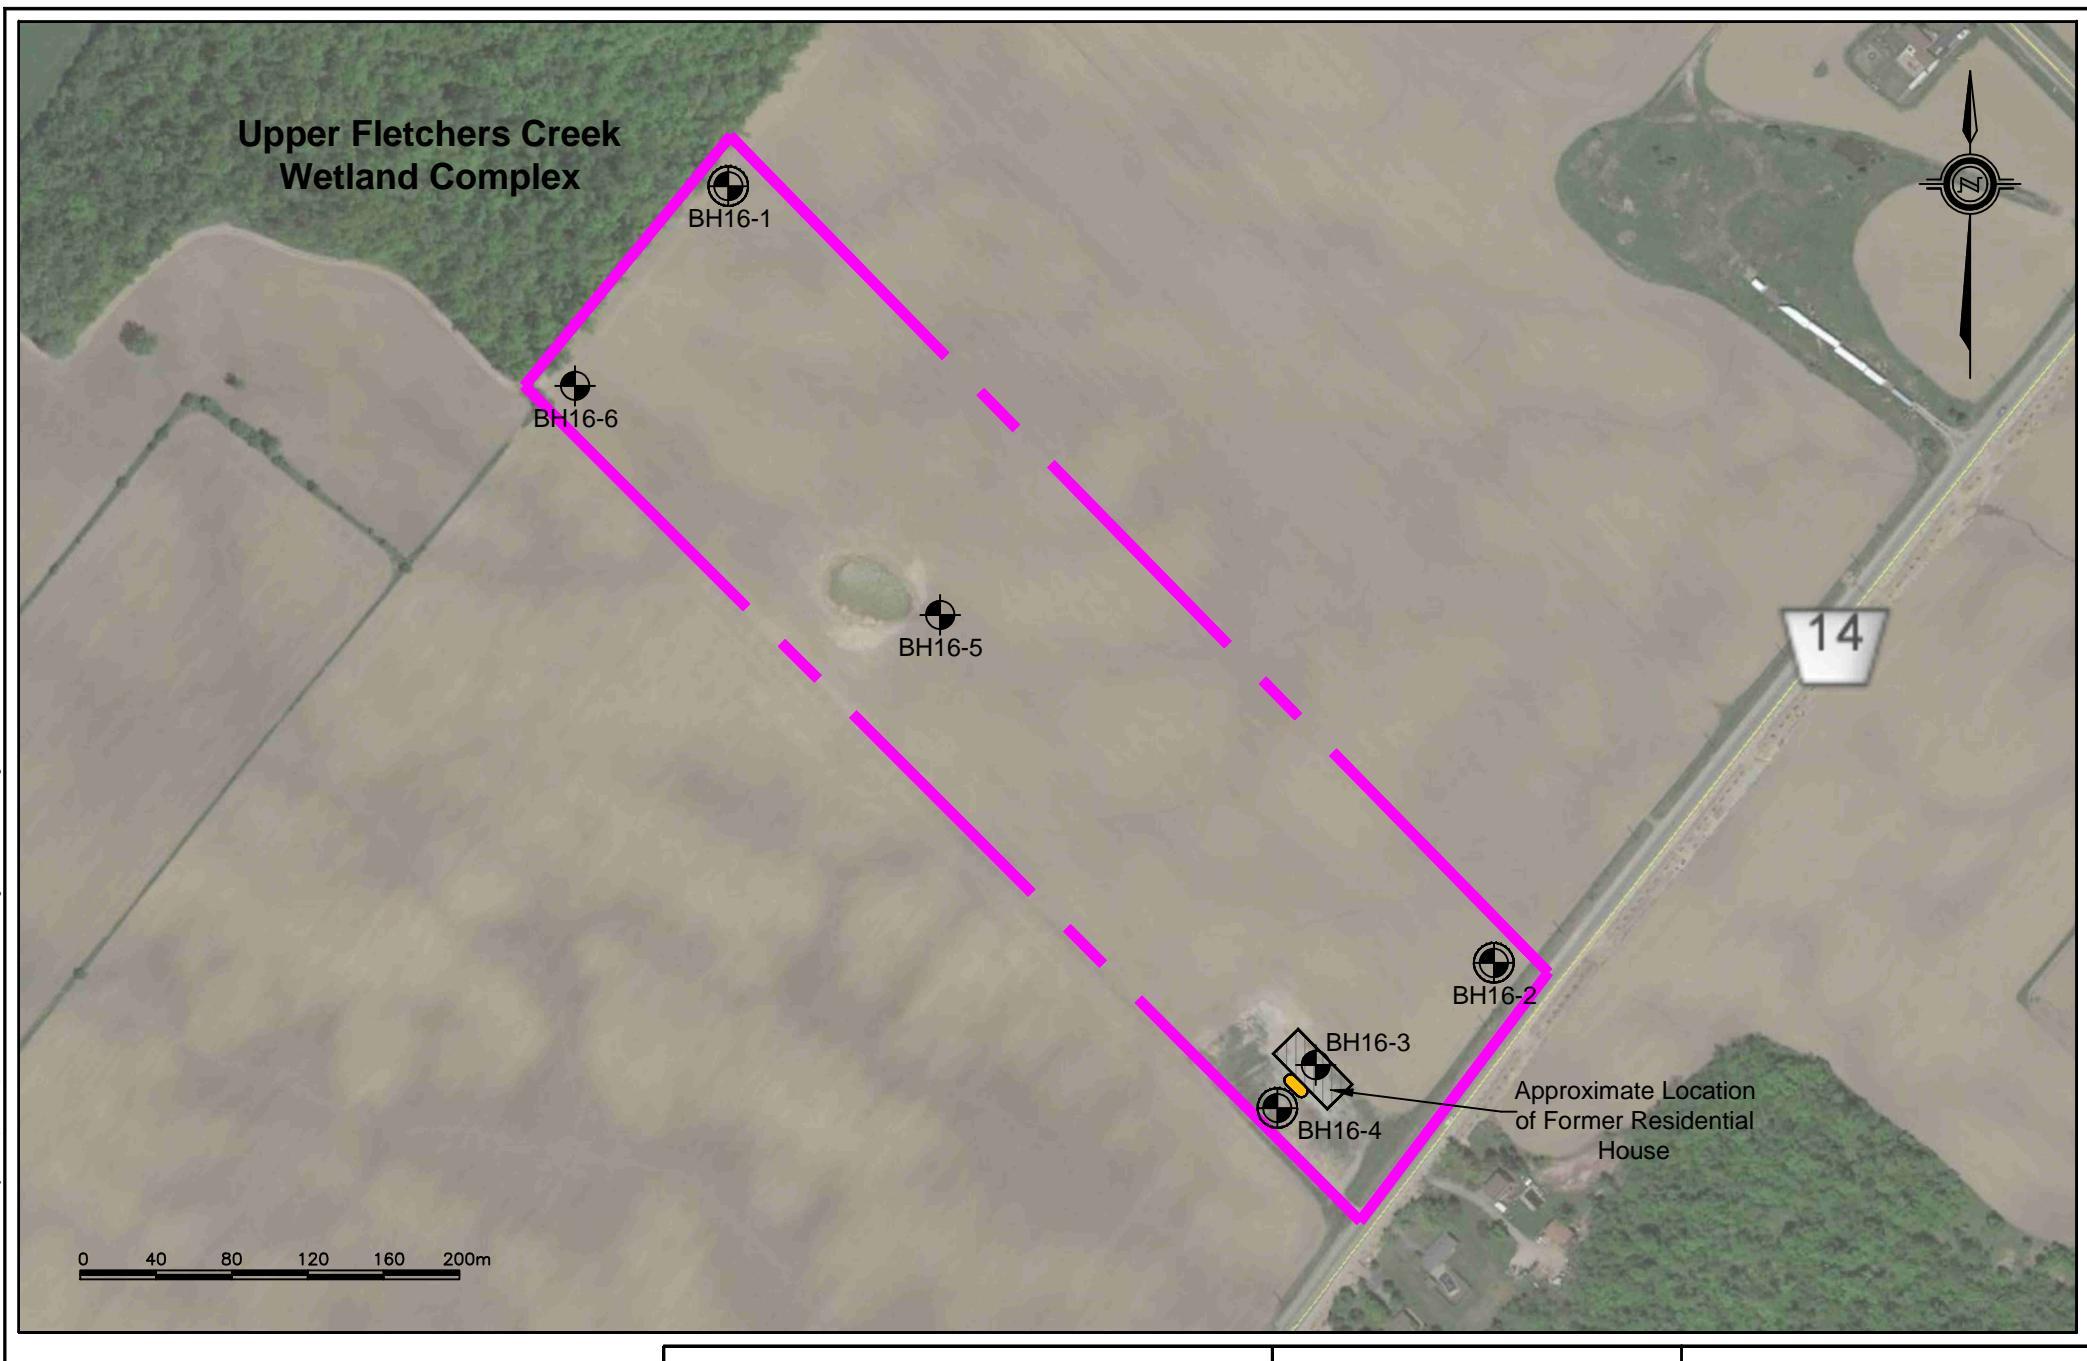
LEGEND:		Client:	lient: Melrose Investments Inc. F			Project No.:	161-08392-00	Drawing No.: 1	
	Phase Two Property	Drawn:	RA	Approved:	MB	Title:	itle: BOREHOLE LOCATION PLAN		
•	Monitoring Well Borehole	Date: S	September 2016	Scale:	As Shown	Project:	PHASE TWO ENVIRO 2256 MAYFIEL	NMENTAL SITE ASSESSMENT D ROAD, CALEDON, ON	
\bigcirc	Approximate Location of Former UST		Tabloid	Rev:	N/A		V	VSP

The Site is rectangular in shape, approximately 11.6 hectares (28.5 acres) in area and is shown in Drawing 1. A legal survey of the Site provided by GB (Mayfield) Inc. is included in Appendix A.

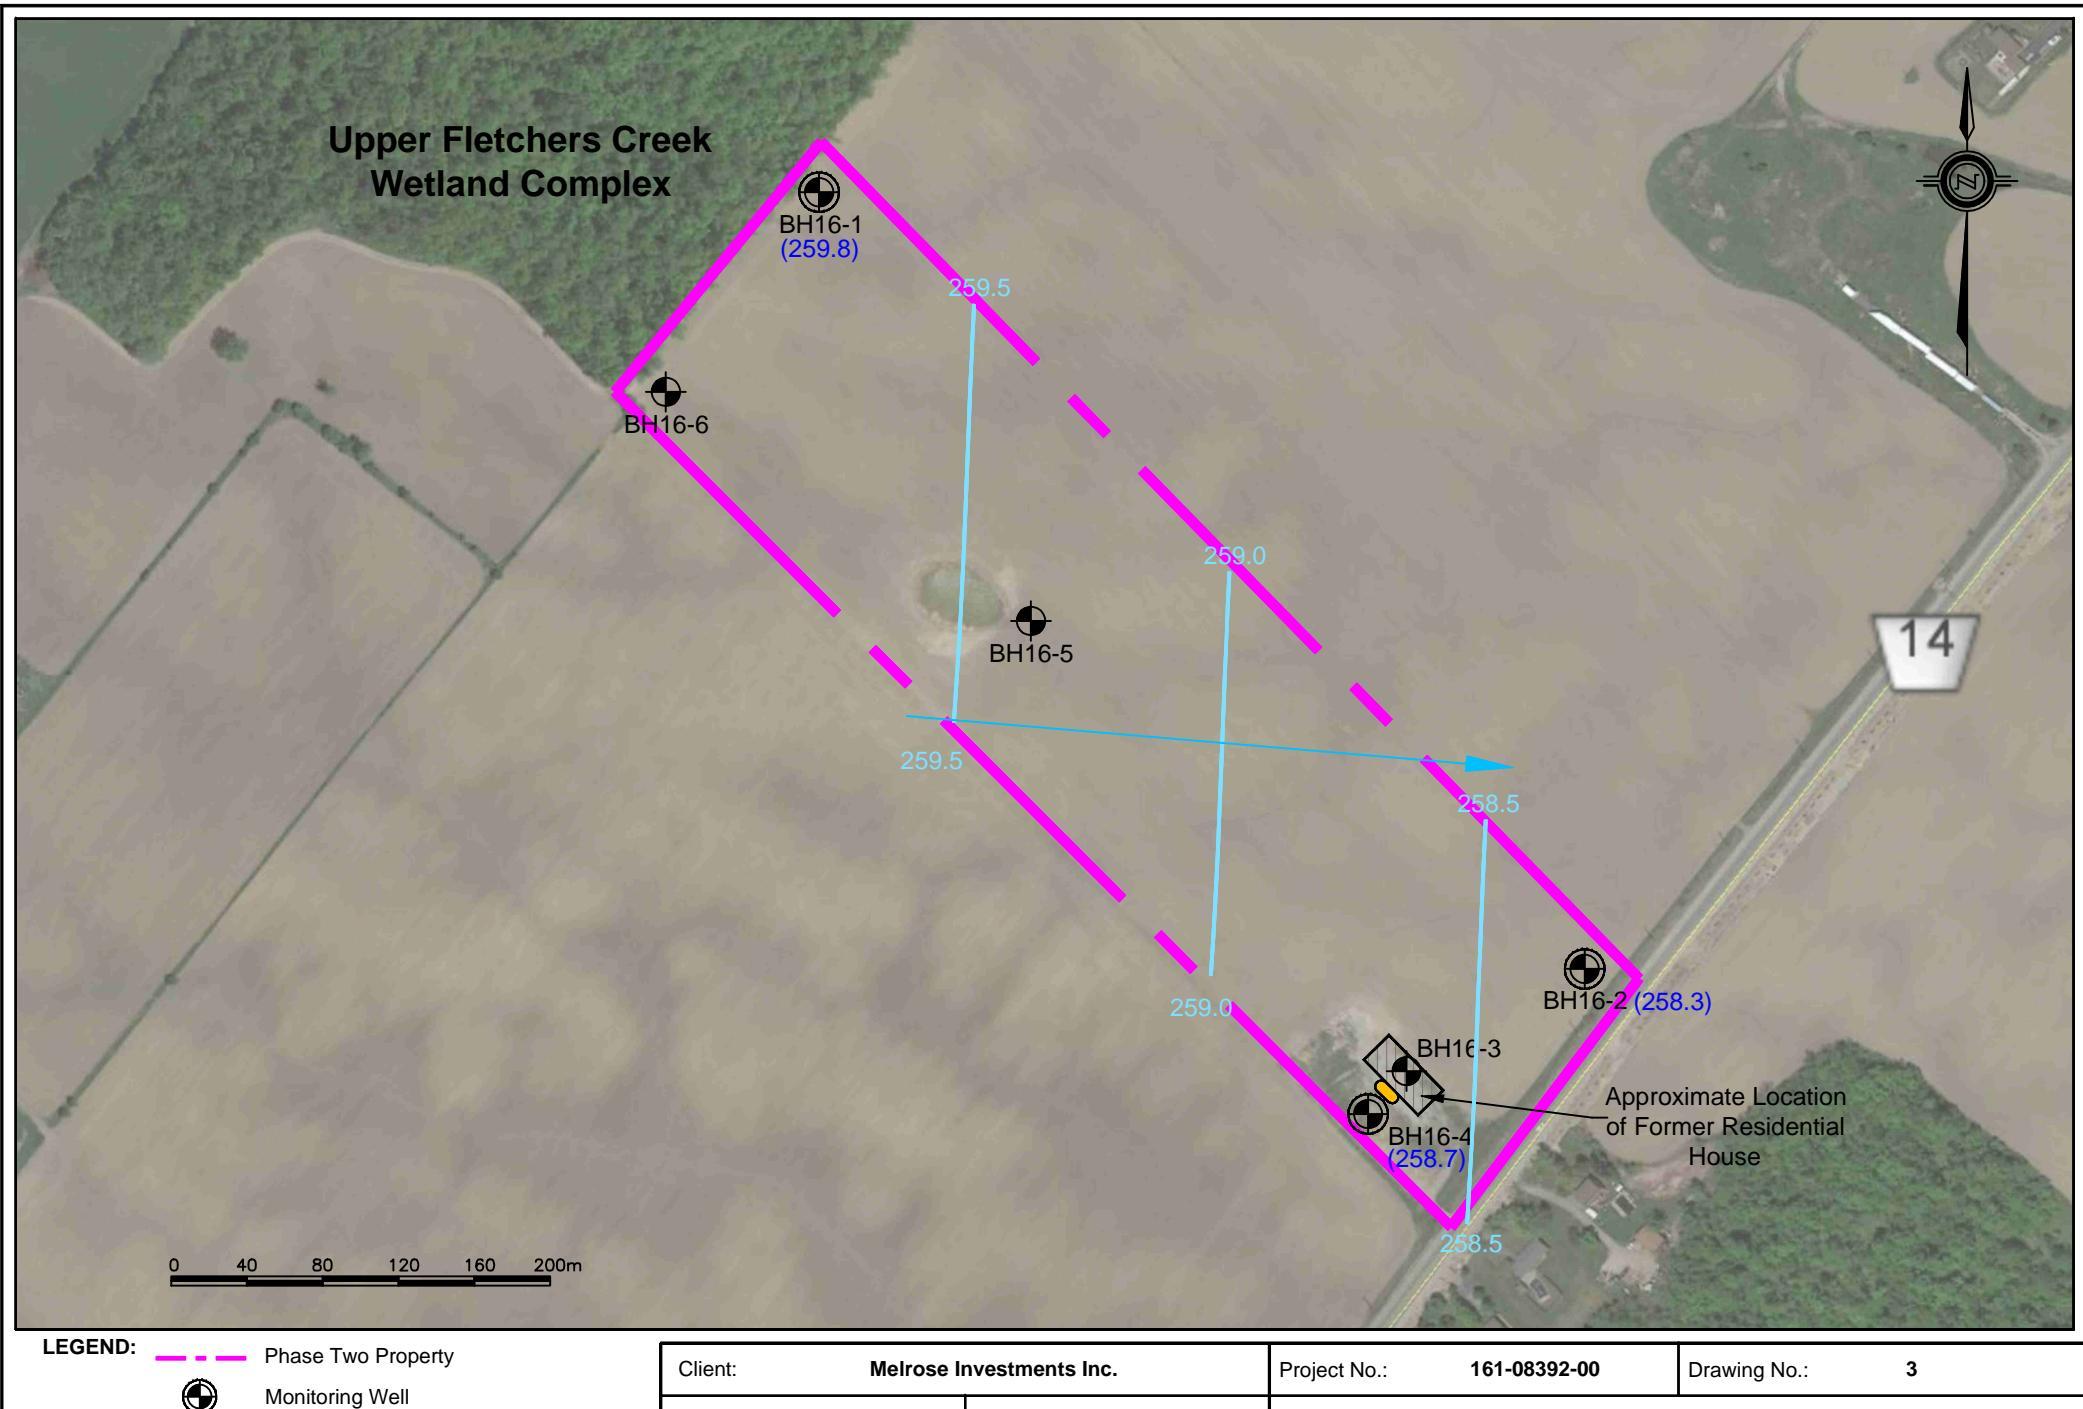
ient: Melrose Investments Inc.			Project No.:	161-08392-00	Drawing No.:	3
	Nonitoring Weil	Drawn:	RA	Approved:	МВ	Title:	RECTION		
$\overset{\frown}{\bigcirc}$	Approximate Location of Former UST	Date:	September 2016	Scale:	As Shown	Project:	PHASE TWO ENVIRO 2256 MAYFIEL	ONMENTAL SITE AS D ROAD, CALEDO	SESSMENT N, ON
	Groundwater Contour	Original	Tableid	Rev:	N/A			VCD	·
(258.7)	Groundwater Level (masl)	Size:	Tabloid					VJF

- The groundwater elevations in the monitoring wells ranged from 258.3 to 259.8 metres above sea level (masl) on June 27, 2016 for the three (3) monitoring wells (BH16-1, BH16-2, and BH16-4) installed by WSP. Based on the water levels the inferred groundwater flow direction is to the southeast. It is possible that groundwater elevations may vary seasonally in this area
