Environmental Assessments & Approvals

AEC 06-011

Re: Addendum Letter to Revised Environmental Impact Study (July 2015) West Part Half Lot 22, Concession 1 Town of Caledon, Region of Peel

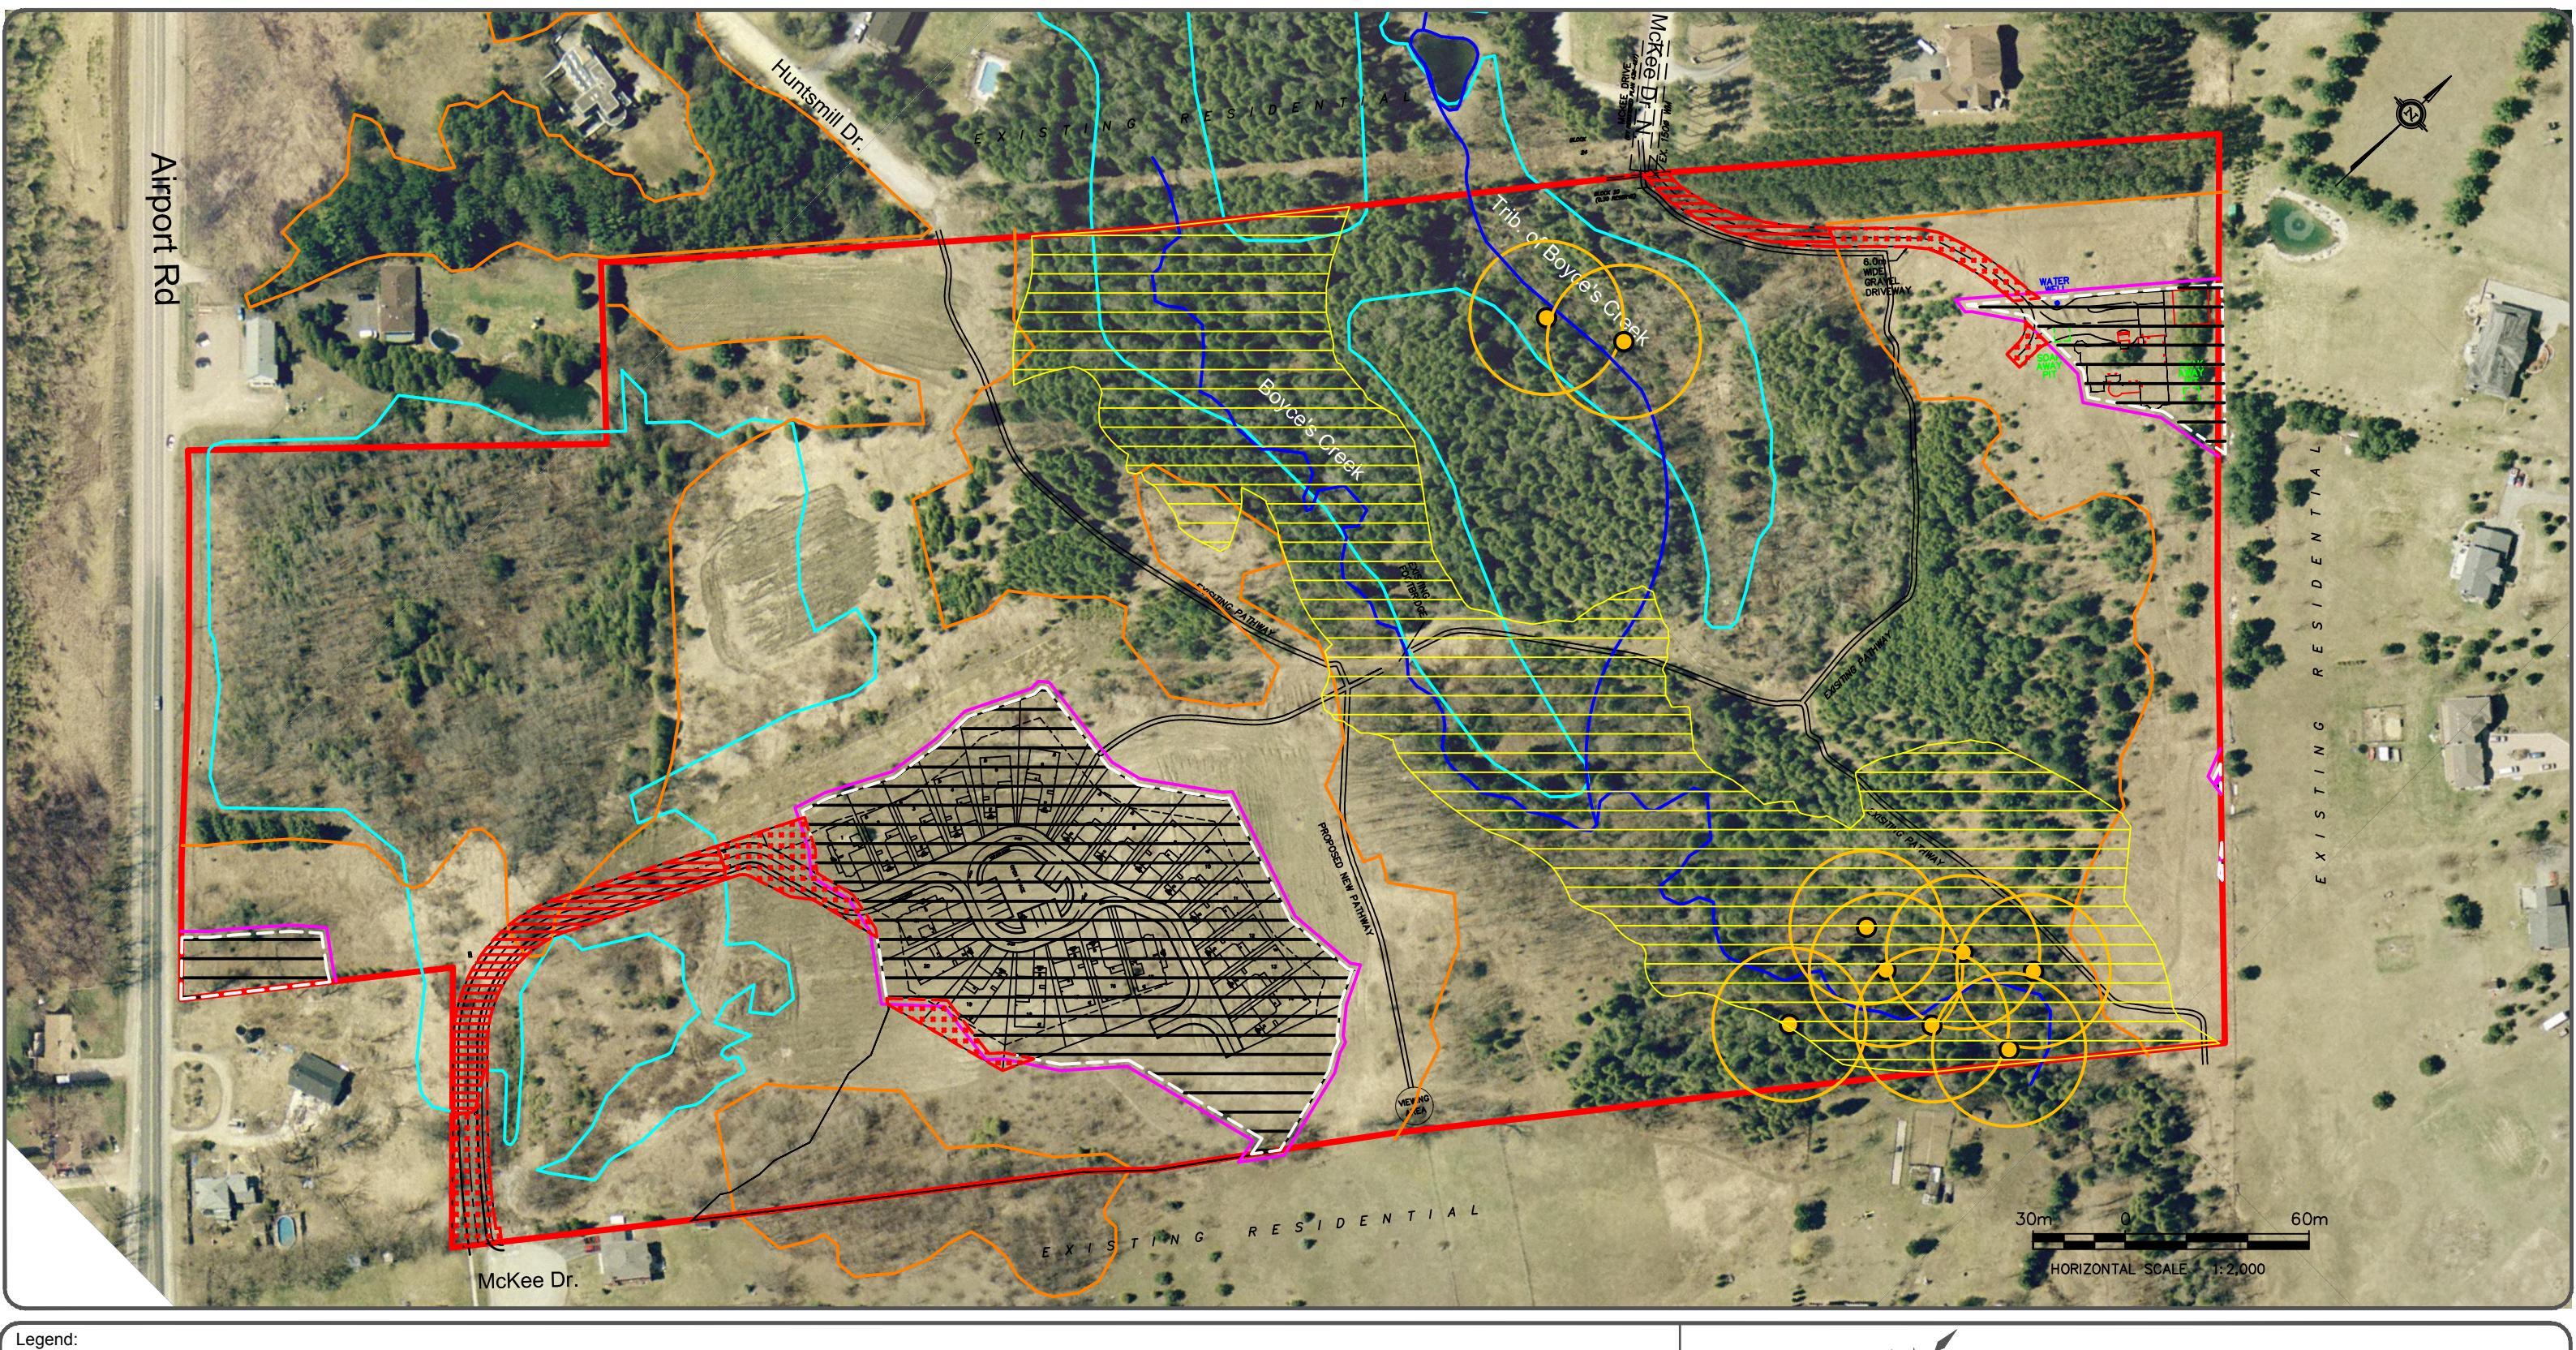
Logondi				· · · · · · · · · · · · · · · · · · ·	
Property Boundary Watercourse - Hydrologically Sensitive Feature (HSE)	& Key Natural Heritage Feature (KNHF)	Minimum Vegetation Protection Zone (MVPZ) (white)	-AZIMUTH ENVIRONMENTAL CONSULTING, INC.		
 (Fish Habitat) MNR Evaluated Wetland (Locally Significant) - HSF Significant Woodland - KNHF 	a ney hatara nentage reature (ninn)	Proposed Encroachment into KNHF/HSF Proposed Encroachment into MVPZ	Consolidated Plan		
Significant Valley Land - KNHF Butternut with 25m Buffer (END) Recommended EPA1 Boundary W:106-011 Caledon East EIS\Drafting\dwg\06-011 2012.dwg			Date Issued:February 2017Created By:JLMProject No.06-011Reference:First Base Solutions	Caledon East EIS Pt W1/2 Lot 22, Con. 1 Town of Caledon	Figure No.

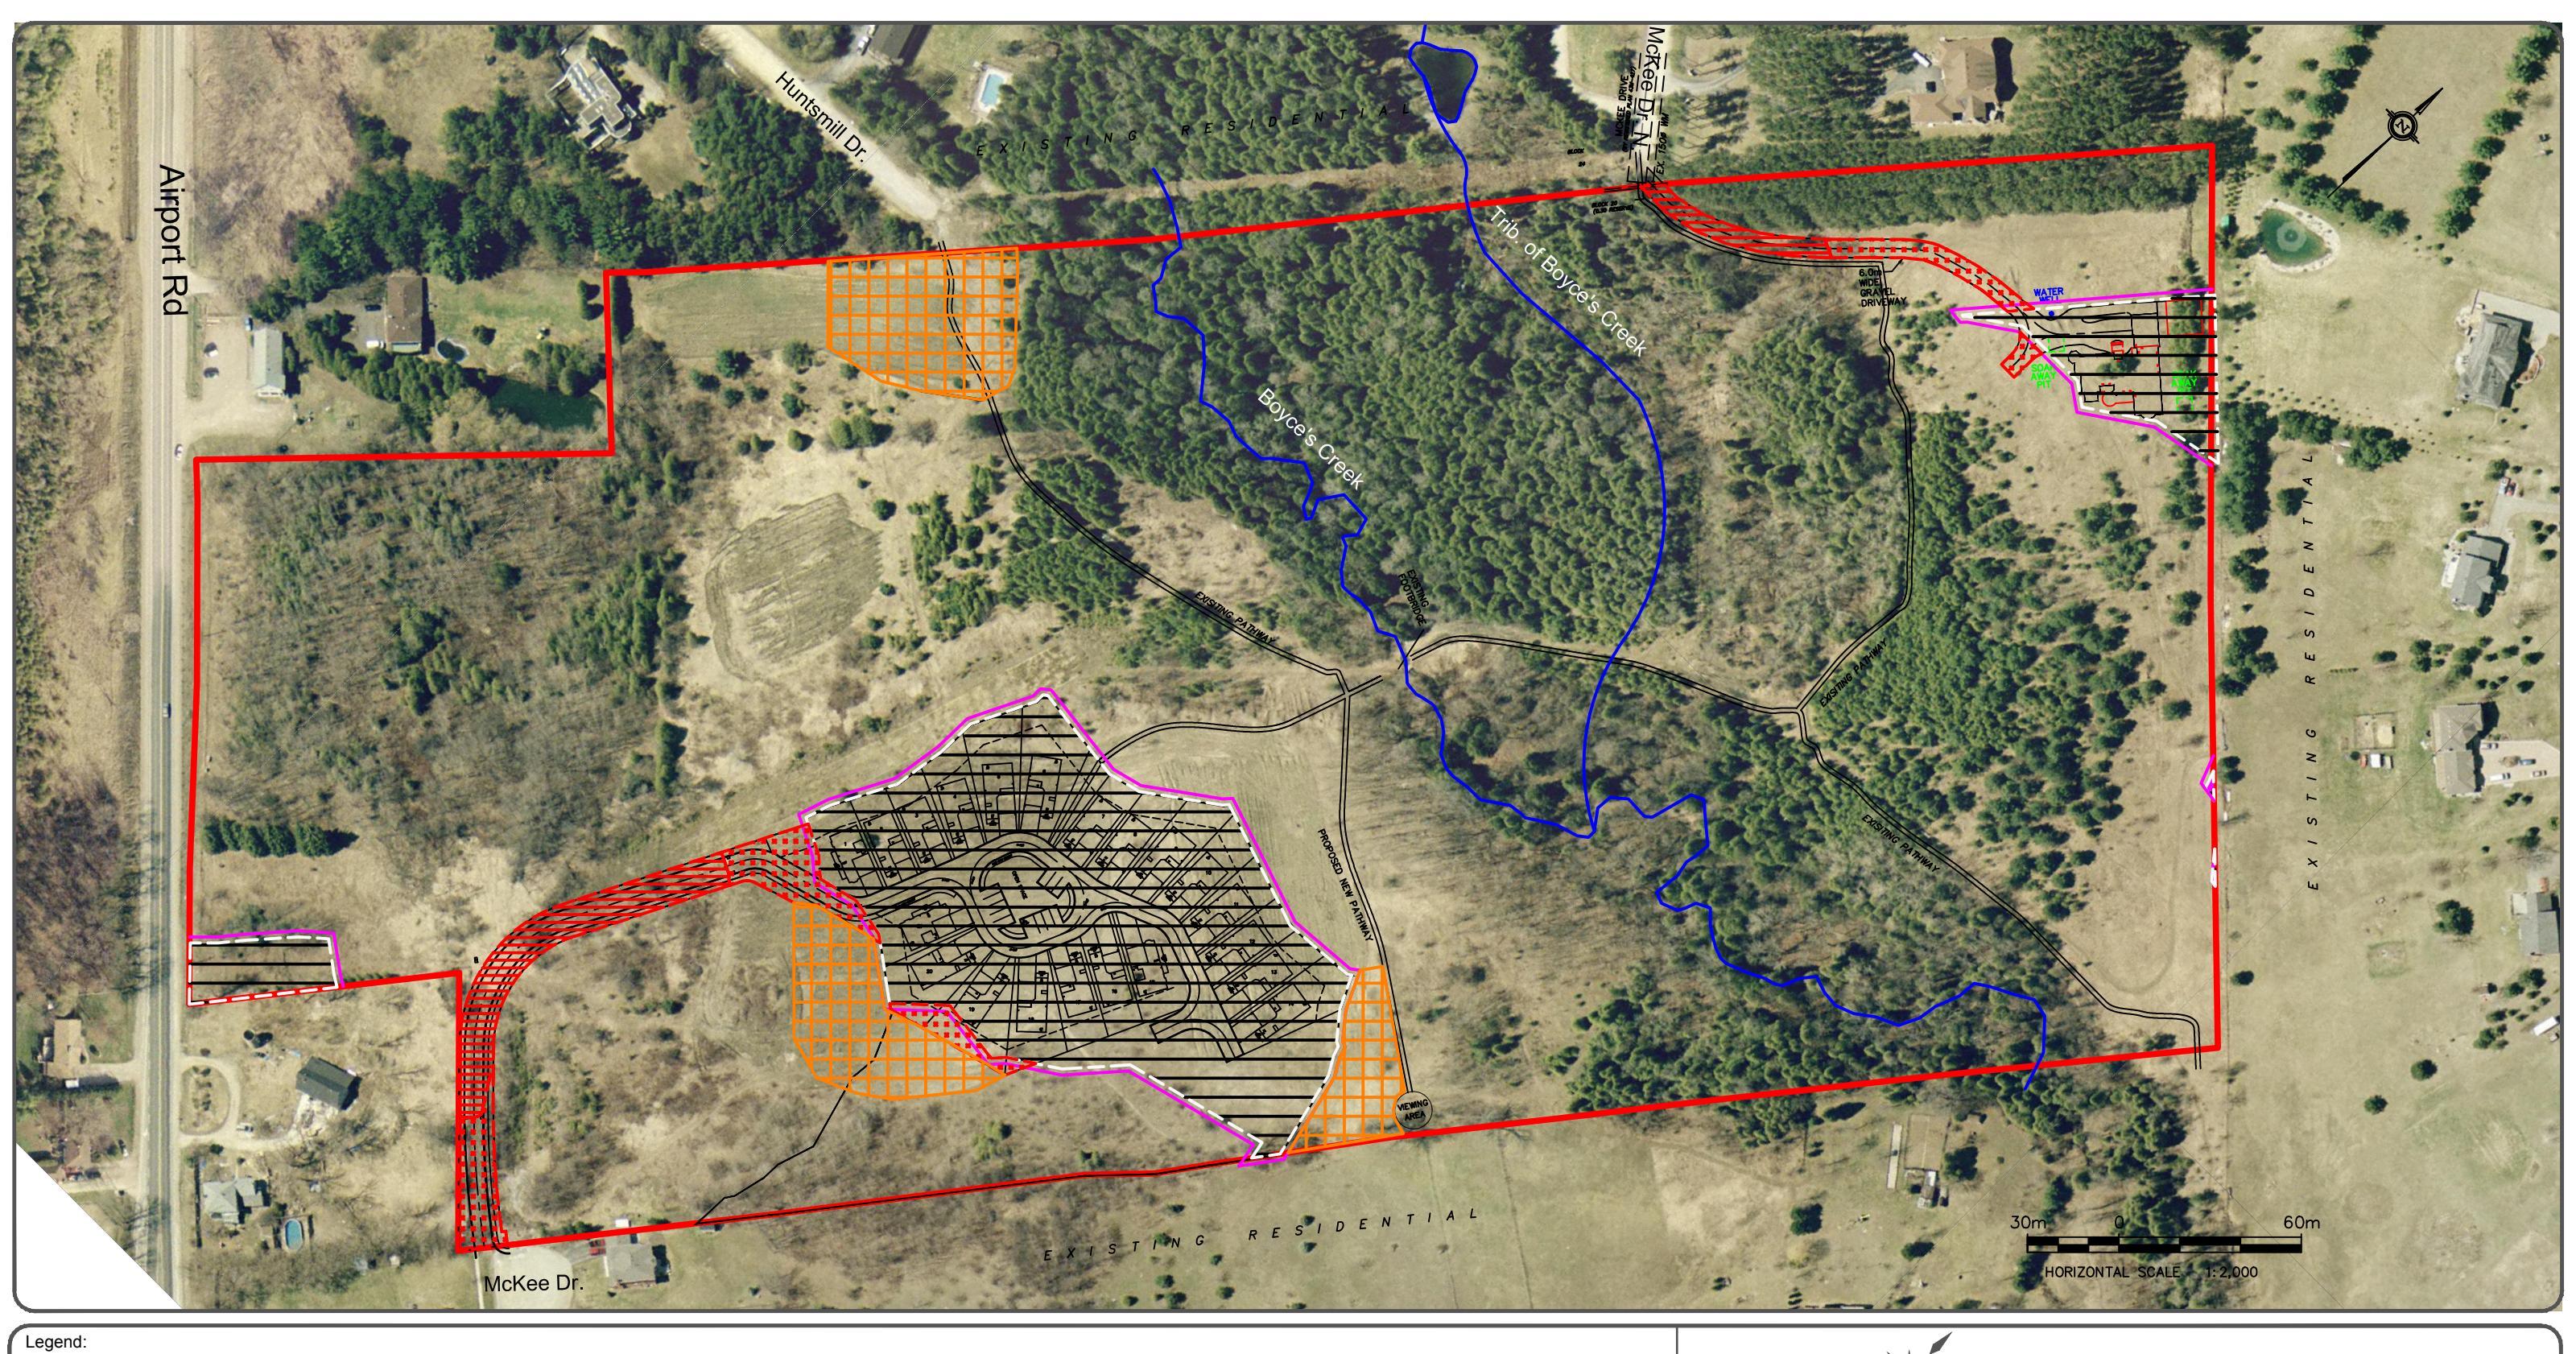
MUTH ENVIRONMENTAL CONSULTING, INC.				
osed Compensation Areas				
Caledon East EIS	Figure No.			
Pt W1/2 Lot 22, Con. 1 Town of Caledon	6

Property Boundary
 Watercourse - Hydrologically Sensitive Feature (HSF) & Key Natural Heritage Feature (KNHF) (Fish Habitat)

Minimum Vegetation Protection Zone (MVPZ) (white)

Potentially Developable Area

Proposed Encroachment into KNHF/HSF

Proposed Encroachment into MVPZ

Proposed Compensation Planting Area

Recommended EPA1 Boundary

In order to compensate for the proposed minor encroachments into identified KNHF/HSF and their associated MVPZ, compensation in the form of an Enhancement Planting Plan is be required. The detailed Enhancement Planting Plan including details of planting

techniques, timing, species composition and maintenance will be prepared at detail design stage. It is proposed that a compensation ratio of 2:1 for encroachment into the KNHF/HSF and that a compensation ratio of 1:1 is provided for encroachment into the MVPZ. Based on this recommended compensation ratio, it is proposed that 0.59 hectares (ha) is planted within areas of the property generally void of tree/shrub cover as depicted on Figure 6. Please note that the proposed compensation areas are for all of the proposed encroachments into the KNHF/HSF and their associated MVPZ related to the entire development proposal (not just for the wetland feature). The proposed enhancement plantings will increase the overall tree/shrub cover on the property while providing a connection between KNHF/HSF both on and off-site.
