# 2024 Annual Stormwater Performance Report

SUBMITTED TO THE MINISTRY OF ENVIRONMENT, CONSERVATION AND PARKS

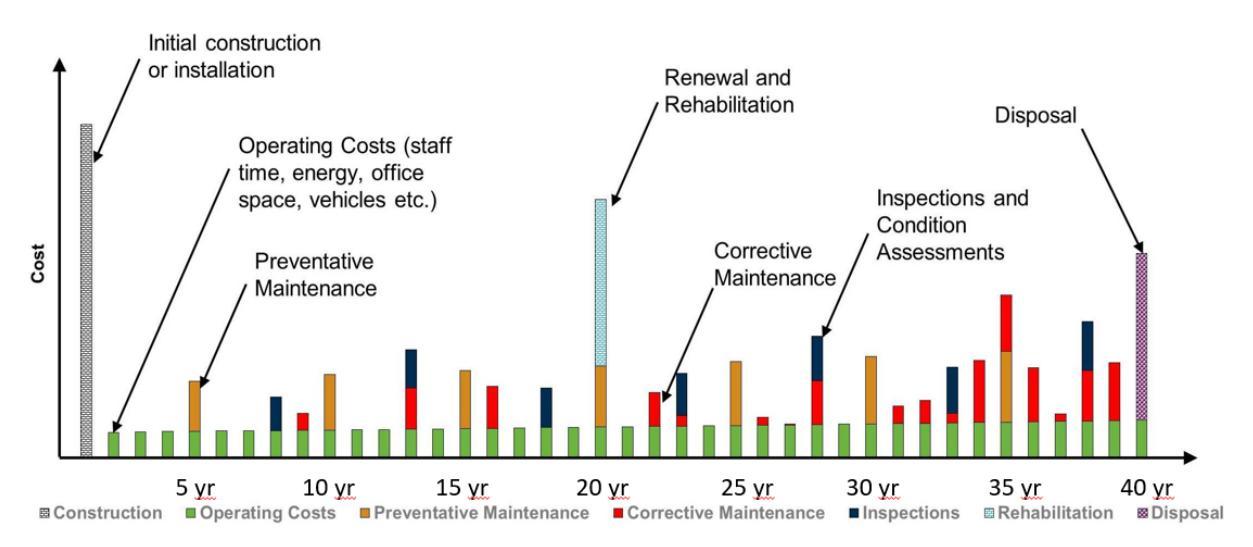
Figure 1: Visual Depiction of the Town's Stormwater Operation and Maintenance Approach

As per the Town's CLI-ECA Issue 2, the Town is to prepare and implement an operation and maintenance manual by January 1, 2026. While the operations and maintenance (O&M) manual is underway, the Town is committed to ensuring the stormwater management system is maintained and operational. The following figure depicts the Town's intended approach to operate and maintain our stormwater infrastructure. The content provided in this section includes actions the Town has undertaken throughout the reporting period to ensure system function.
