GIFFEN FARMHOUSE

Statement of Cultural Heritage Value or Interest

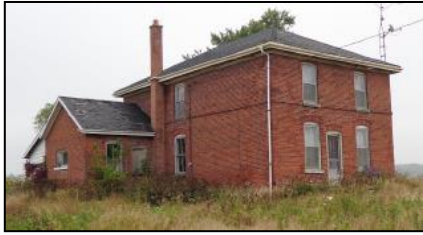
The Giffen Farmhouse is a well-crafted two storey, hip roofed house form building clad in a red brick veneer. A one storey brick wing, attached to the north side of the building, has a gable roof. The building is distinguished by its southern entrance opening, which contains a centre door, segmental arched transom, side lights and box paneling, by its use of terra cotta in banding around the three elevations visible to the street and in the filigreed tiles in the second storey of the west elevation and by the narrow projecting brick hoods over almost all window and door openings. Other notable features on the exterior of this structure include almost all opening having segmental arches with radiating brick voussoirs, the two over two original window sashes, the projecting eaves and the coursed, squared rubble stone foundation with a rock faced finish. The building displays a high degree of heritage integrity on the exterior, retaining most of its original features.

- The two storey dwelling;
- The scale, form and massing of the rectangular plan with its one storey kitchen wing on the north elevation;
- The coursed squared rubble stone foundation with its rock faced finish;

- The red brick cladding, with wood lug window sills, brick ears on the window openings and radiating brick voussoirs over the segmental arches over all openings except the door opening on the west elevation of the kitchen wing which has a flat arch;

- The hip roof of the main structure with its the projecting eaves, moulded frieze and quarter round;
- The asymmetrical organization of all facades;
- All window openings, except the window on the north elevation of the kitchen wing, window frames and sashes, including the two over two glazing in almost all windows together with the glazing of the windows on the east elevation;

- The entrance opening on the south elevation, including frame, door, side light and transom;
- The entrance opening on the west elevation;
- The interior window openings and their casings;
