# Hydrogeological Investigation Septic Impact Assessment Residential Townhouse Subdivision Agnes Street

The Alton Development Inc.  
1402 Queen Street  
Alton, ON  
L7K 0C3

January 28, 2025  
Revised October 15, 2025  
T1220087.000

Alton, Ontario

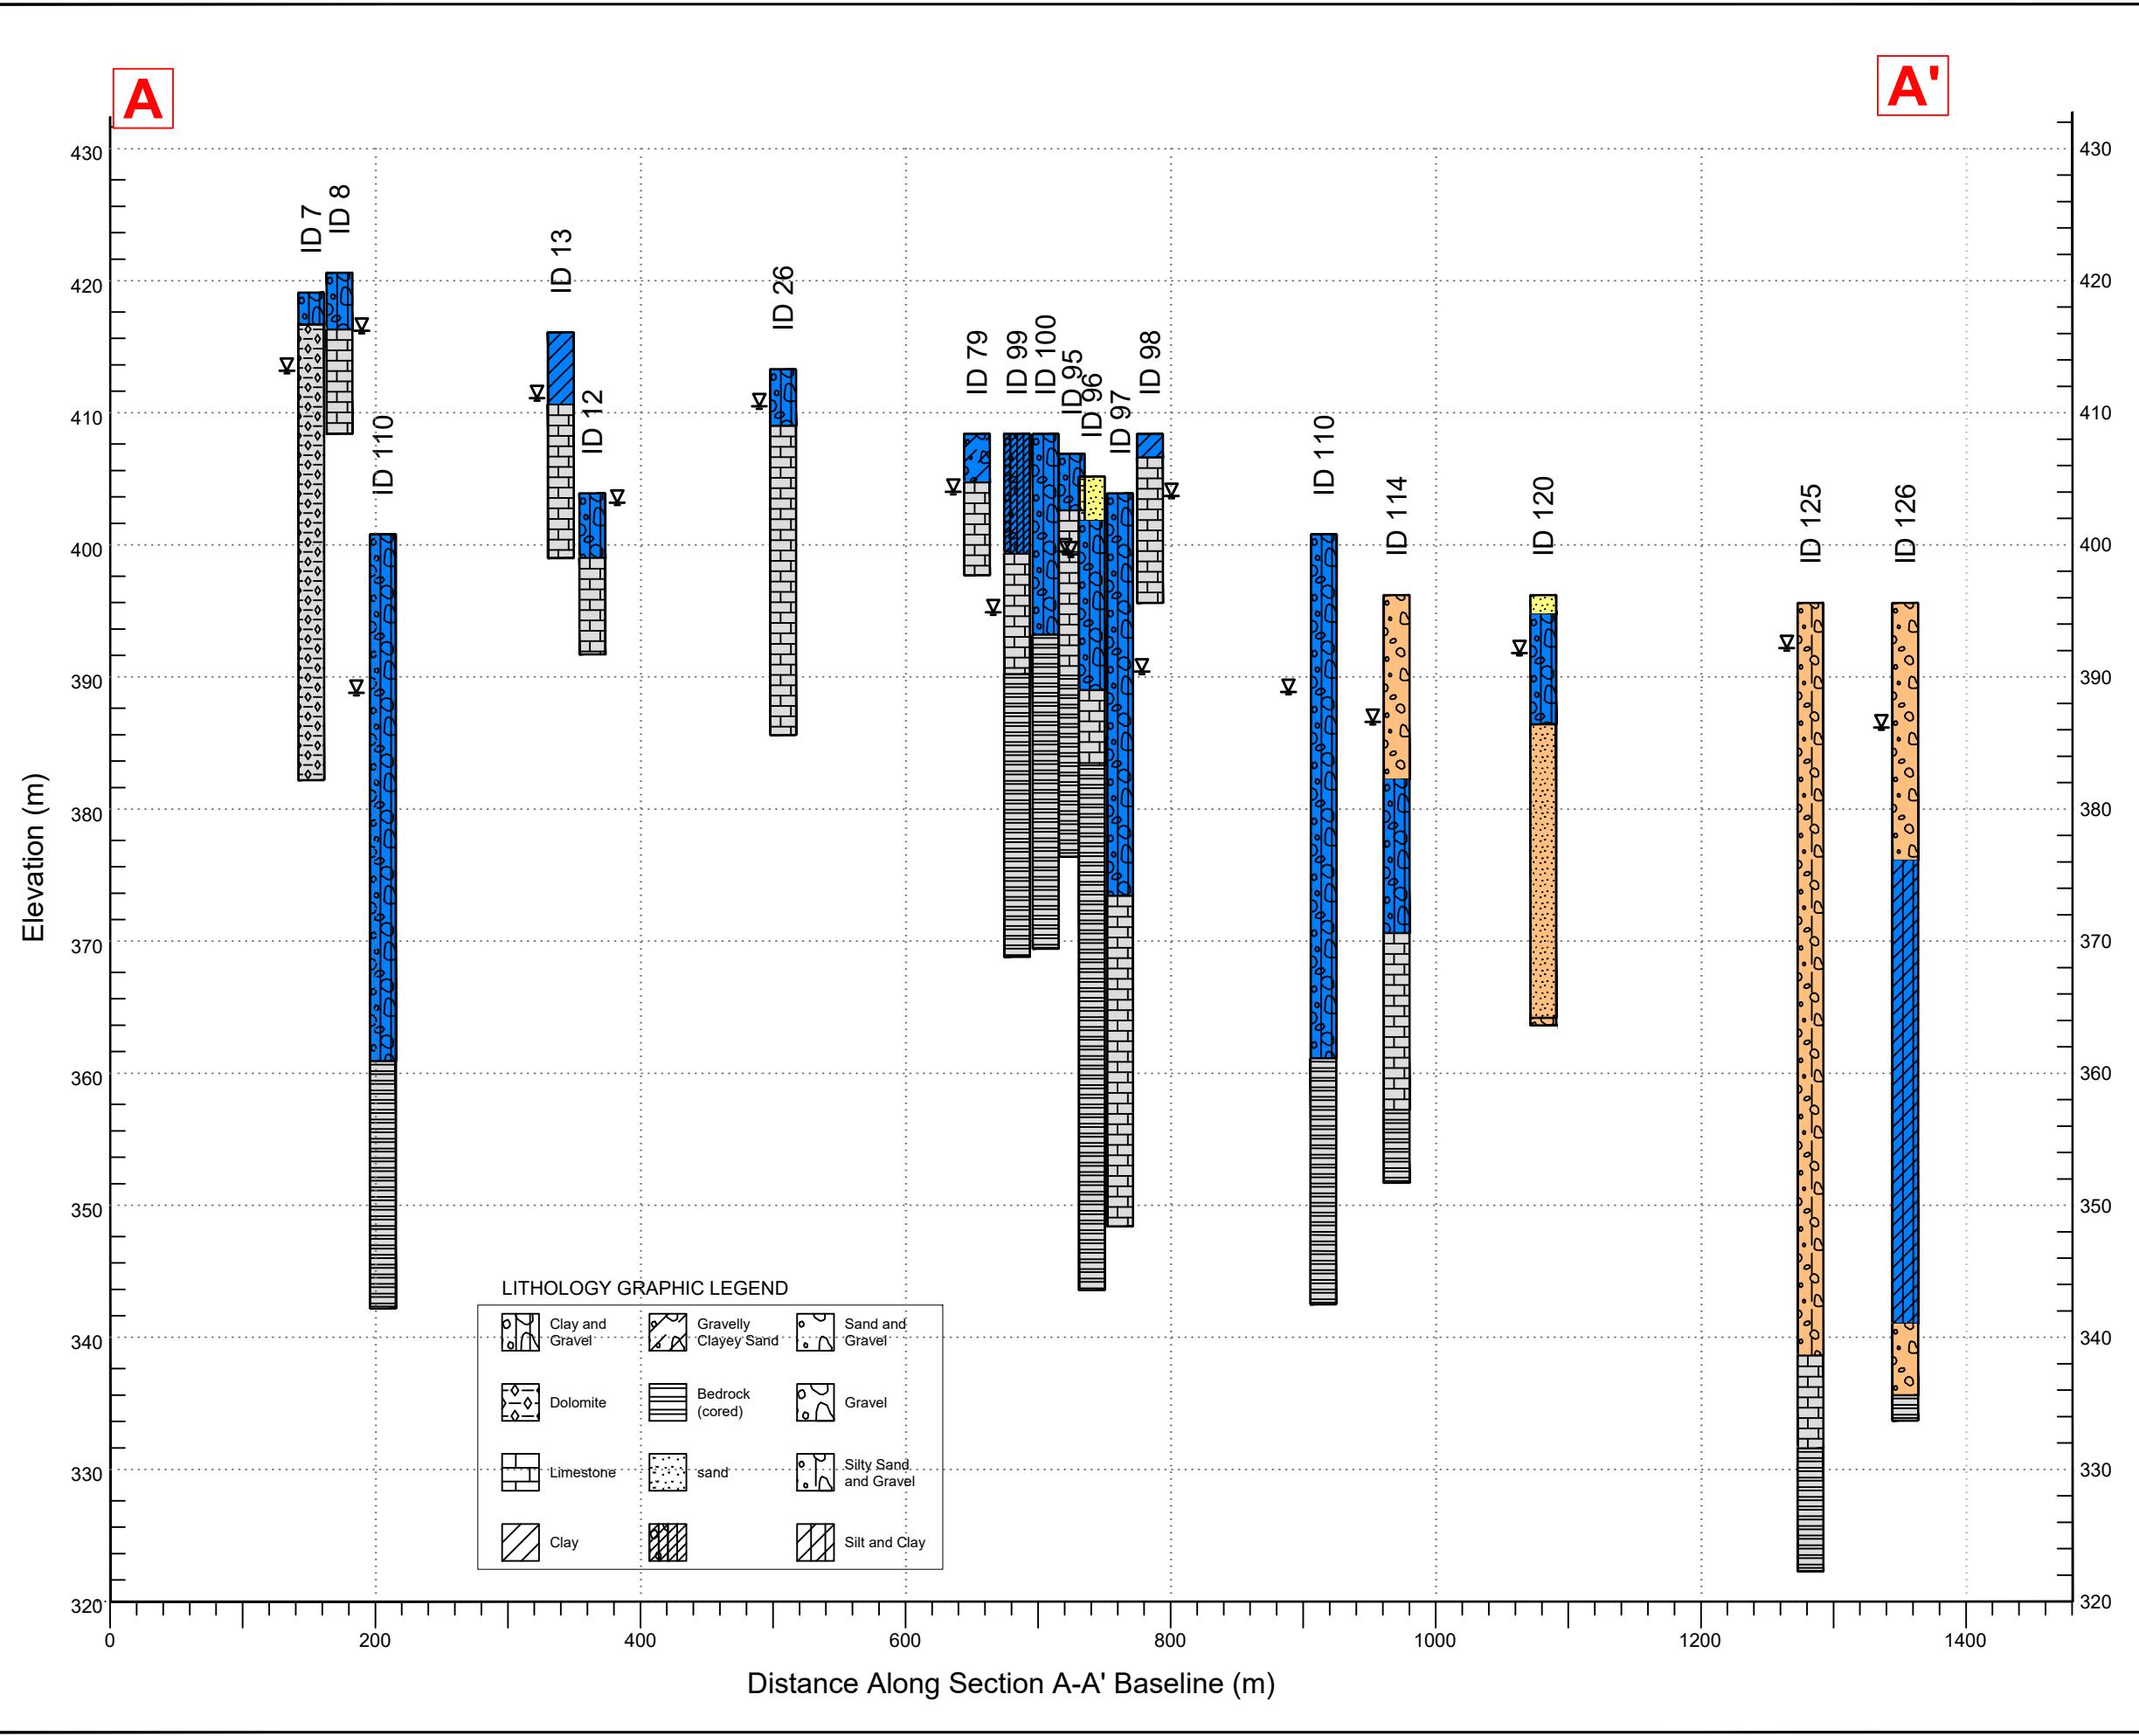
A		Final	
Revision	Date	Issue	Approval
<b>The Alton Development Inc.</b>			
<b>Agnes Street, Alton, Ontario</b>			
<b>Hydrogeological Investigation</b>			
<b>Cross-Section A-A'</b>			
Designed By	P.R	Scale	As Shown
Drawn By	J.B	Date	October 2024
Approved By	B.W	Project No.	T1220087.000
Figure No. 6

Gravels
Cohesive Soils
Sand
Bedrock

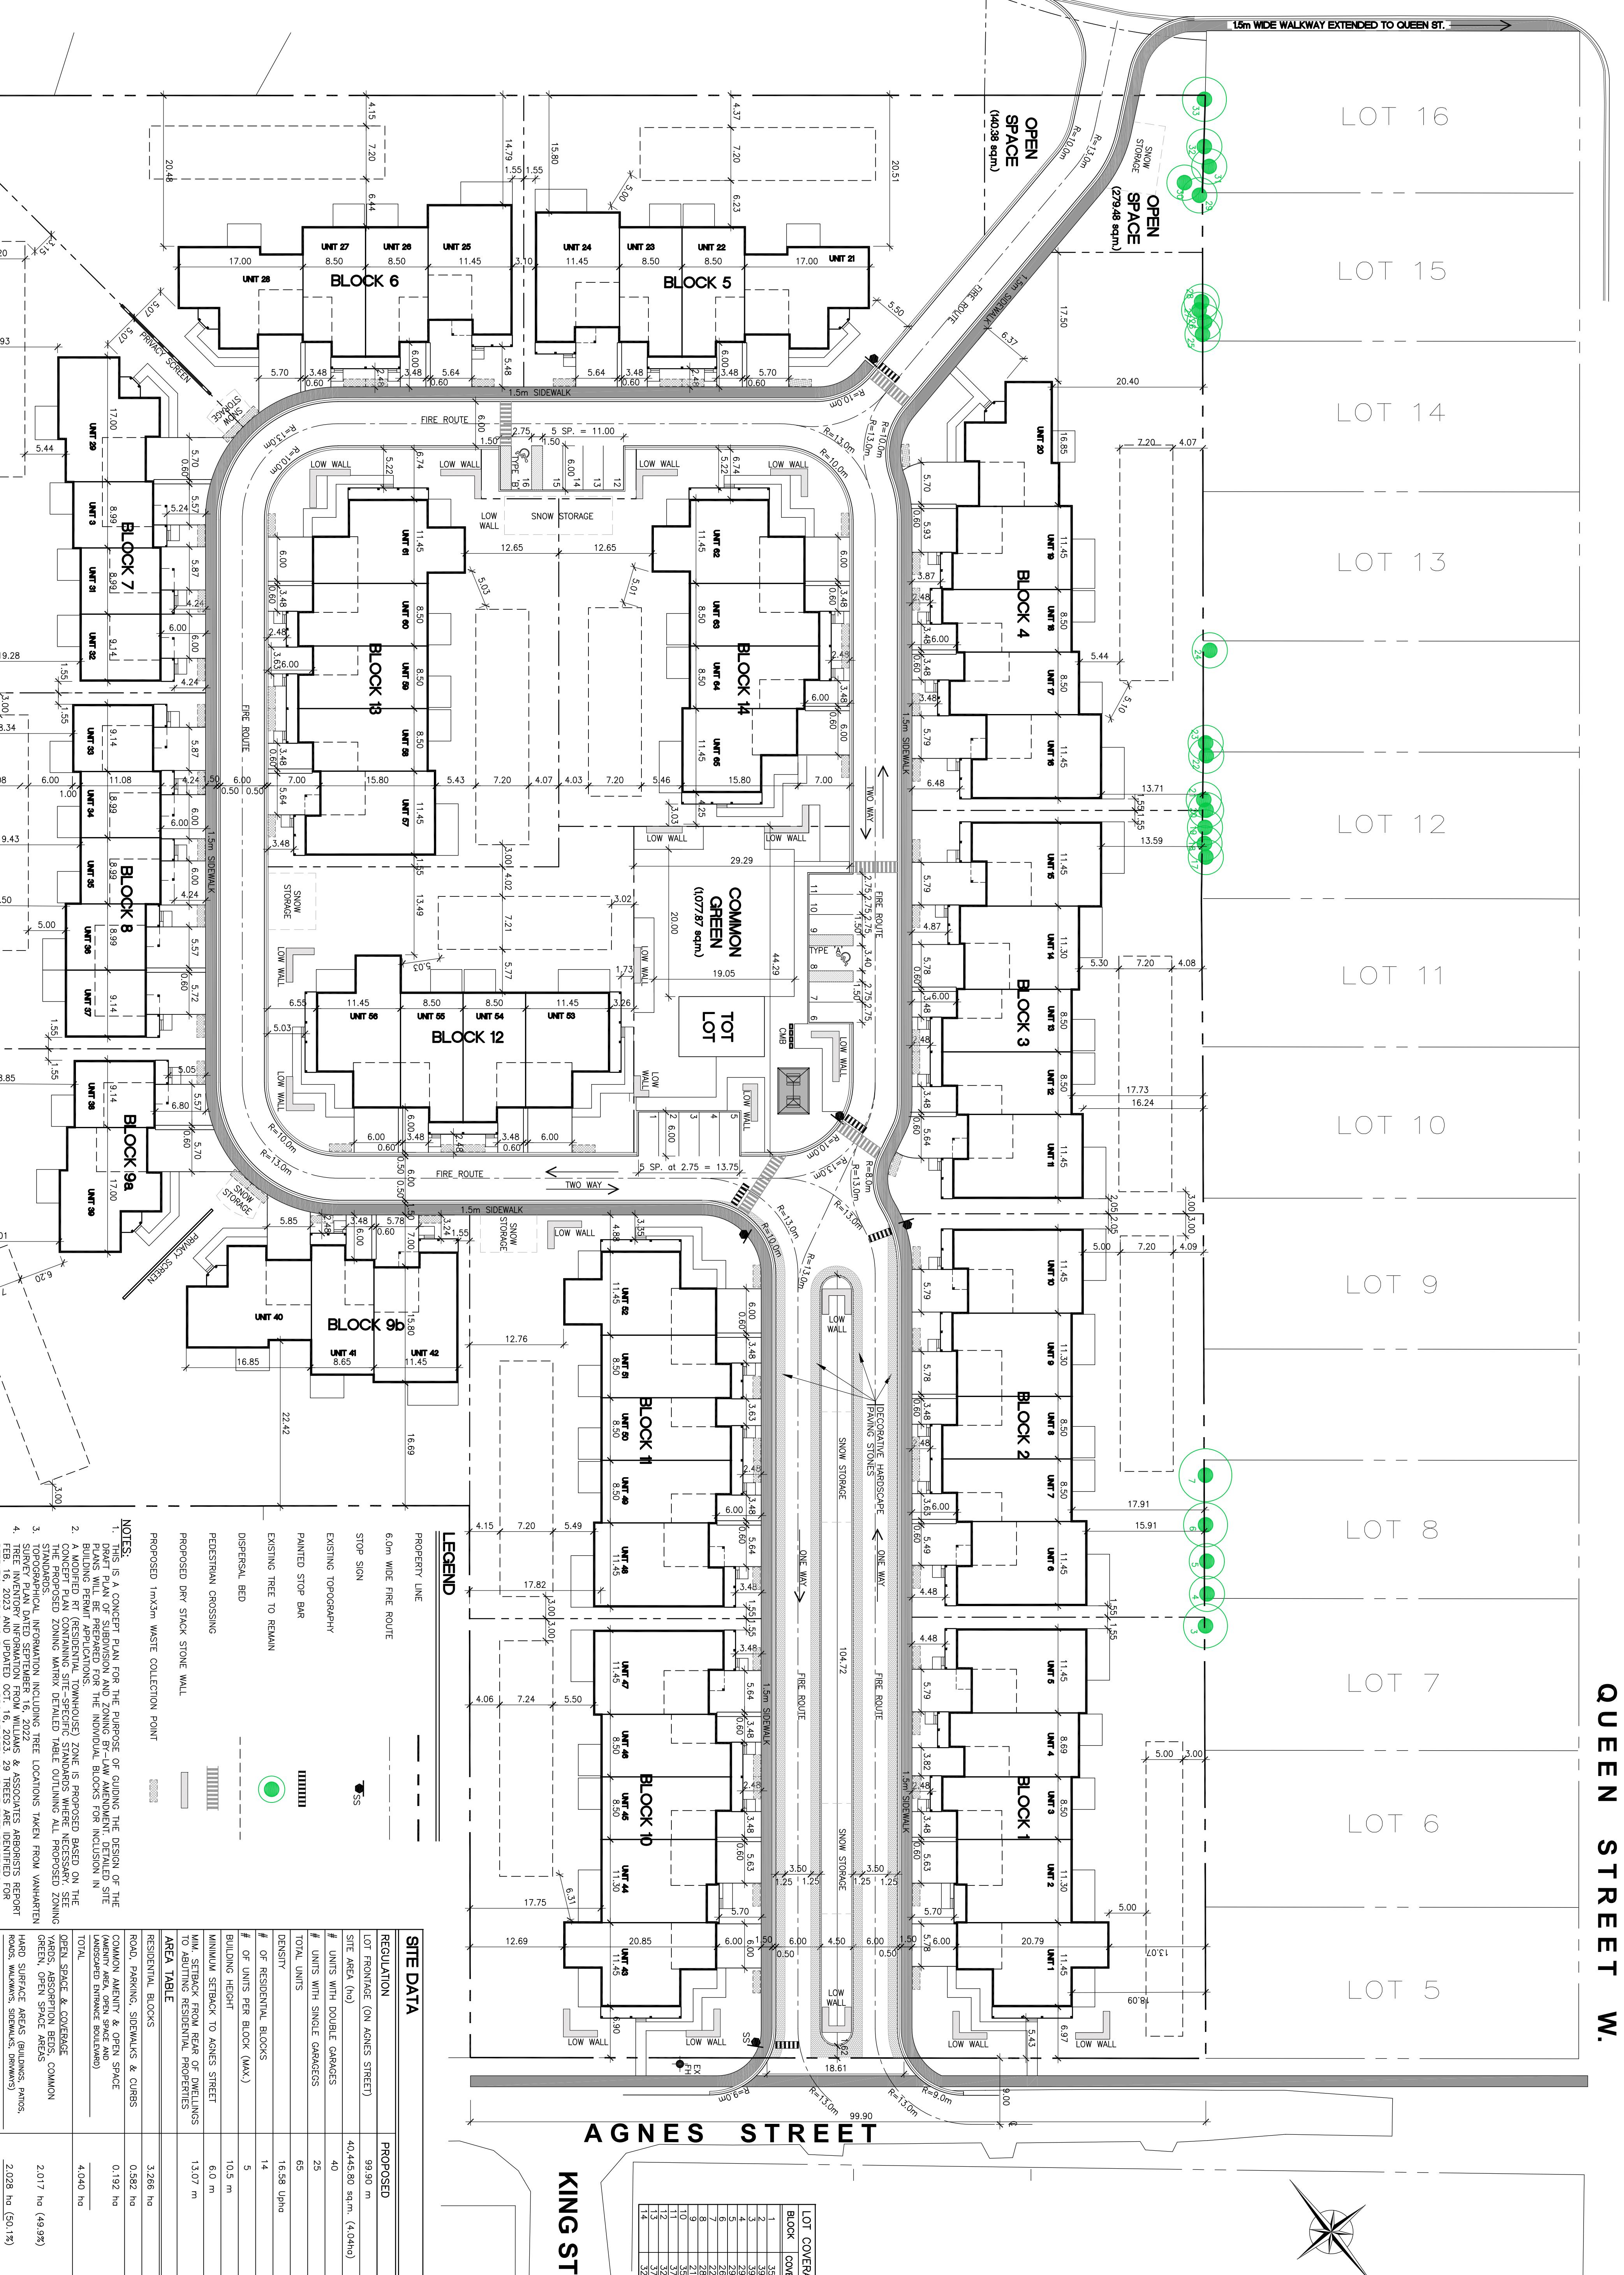
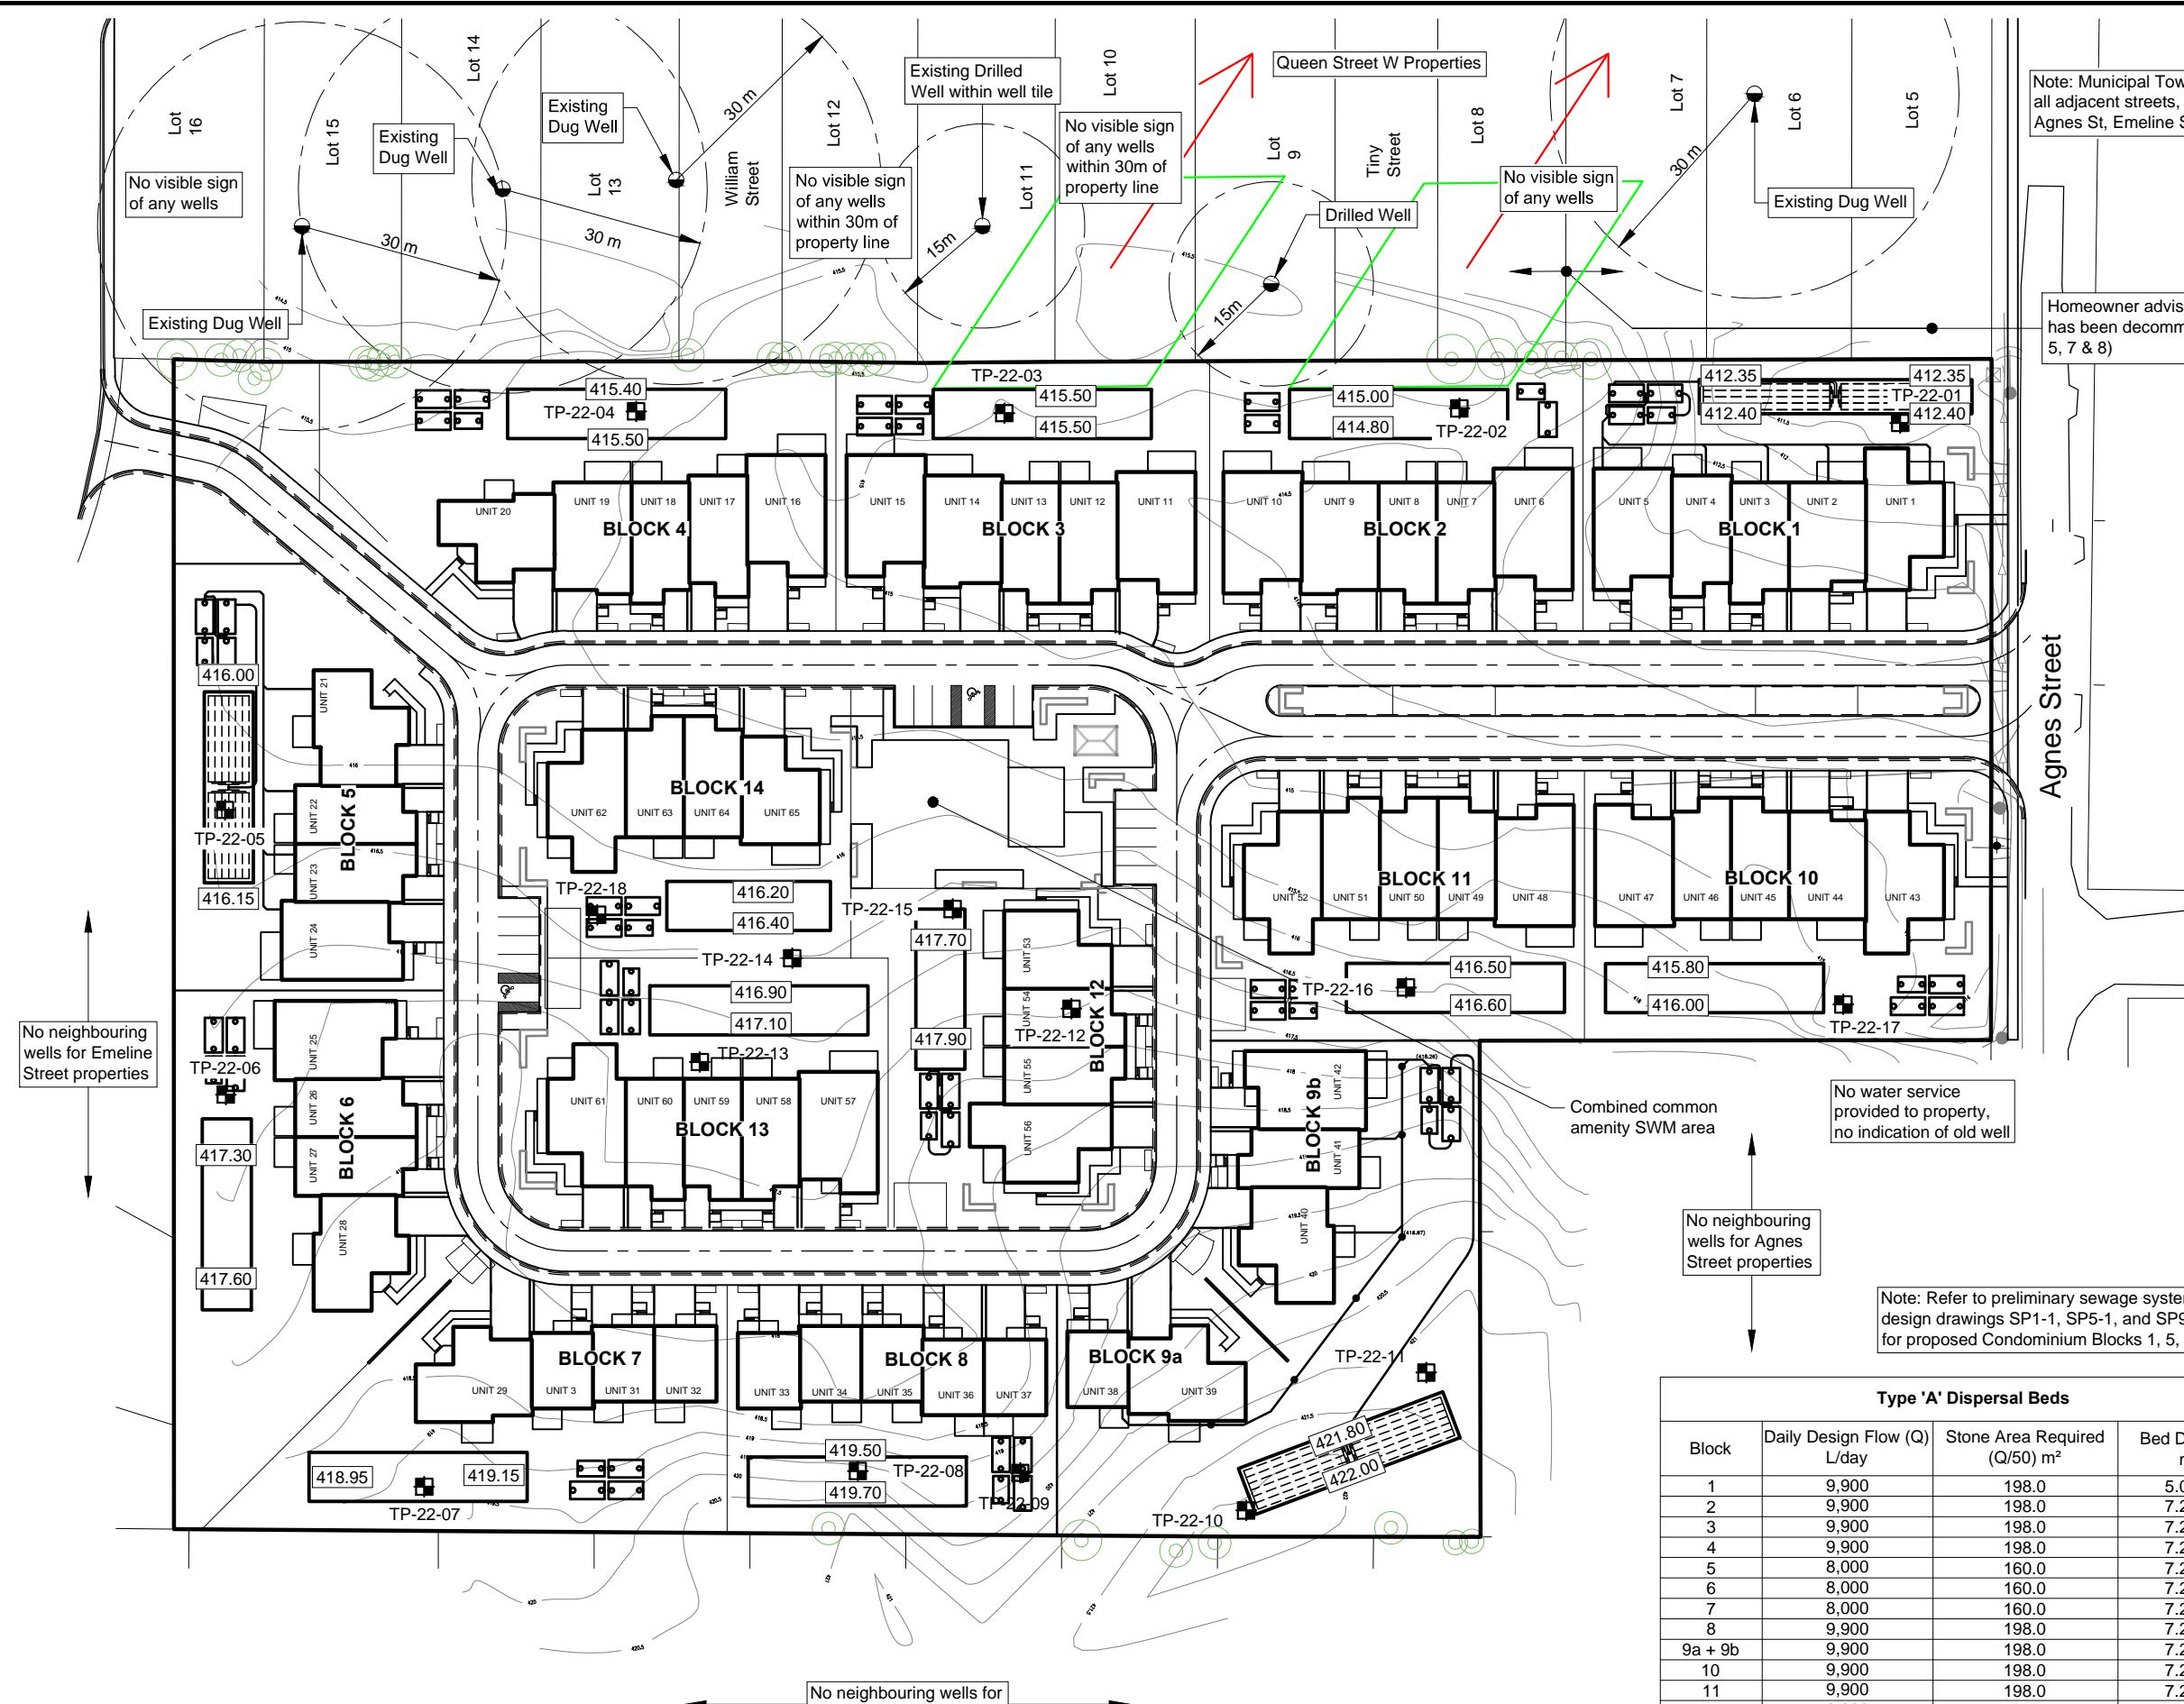
**D3082 SP-1**

- Existing Known Wells
- Test Pit Locations
- Sub-Surface Groundwater flow direction, per Englobe Hydro-G Reporting
- Effluent Plume Flow Direction

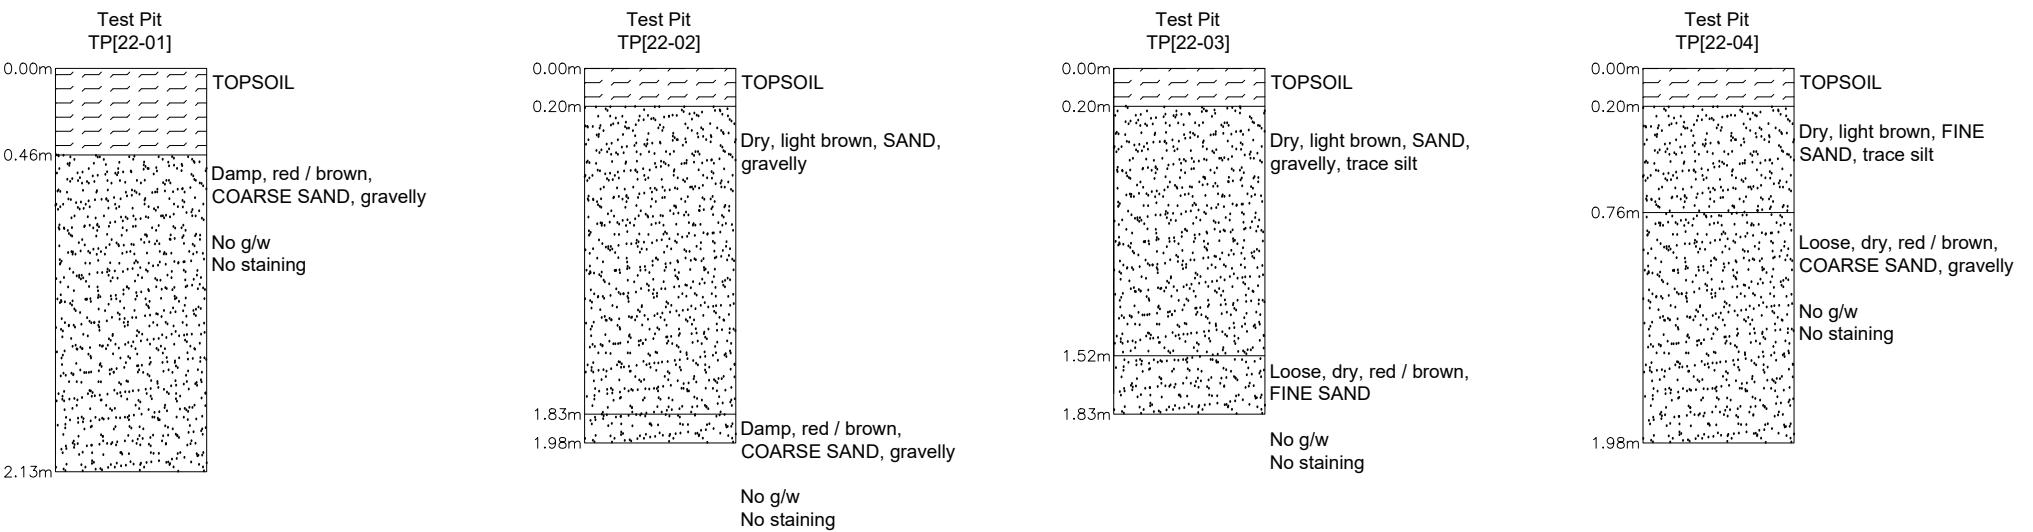
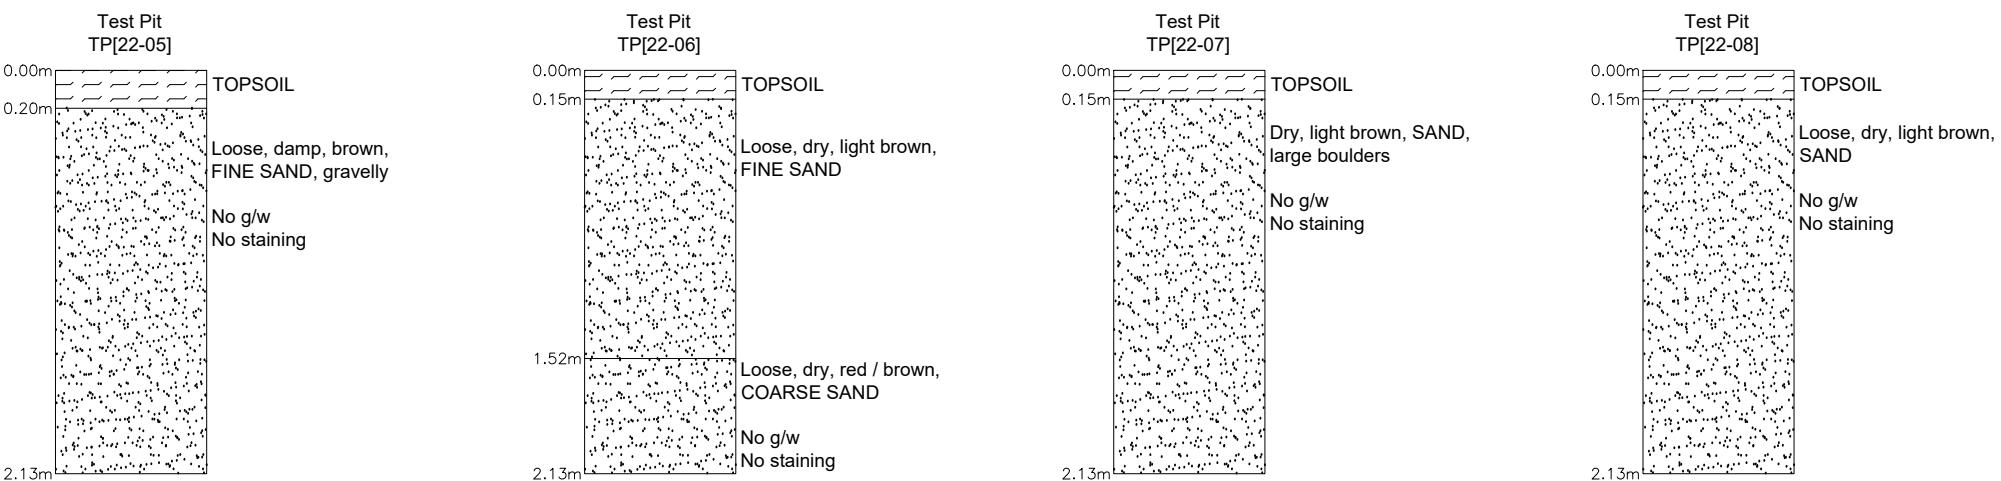
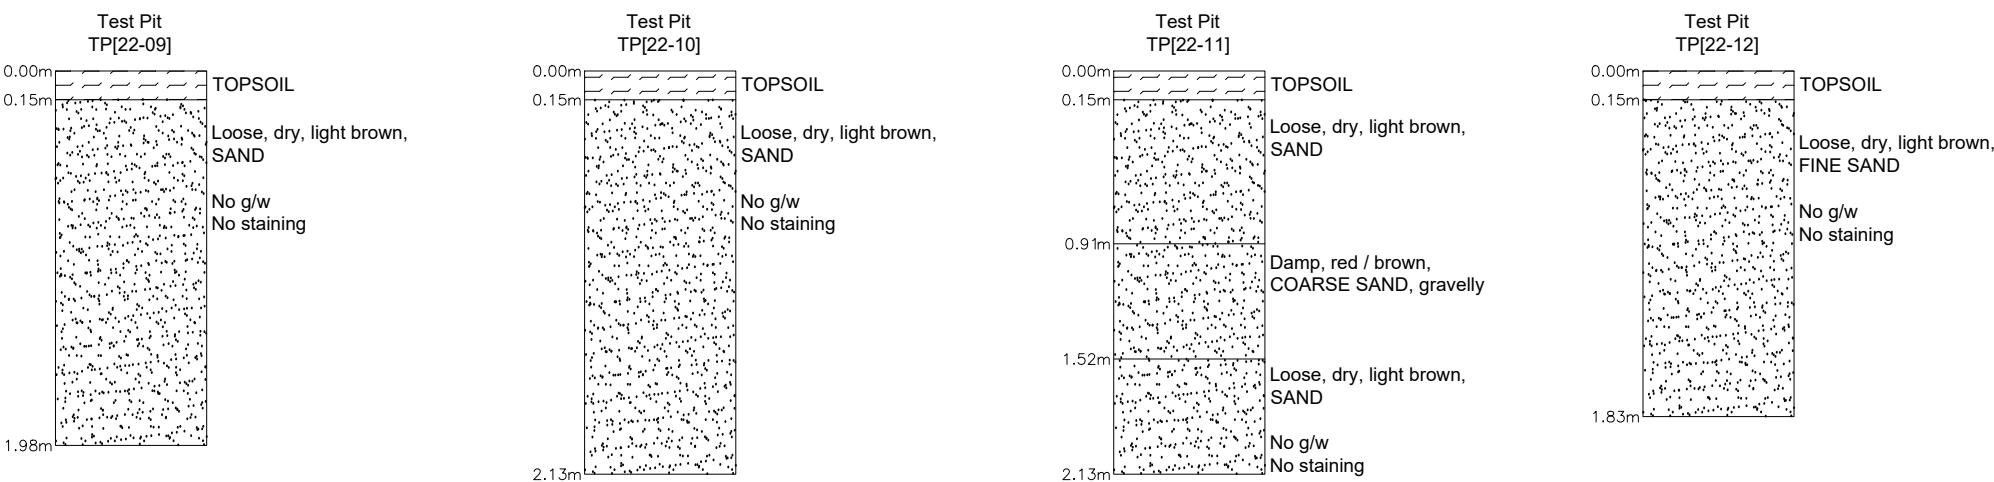
**D3082** **DT-1**

### Test Pit Soil Profiles

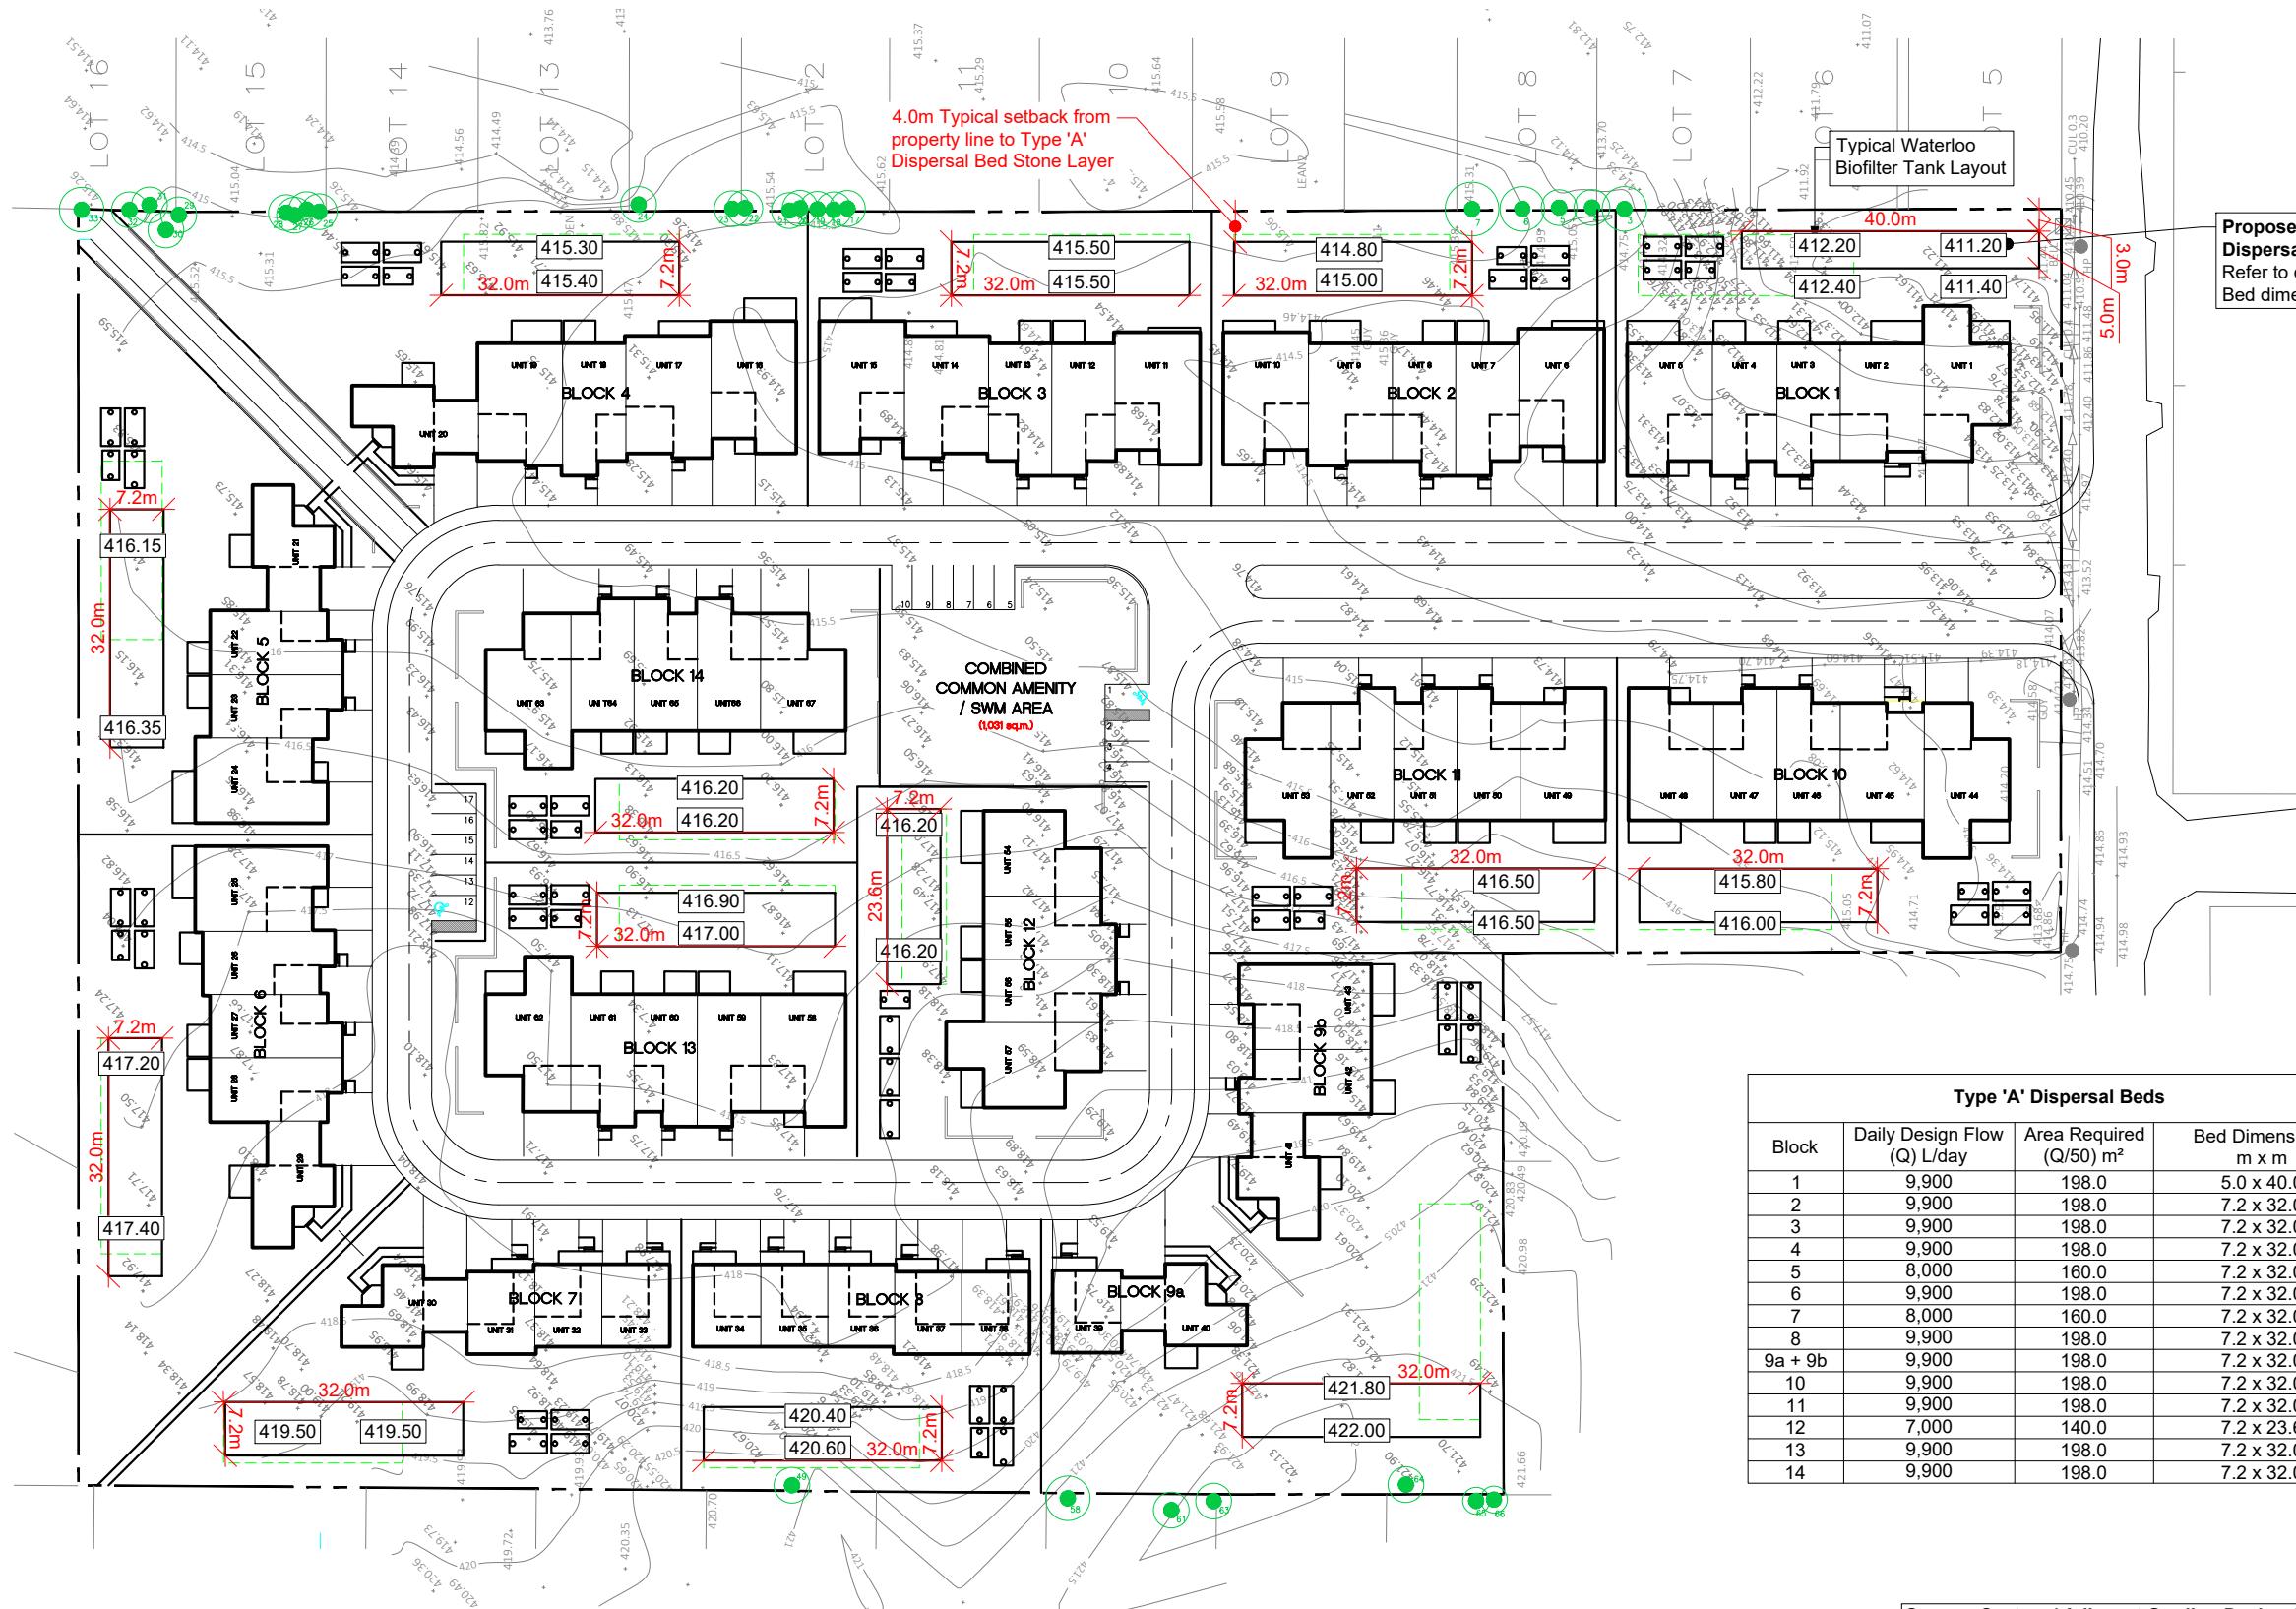
Type 'A' Dispersal Beds

Block	Daily Design Flow (Q) L/day	Area Required (Q/50) m <sup>2</sup>	Bed Dimensions m x m
1	9,900	198.0	5.0 x 40.0
2	9,900	198.0	7.2 x 32.0
3	9,900	198.0	7.2 x 32.0
4	9,900	198.0	7.2 x 32.0
5	8,000	160.0	7.2 x 32.0
6	9,900	198.0	7.2 x 32.0
7	8,000	160.0	7.2 x 32.0
8	9,900	198.0	7.2 x 32.0
9a + 9b	9,900	198.0	7.2 x 32.0
10	9,900	198.0	7.2 x 32.0
11	9,900	198.0	7.2 x 32.0
12	7,000	140.0	7.2 x 23.6
13	9,900	198.0	7.2 x 32.0
14	9,900	198.0	7.2 x 32.0

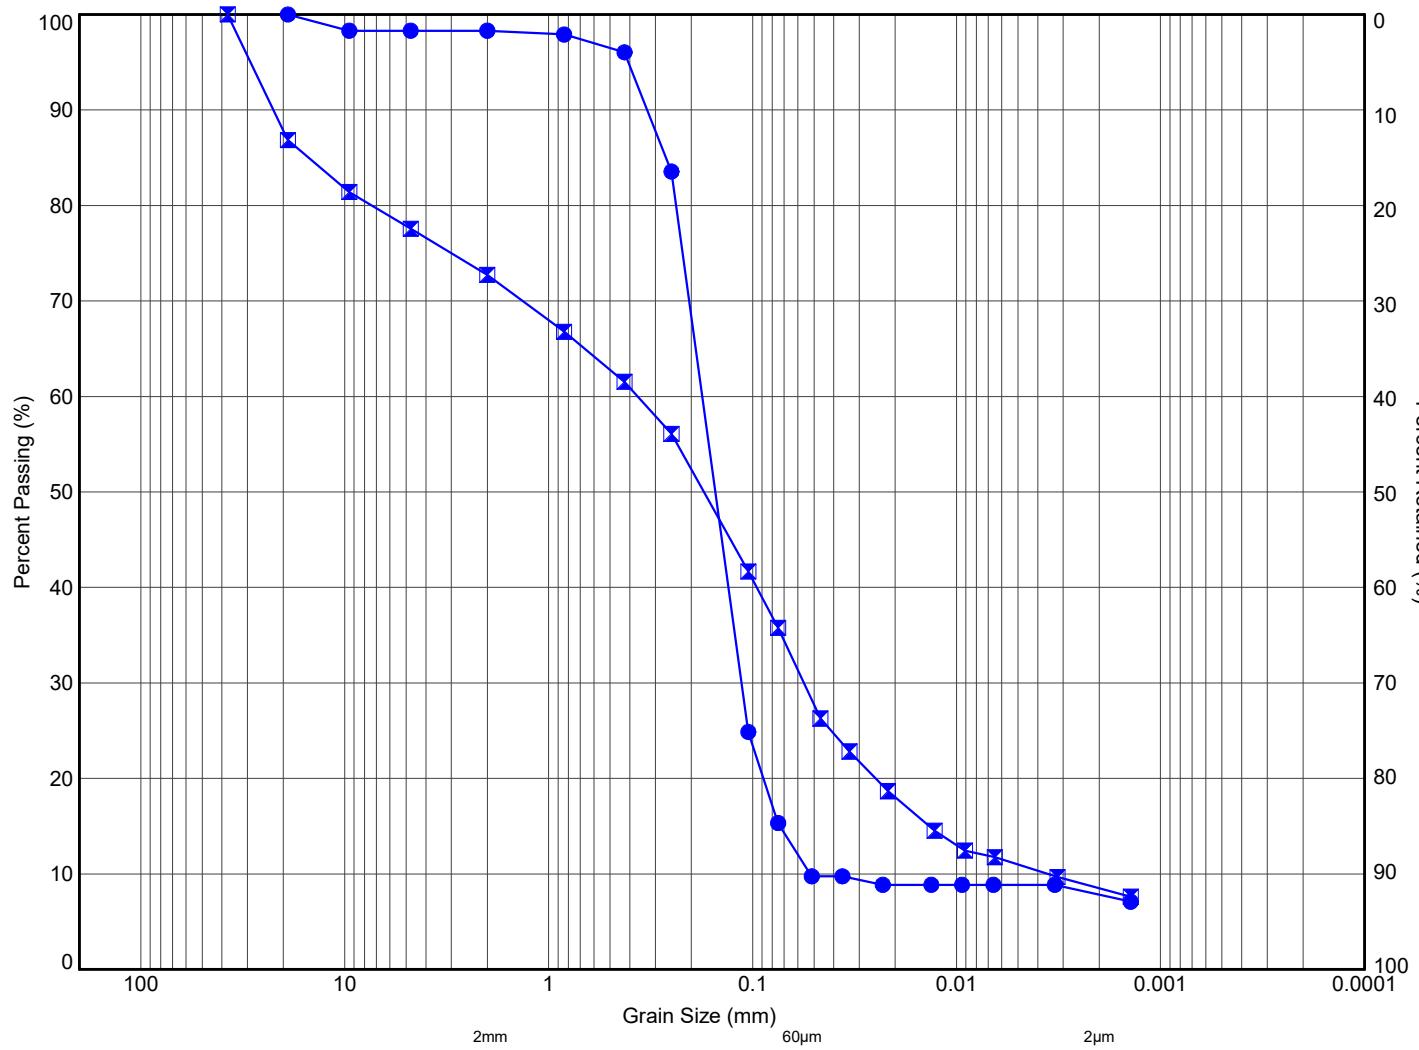
MIT SYSTEM								
Hole ID	Sample	Depth (m)	Elev. (m)	Gravel (%)	Sand (%)	Silt (%)	Clay (%)	(Fines, %)
● 1	SS2	1.0	417.2	2	86	4	8	
■ 8	SS3	1.8	412.1	27	41	23	9

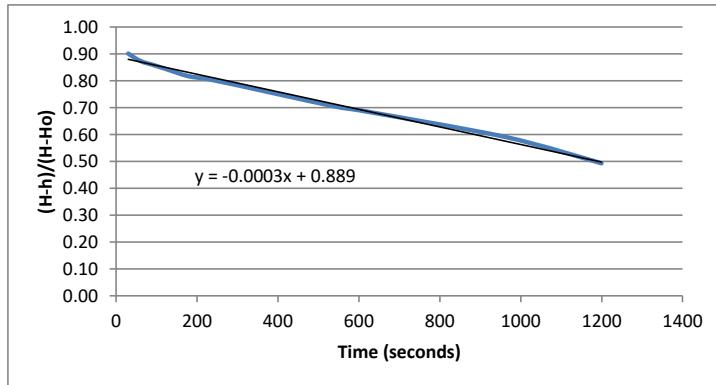
Water Level (mbgl)	(H-h)/(H-Ho)	Elapsed Time (s)
1.93	0.90	30
1.91	0.87	60
1.90	0.86	90
1.89	0.85	120
1.87	0.82	180
1.86	0.80	240
1.79	0.70	540
1.78	0.69	600
1.71	0.59	960
1.64	0.49	1200

Single well response tests were carried out at each monitoring well location to evaluate the rate of flow of groundwater through native soils present at the Site. Single well response tests were carried out as rising head tests at MW2-S, MW2-D and MW8. Rising head hydraulic conductivity testing involved removing a quantity of groundwater from within the well and monitoring the rate of groundwater recovery to static conditions with time. Due to insufficient groundwater within MW5 hydraulic conductivity testing was not completed at this Location. **Table 3-8** provides a summary of the results of in-situ hydraulic conductivity testing carried out at the Site:

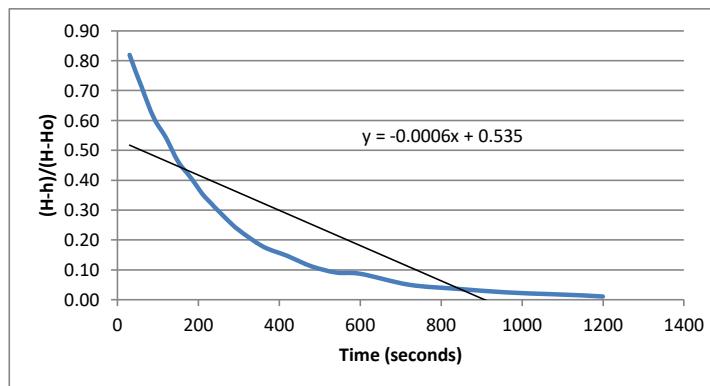
Water Level (mbgl)	(H-h)/(H-Ho)	Elapsed Time (s)
5.22	0.82	30
4.75	0.71	60
4.30	0.61	90
4.01	0.54	120
3.66	0.46	150
3.44	0.41	180
3.19	0.35	210
3.00	0.31	240
2.82	0.27	270
2.66	0.23	300
2.42	0.18	360
2.28	0.15	420
2.13	0.11	480
2.04	0.09	540
2.02	0.09	600
1.86	0.05	720
1.80	0.04	840
1.75	0.03	960
1.72	0.02	1080
1.69	0.01	1200

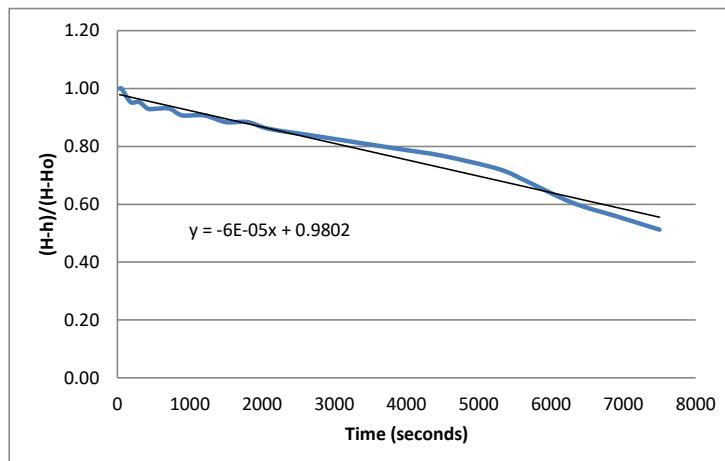
Water Level (mbgl)	(H-h)/(H-Ho)	Elapsed Time (s)
5.67	1.00	30
5.67	1.00	60
5.69	0.95	180
5.69	0.95	300
5.70	0.93	420
5.70	0.93	540
5.70	0.93	720
5.71	0.91	900
5.71	0.91	1200
5.72	0.88	1500
5.72	0.88	1800
5.73	0.86	2100
5.74	0.84	2700
5.75	0.81	3300
5.76	0.79	3900
5.77	0.77	4500
5.79	0.72	5280
5.81	0.67	5700
5.84	0.60	6300
5.86	0.56	6900
5.88	0.51	7500

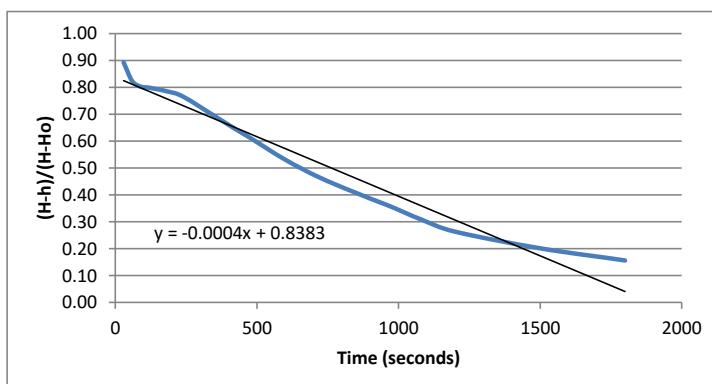
Water Level (mbgl)	(H-h)/(H-Ho)	Elapsed Time (s)
3.19	0.89	30
3.02	0.82	60
2.97	0.80	90
2.96	0.80	120
2.93	0.79	180
2.88	0.77	240
2.69	0.69	360
2.50	0.61	480
2.31	0.53	600
2.15	0.47	720
2.02	0.41	840
1.90	0.36	960
1.77	0.31	1080
1.66	0.26	1200
1.51	0.20	1500
1.40	0.16	1800

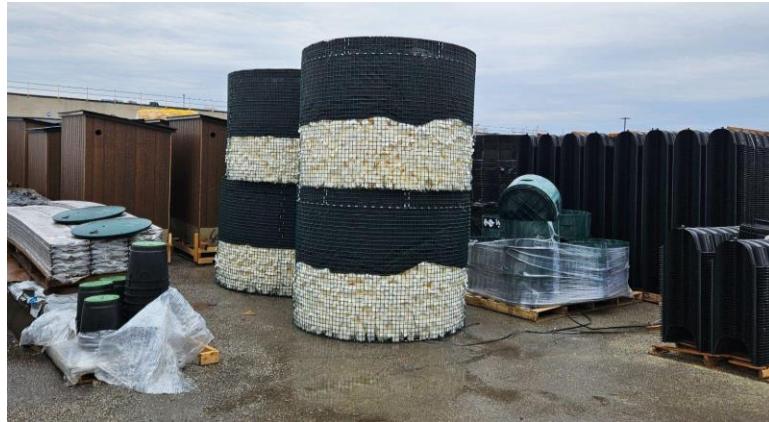
Waterloo Biofilter System - Filter Medium (Guelph, Ontario manufacturing facility)

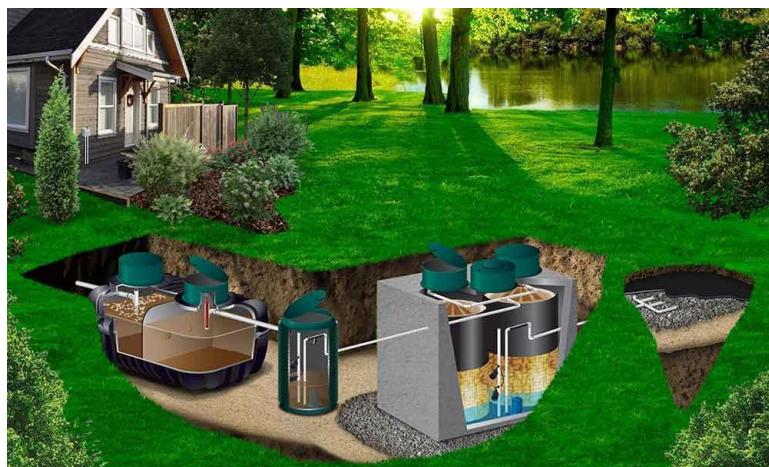
Waterloo Biofilter Standard Layout

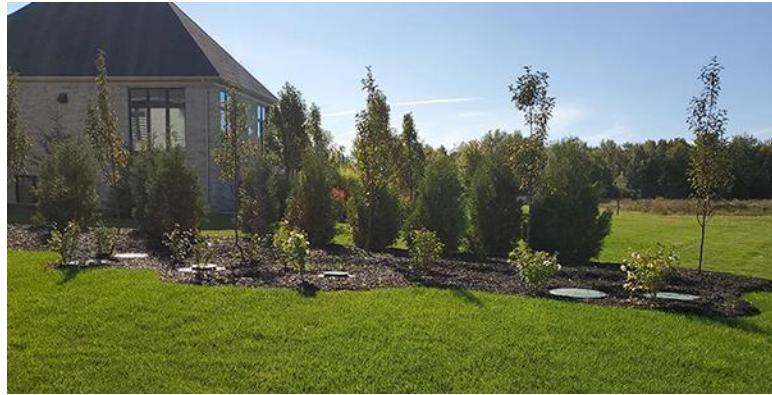
Waterloo Biofilter System - landscaped area with access lids
