# 0 Airport Road Development

## Geotechnical Investigation & Slope Assessment

0 Airport Road  
Caledon, ON

**MTE File No.:** 56106-100

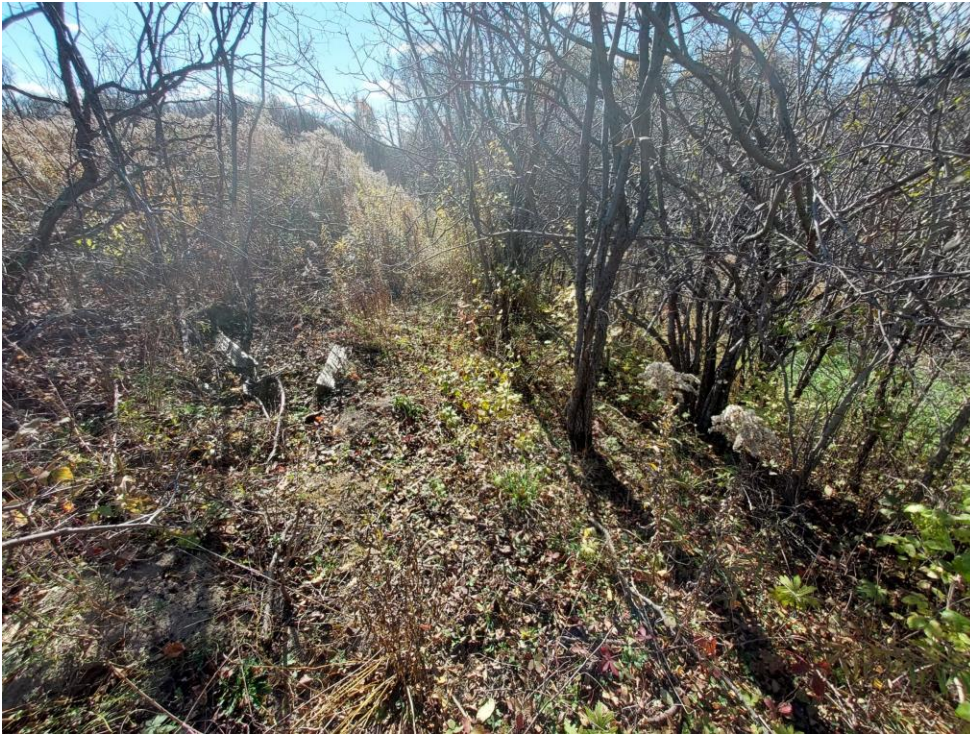
**Photograph 1 - Section A-A top of slope [looking south]**

The existing slope is considered well vegetated with generally well standing vertical trees with dense bushes throughout the woodlot. No evidence of rotational slides, tension cracks, slumps, or bulges were observed at the time of the site visit. The change in elevation ranges from approximately 5.0 to 6.0 meters and in inclinations between 1.4 to 4.0 horizontal to 1.0 vertical as shown on the Cross Sections on Figures 3 to 5 in Appendix A. It should be noted that steeper and shallower portions are present at localized regions along the slope. A watercourse is located within the wetland feature situated at the toe of the slope.

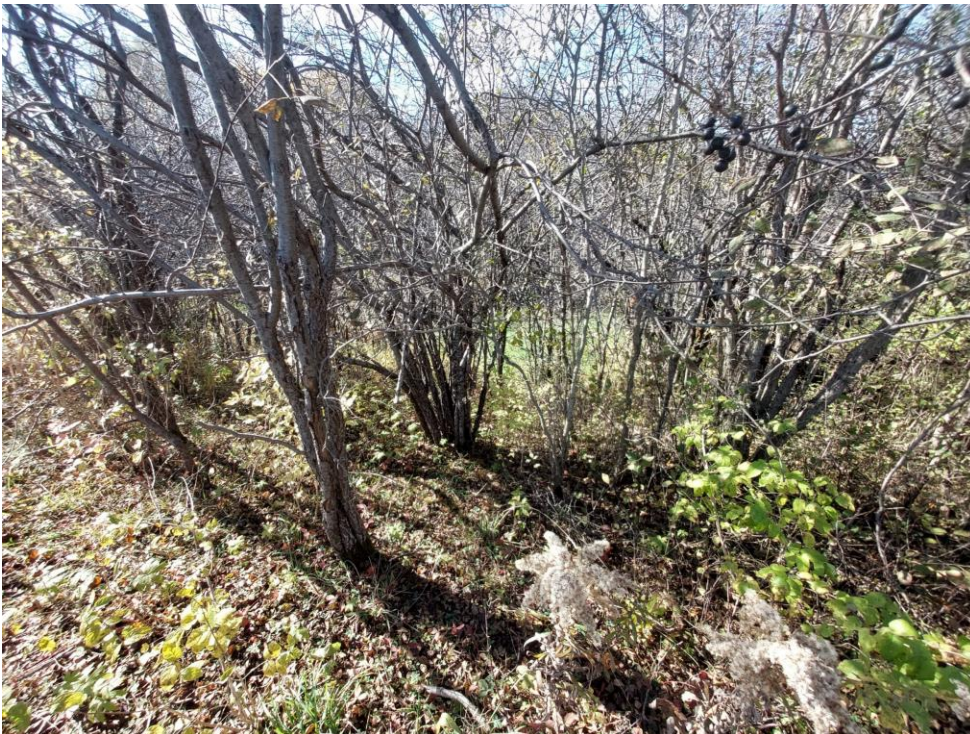
**Photograph 2 - Section A-A top of slope [looking down slope]**

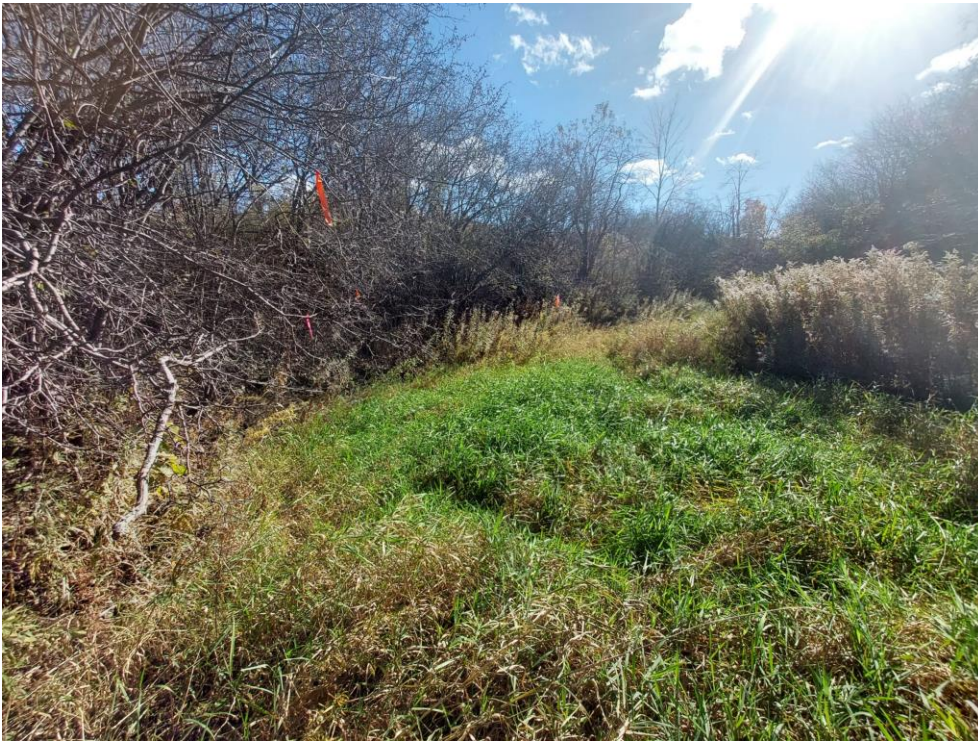
**Photograph 3 - Section A-A toe of slope [looking south]**

A toe erosion allowance is not required for slope sections B-B and C-C due to the proximity of the watercourse exceeding 15 m from the slope toe. However, slope section A-A does require a toe erosion based on the recommendations provided by the Ontario Ministry of Natural Resources Table 3: Determination of Toe Erosion Allowance. Based on the referenced table, a suitable toe erosion allowance was determined to be 5 m. This erosion limit was determined based on the composition and density of the native soils, the watercourse flow velocities and the limited evidence of active erosion along the slope toe. The watercourse system is a minor stream running through the wetland area with limited grade fall and velocities present.

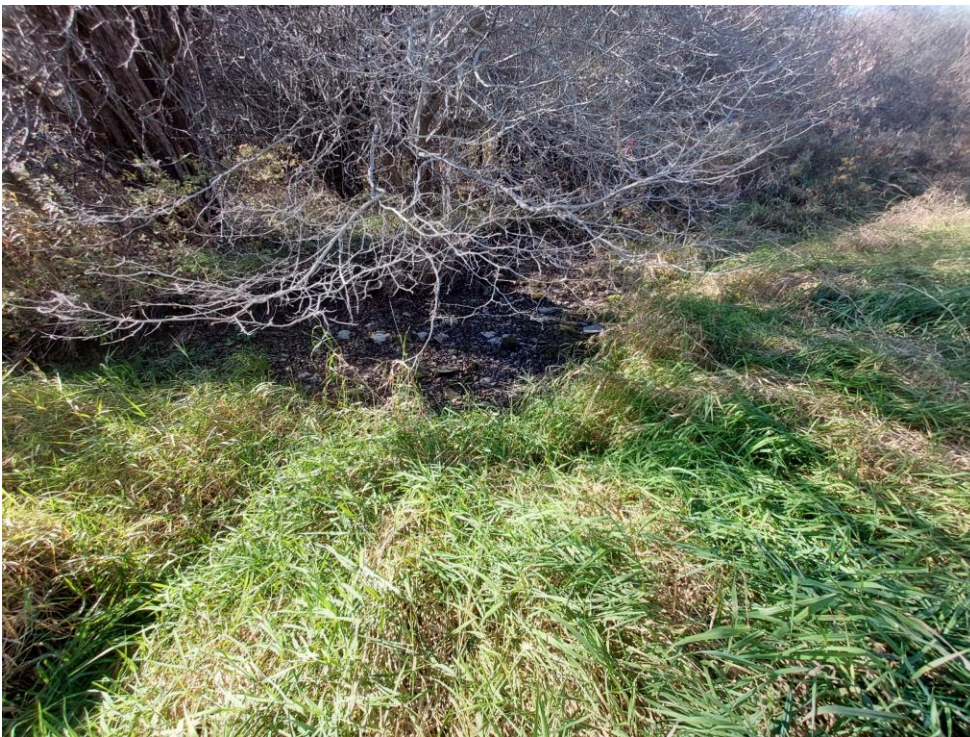
**Photograph 4 - Section A-A toe of slope [looking at watercourse]**

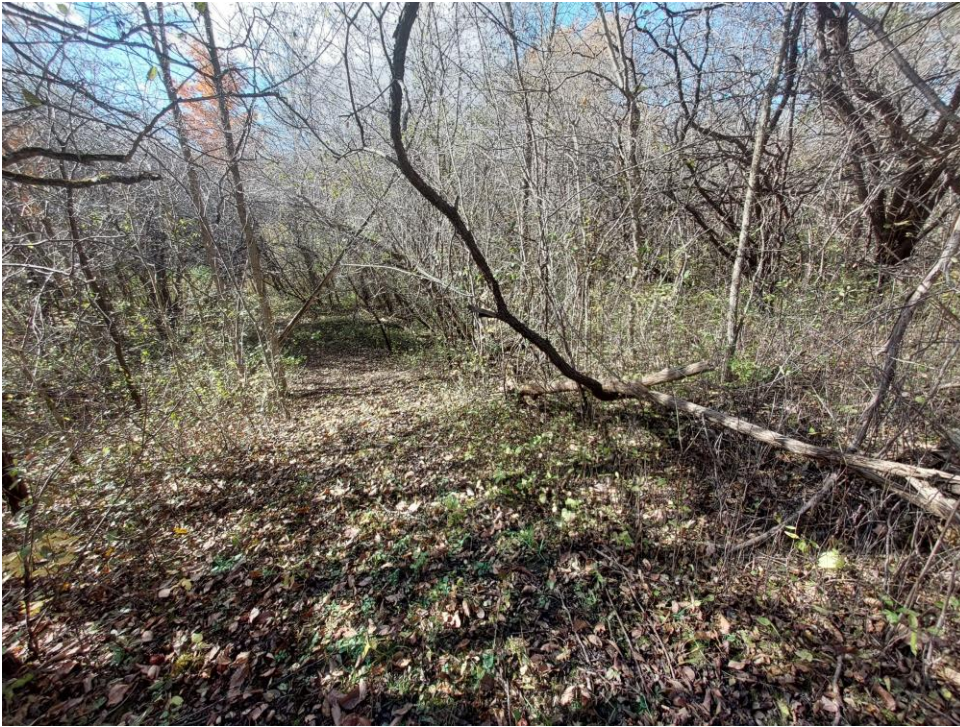
**Photograph 5 - Section B-B top of slope [looking down slope]**

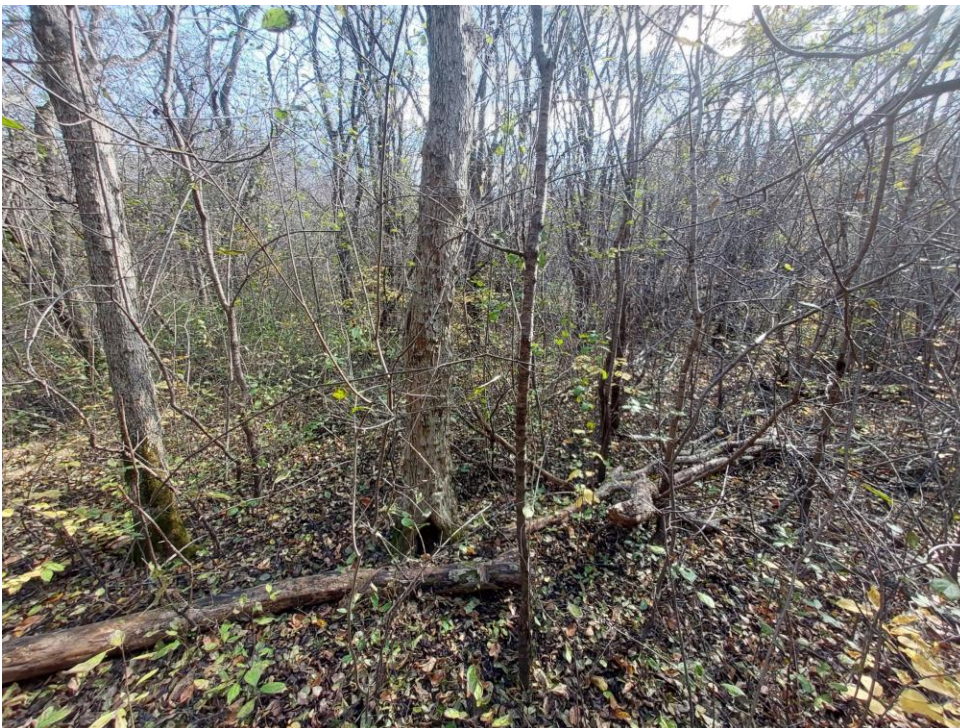
**Photograph 6 - Section B-B toe of slope [looking south]**

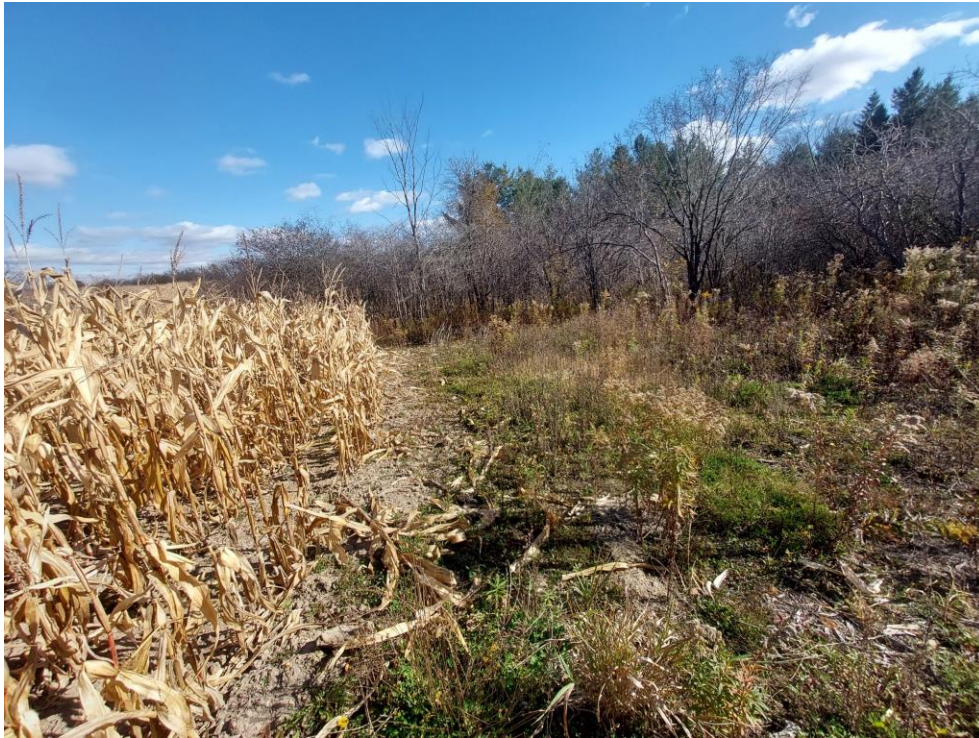
**Photograph 7 - Section C-C top of slope [looking east]**

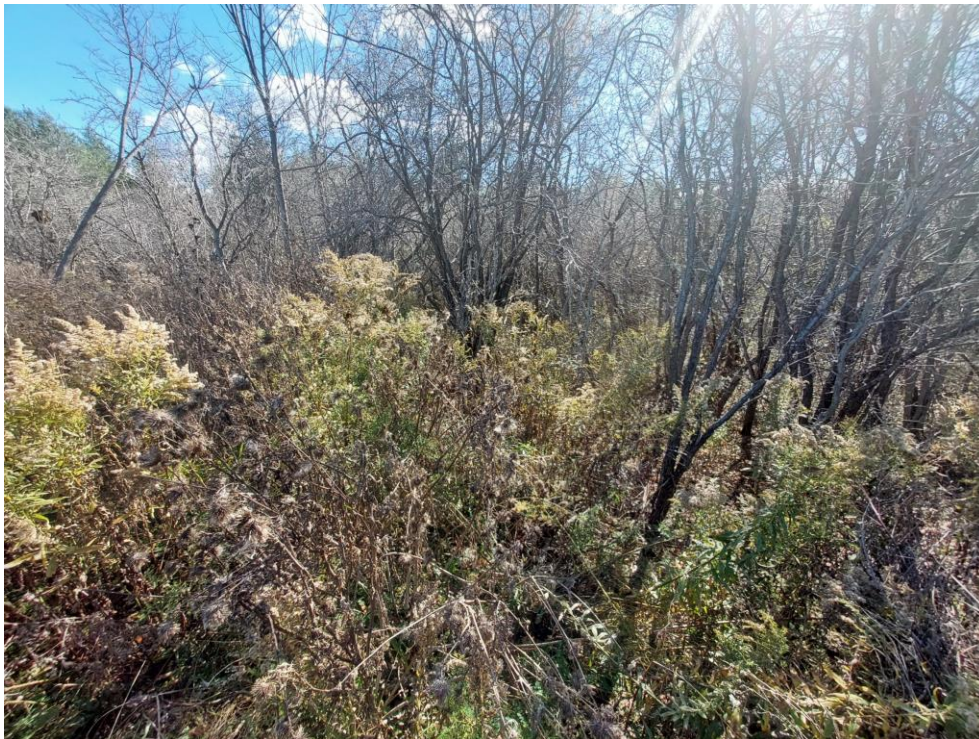
**Photograph 8 - Section C-C top of slope [looking down slope]**

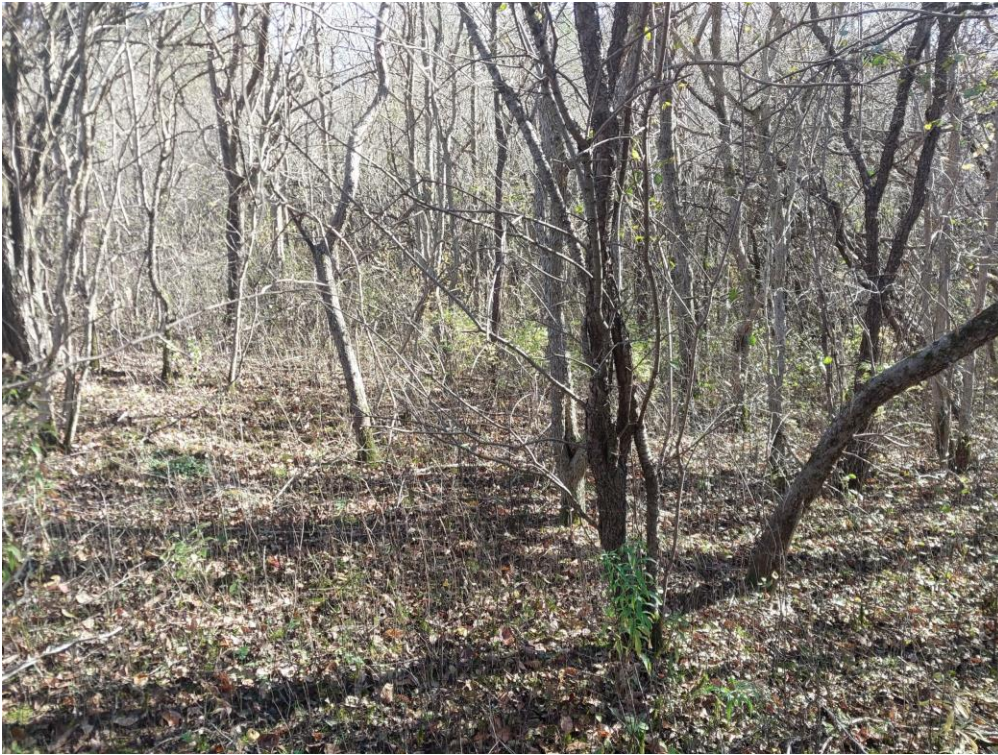
**Photograph 9 - Section C-C toe of slope [looking east]**
