BROCCOLINI ESTATE GROUP
AIRPORT ROAD INDUSTRIAL DEVELOPMENT

TREE PRESERVATION PLAN

Drawing: TREE PRESERVATION PLAN - ENLARGEMENT

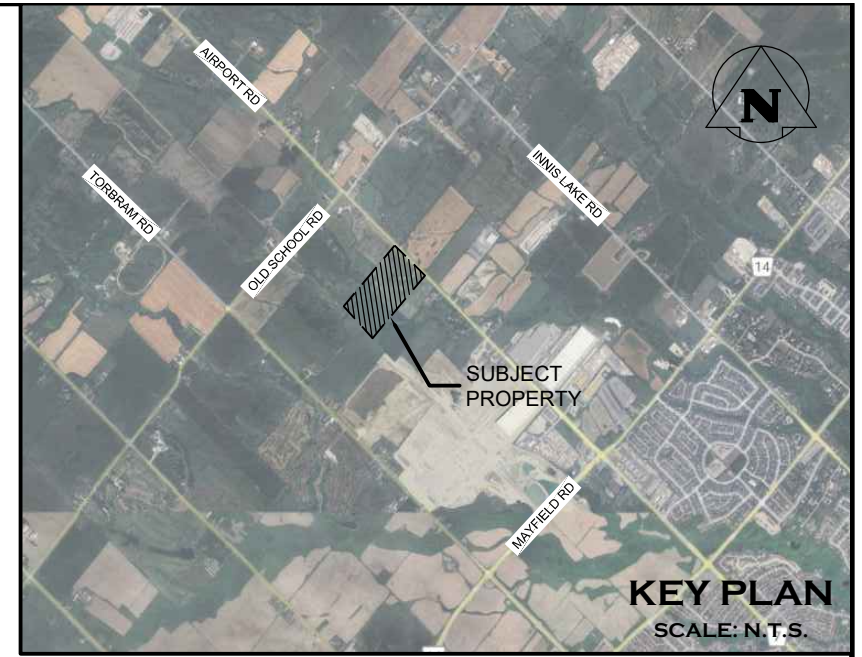
- LEGEND**
- PROPERTY BOUNDARY
 - FUTURE SEVERANCE
 - BUILDING
 - WATERCOURSE
 - EXISTING VEGETATION TO BE REMOVED
 - EDGE OF VEGETATION TO BE RETAINED AND PROTECTED
 - TREE PROTECTION FENCE
 - EXISTING DECIDUOUS TREE TO BE REMOVED
 - EXISTING CONIFEROUS TREE TO BE REMOVED
 - EXISTING DECIDUOUS TREE TO BE RETAINED OR PROTECTED
 - EXISTING CONIFEROUS TREE TO BE RETAINED OR PROTECTED
 - TREE TO BE PRESERVED
 - TREE IDENTIFICATION TAGS
 - TREE TO BE REMOVED
