HYDROGEOLOGICAL ASSESSMENT FOR STELLAR ESTATES PHASE 2

TOWN OF CALEDON, ONTARIO

Ecometrix Incorporated
www.ecometrix.ca
Mississauga, ON

Ref. 22-3001
17 January 2025

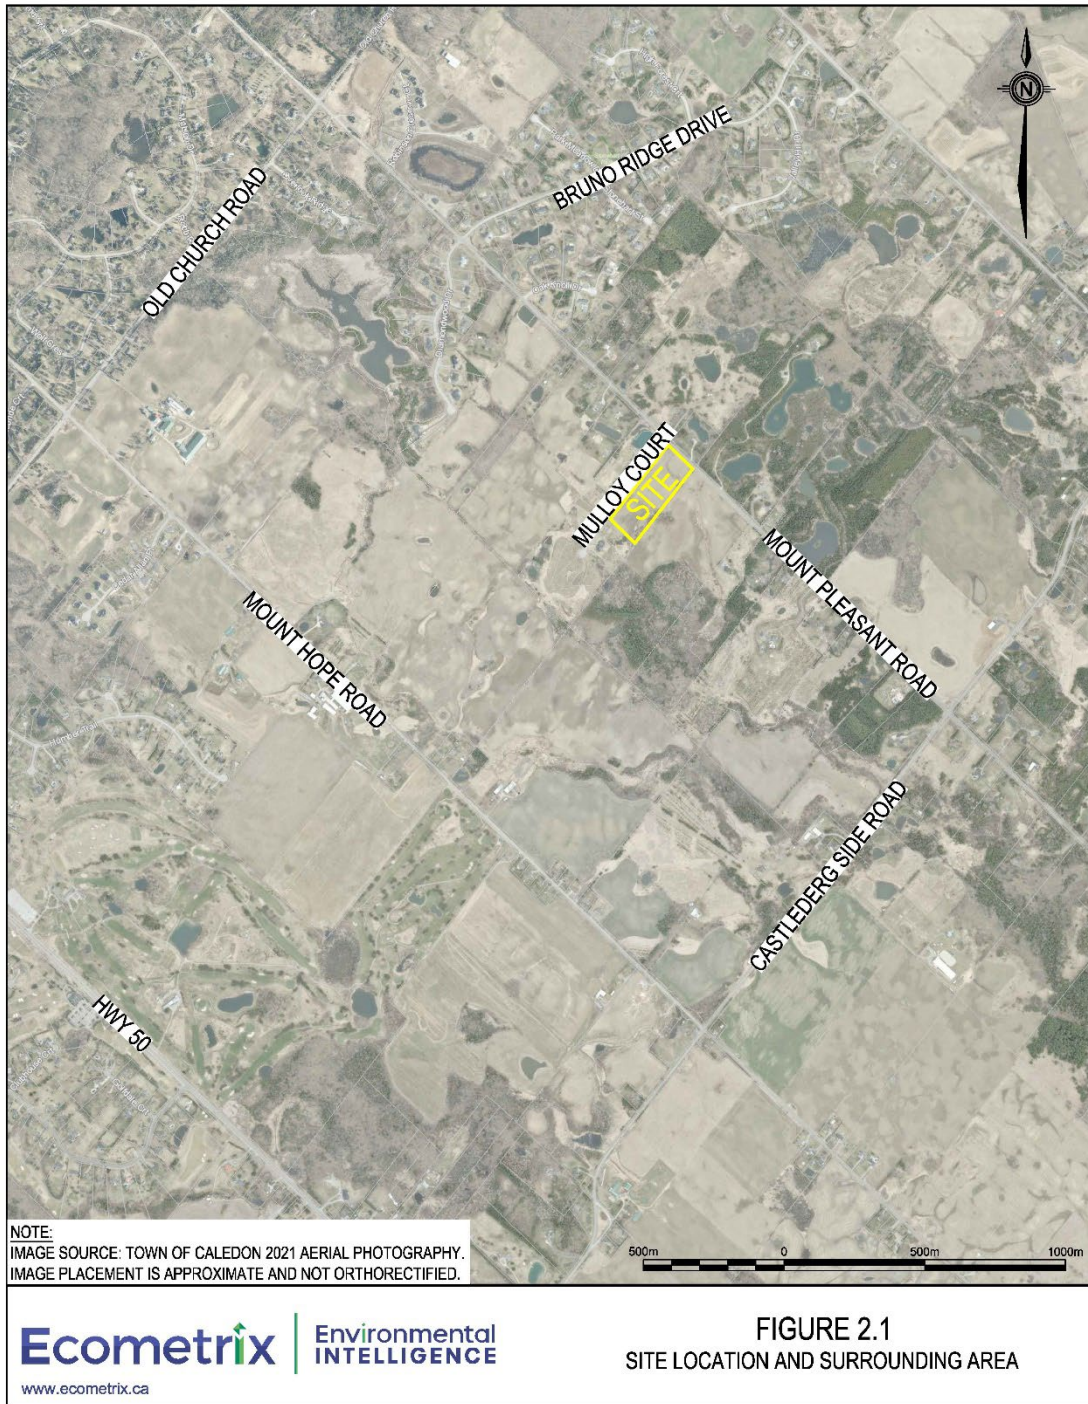
Figure 2.1: Site Location and Surrounding Area

The Site location is approximately 8 km northeast of the village of Bolton (Figure 2.1). The Site is bounded by Mount Pleasant Road to the east, Mulloy Court and associated estate residential development to the north, estate residential development to the west, and agricultural land to the south. The legal description of the Site is Part of Lot 18, Concession 8 (Albion), Town of Caledon, Regional Municipality of Peel.

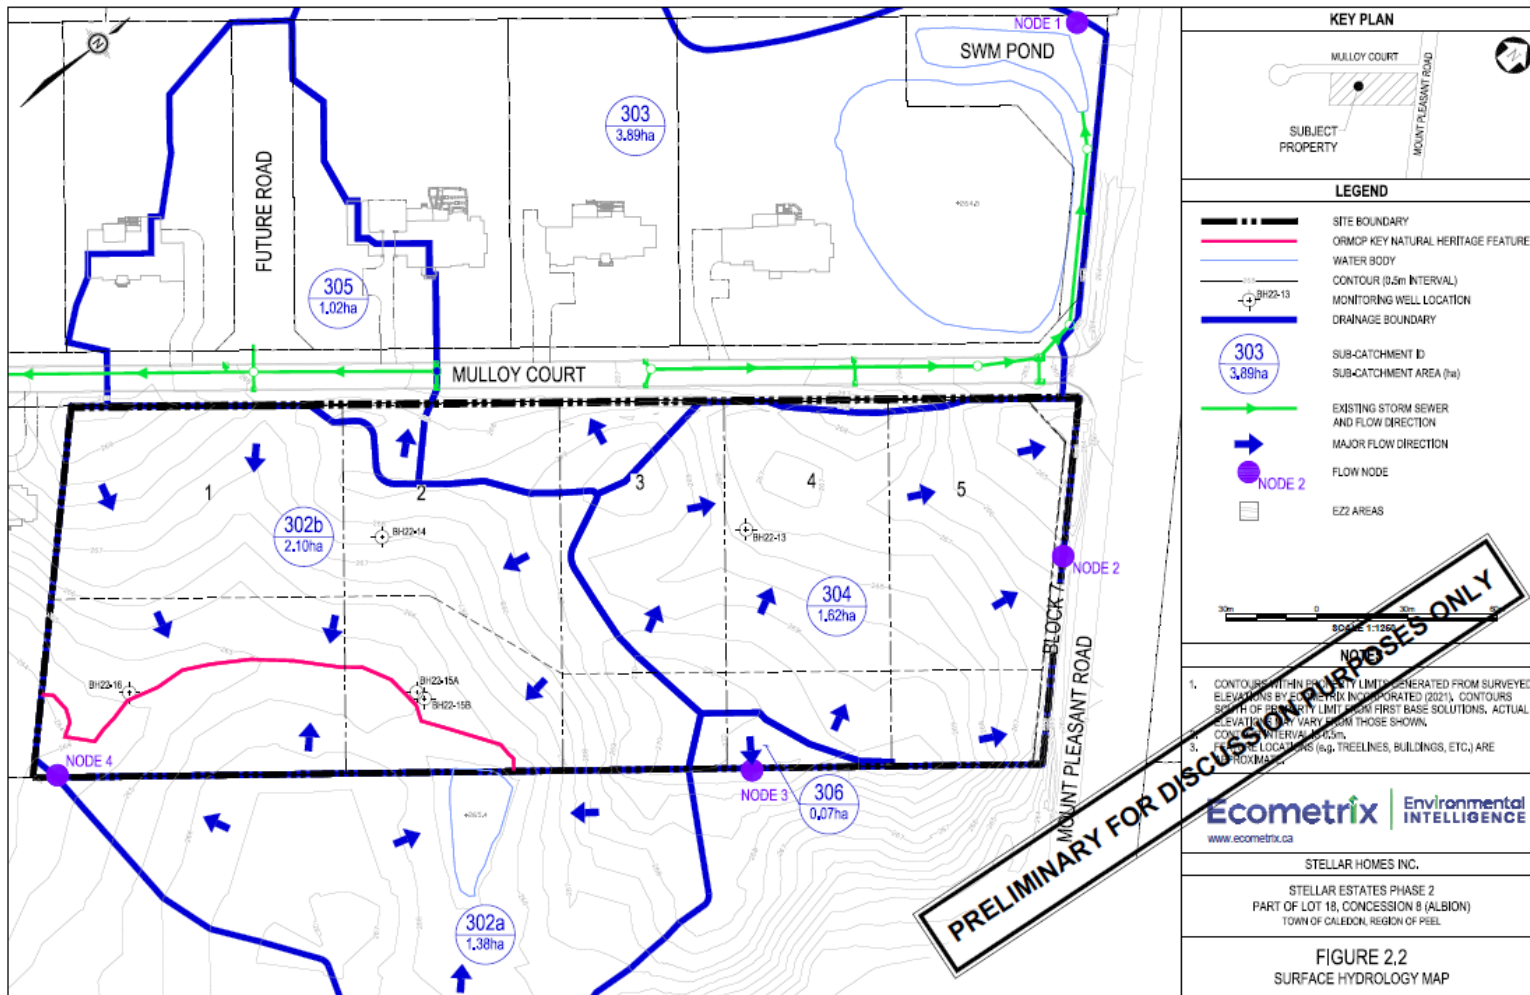
Figure 2.2: Local Topography and Drainage

Local topography and drainage patterns are shown in Figure 2.2. Generally, the Site and surrounding areas are characterized as hummocky terrain, with many hills and low-lying wetlands scattered across the landscape. Elevation tends to gradually decrease moving from northwest of the Site to southeast of the Site. Surface waters from the Site and surrounding areas drain into the Humber River watershed (TRCA, 2022). Thus, the Site falls under the jurisdiction of the Toronto and Region Conservation Authority (Humber River Watershed). Specifically, the Site is part of the Cold Creek subwatershed, which includes a number of upper tributaries to the south and southeast of the Site, draining into the main branch of the Humber River (TRCA, 2008).

A provincially significant wetland exists along the southern border of the Site (MNRF, 2022), downslope of Lots 1, 2, and 3 (Figure 2.2).

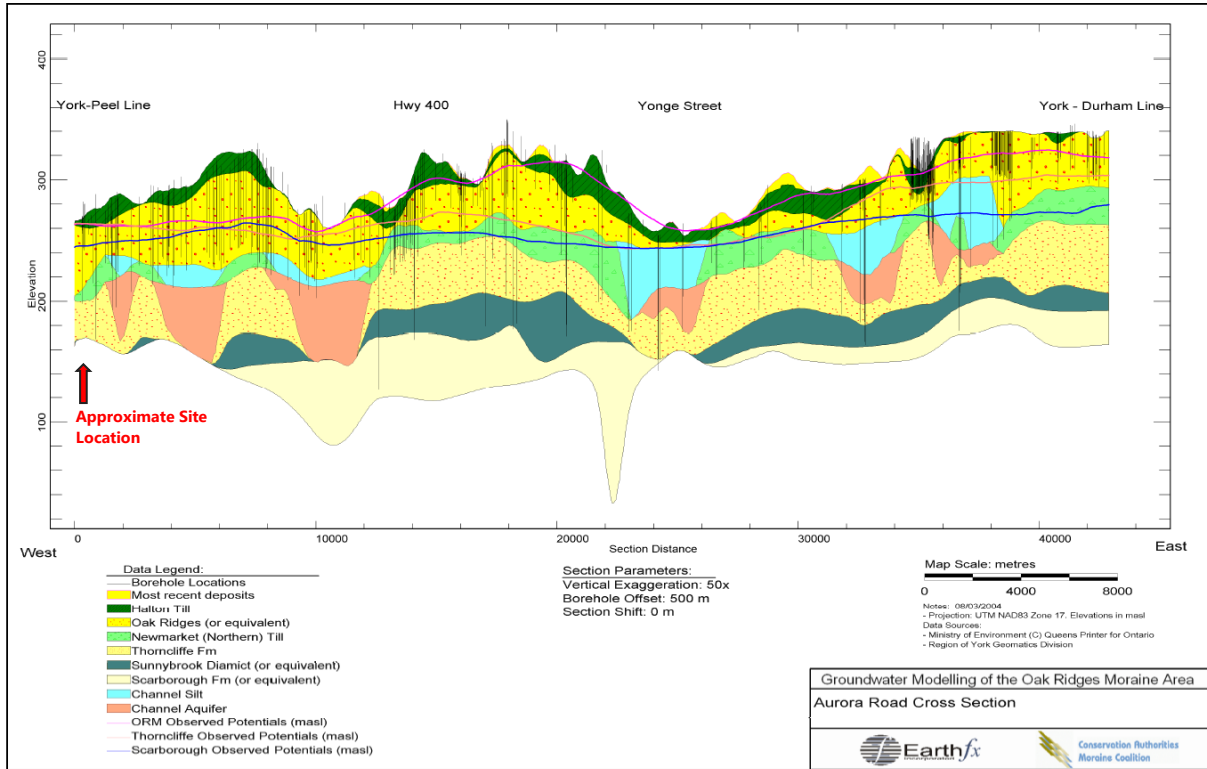
Figure 2.3A: East-West Cross-Section along Aurora Road (Figure 49 from EarthFX, 2006)

As part of the program, a groundwater modelling study was completed (EarthFX, 2006) that provides a conceptual hydrostratigraphic framework to understand and identify regional aquifers and aquitards influencing the flow of groundwater. The key aquifers in the region include the Oak Ridges Aquifer Complex (ORAC), Thorncliffe Aquifer Complex (TAC), and Scarborough Aquifer Complex (SAC). The ORAC and TAC are separated by the Newmarket Aquitard; and the TAC and SAR are separated by the Sunnybrook Aquitard. Regionally, discontinuous tunnel channels which have eroded through the Newmarket Till and possibly through deeper units contribute to leakage between the shallower and deeper flow system (EarthFX, 2006). Figure 2.3A shows a hydrostratigraphic cross-section which includes the Site, which is located just west of the York-Peel line.

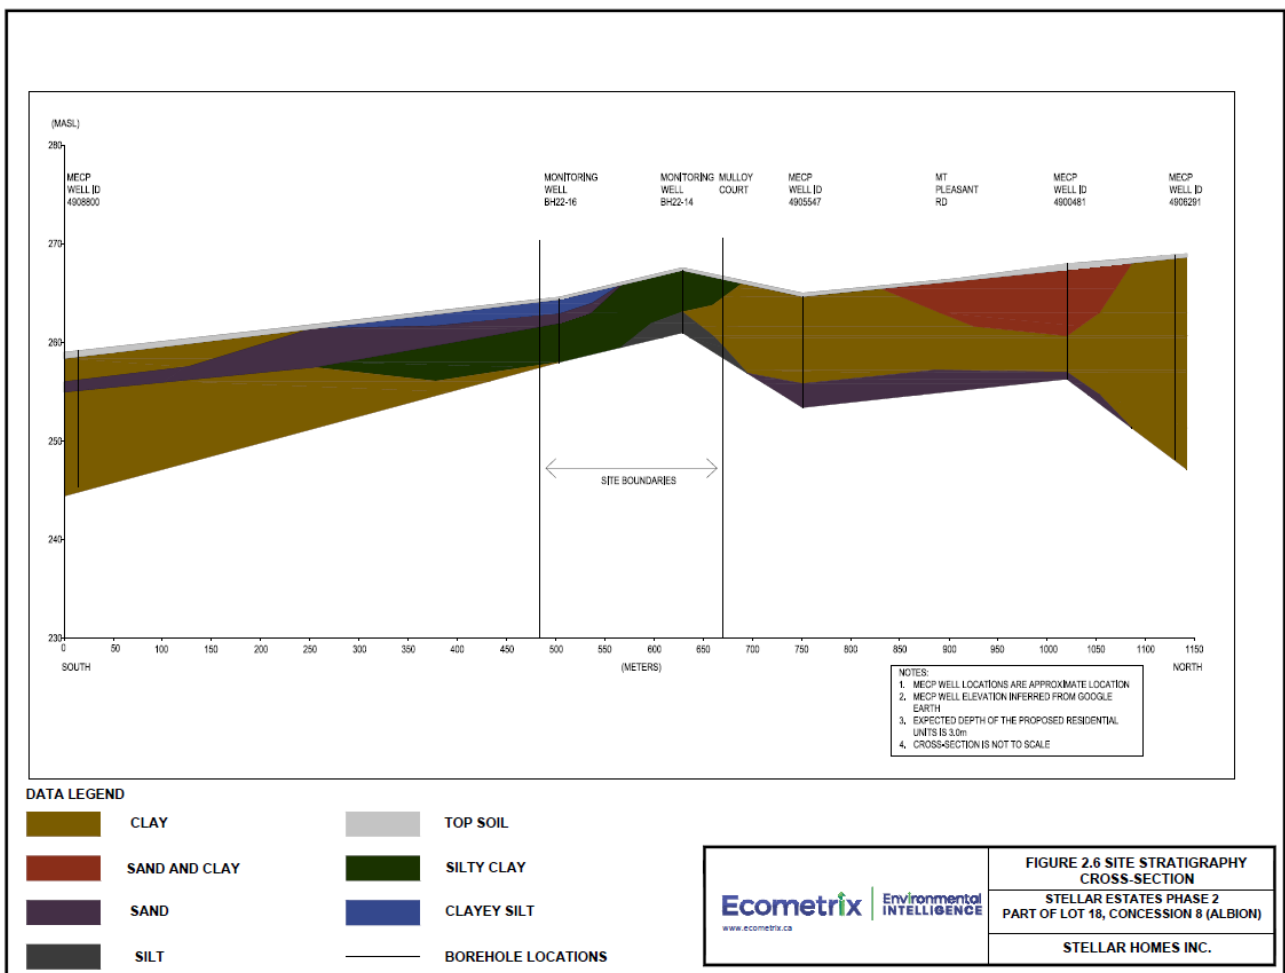
Figure 2.3B: Site Stratigraphy Cross-Section from South to North

Overburden aquifer materials generally consist primarily of clay, with occasional seams of sand and other loose-packed materials. Observed static water levels in the shallow wells range from 1.5 to 12.2 m and well yields range from 0.25 to 5 gallons per minute (GPM; 0.95 to 19 liters per minute, LPM). A detailed cross-section of the site stratigraphy extending 500 metres around it, including the locations of monitoring wells and some MECP wells is shown on Figure 2.3B

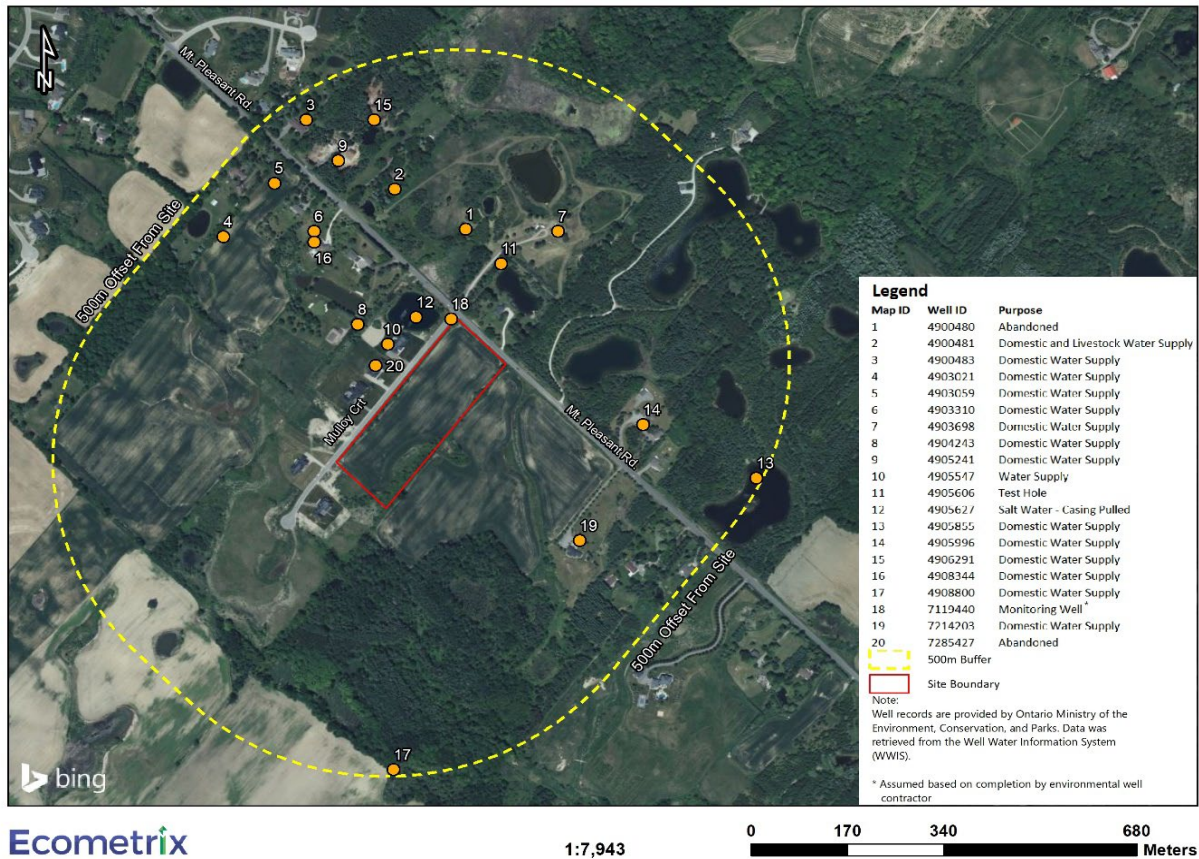
Figure 2.4: Well Records within 500m of the Stellar Estates Phase 2 Site

A search of the Ministry of the Environment, Conservation and Parks (MECP) water well database resulted in the identification of 20 records for the area within 500 m of the Site boundary. Water use in the area includes 15 water supply wells for livestock and domestic use. Of the remaining five well records, two wells (Well IDs 4900480 and 7285427) were listed as abandoned; one well record (Well ID 4905855) noted that the casing was pulled upon discovery of salt water; one well record was identified as a test hole (Well ID 4905606); and a cluster of three wells (Well ID 7119440) did not indicate a purpose but is assumed to have been installed for monitoring purposes based on the installation contractor (Strata Soil Sampling). The approximate locations of identified wells are shown on Figure 2.4. A summary table of all well records, and individual records obtained from MECP well water database, are provided in Appendix B.

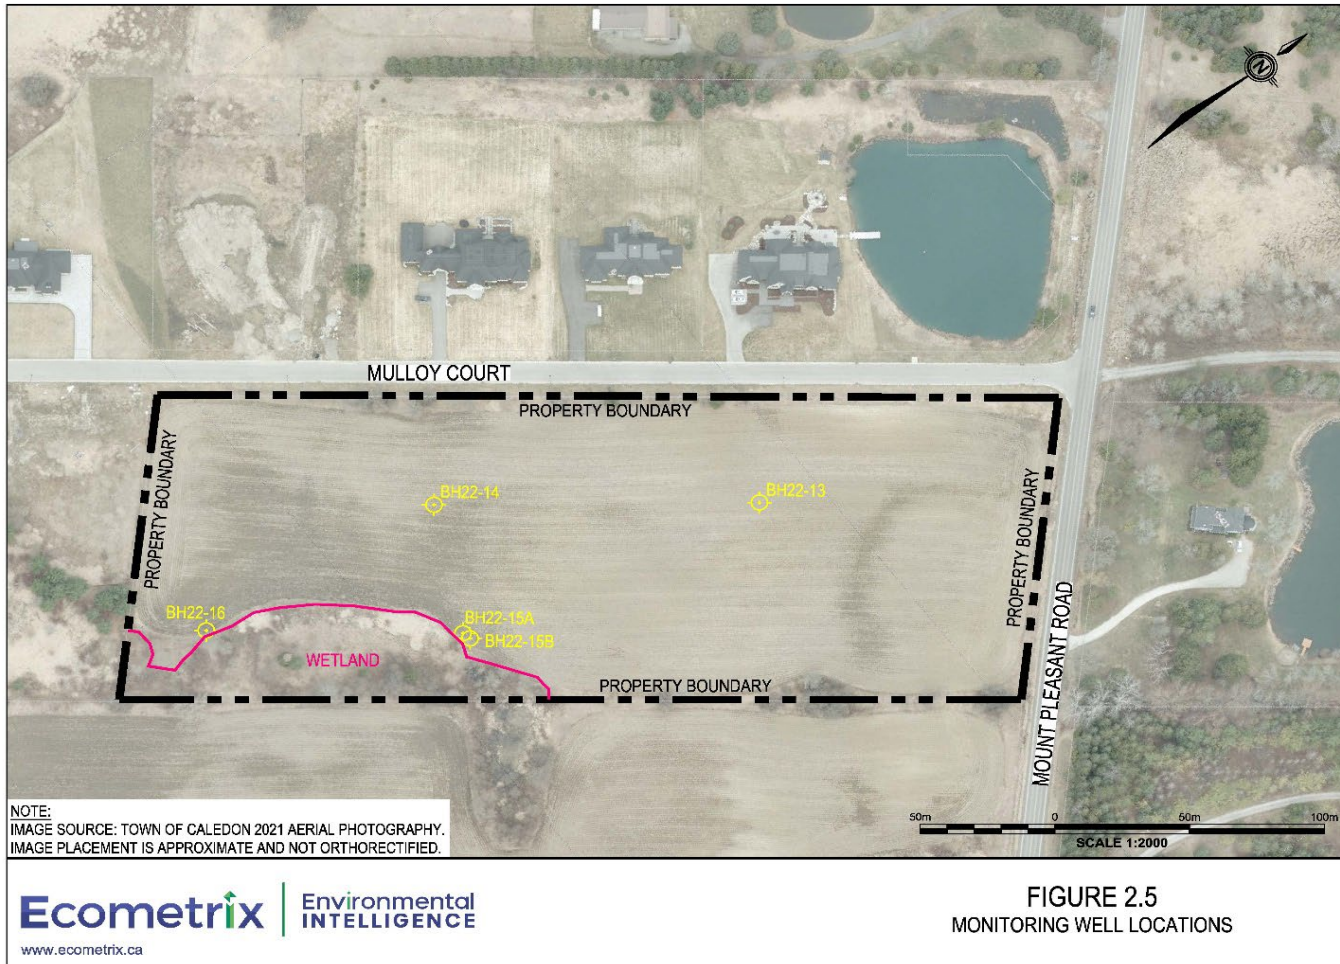
Figure 2.5: Monitoring Well Locations

As part of the geotechnical investigation at the Site, 5 boreholes were advanced to depths of 6.6 to 15.7 mbgs (GeoTerre, 2022). Borehole logs are provided in Appendix A. Monitoring wells were installed in each borehole to depths ranging from 4.1 to 14.6 mbgs (Table 2-1). Nested monitoring wells BH22-15A and BH22-15B were installed in separate boreholes at depths of 5.38 and 14.6 mbgs, respectively. The locations of the monitoring wells are illustrated in Figure 2.5.

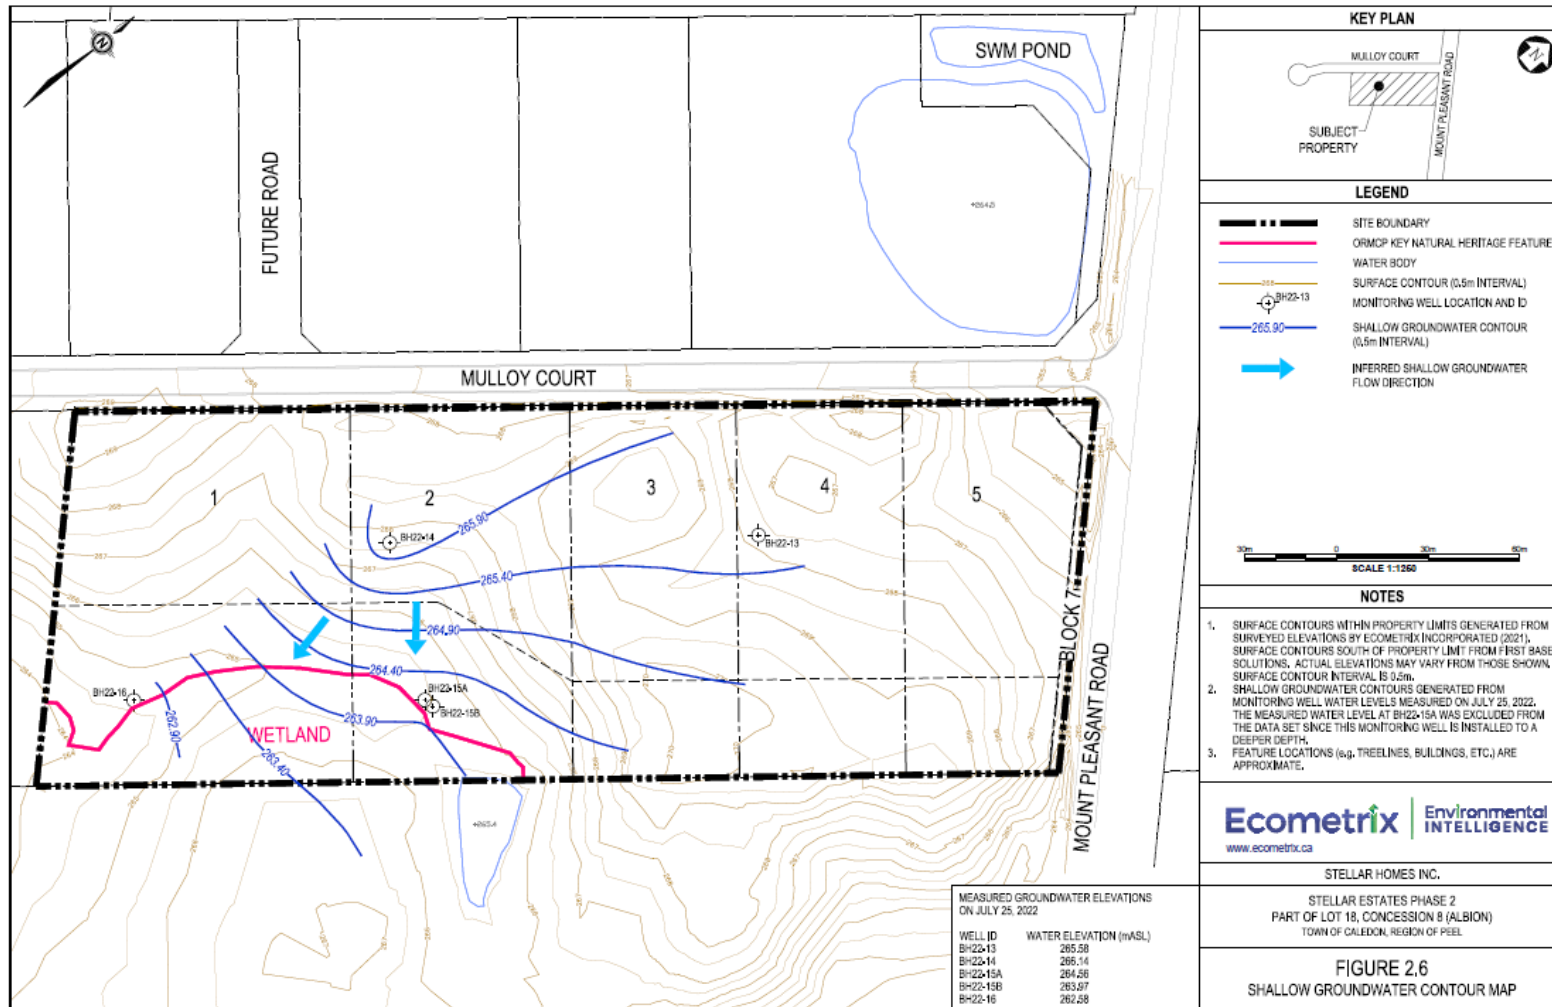
Figure 2.6: Shallow Groundwater Contour Map

A map of shallow groundwater levels showing the inferred groundwater flow direction in the shallow groundwater system is shown in Figure 2.6 for water levels measured on July 25, 2022. The water level at BH22-15A, installed at a greater depth, was not included in the figure. The low permeability deposits near surface, and the undulating topography are indicative that topographic control on the water table occurs throughout the area. The water elevations in the monitoring wells confirm that the water table remains close to surface over a wide range of elevations across the site and is typically within 5m or less of ground surface. An upward flow direction at the edge of the wetland measured in wells BH22-15A and BH22-15B is indicative of a local-scale flow system influenced by the topography at the scale of the Site. This type of shallow, local-scale groundwater flow system is commonly influenced by seasonal changes and hydraulic connections with surface water bodies.

It is important to highlight that the water level elevations shown in Figure 2.6 which is dated July 25, 2022, are representative of the overall flow path in the area. Subsequent measurements on November 23, 2022, April 19, 2023, September 27, 2023, March 15, 2024, June 28, 2024 and October 11, 2024 consistently follow a similar pattern, exhibiting normal seasonal fluctuations. Despite these changes, the general trend shows that shallow groundwater tends to flow towards the topographic low areas, specifically directed towards the identified wetlands in the southern portion of the site (Figure 2.6).

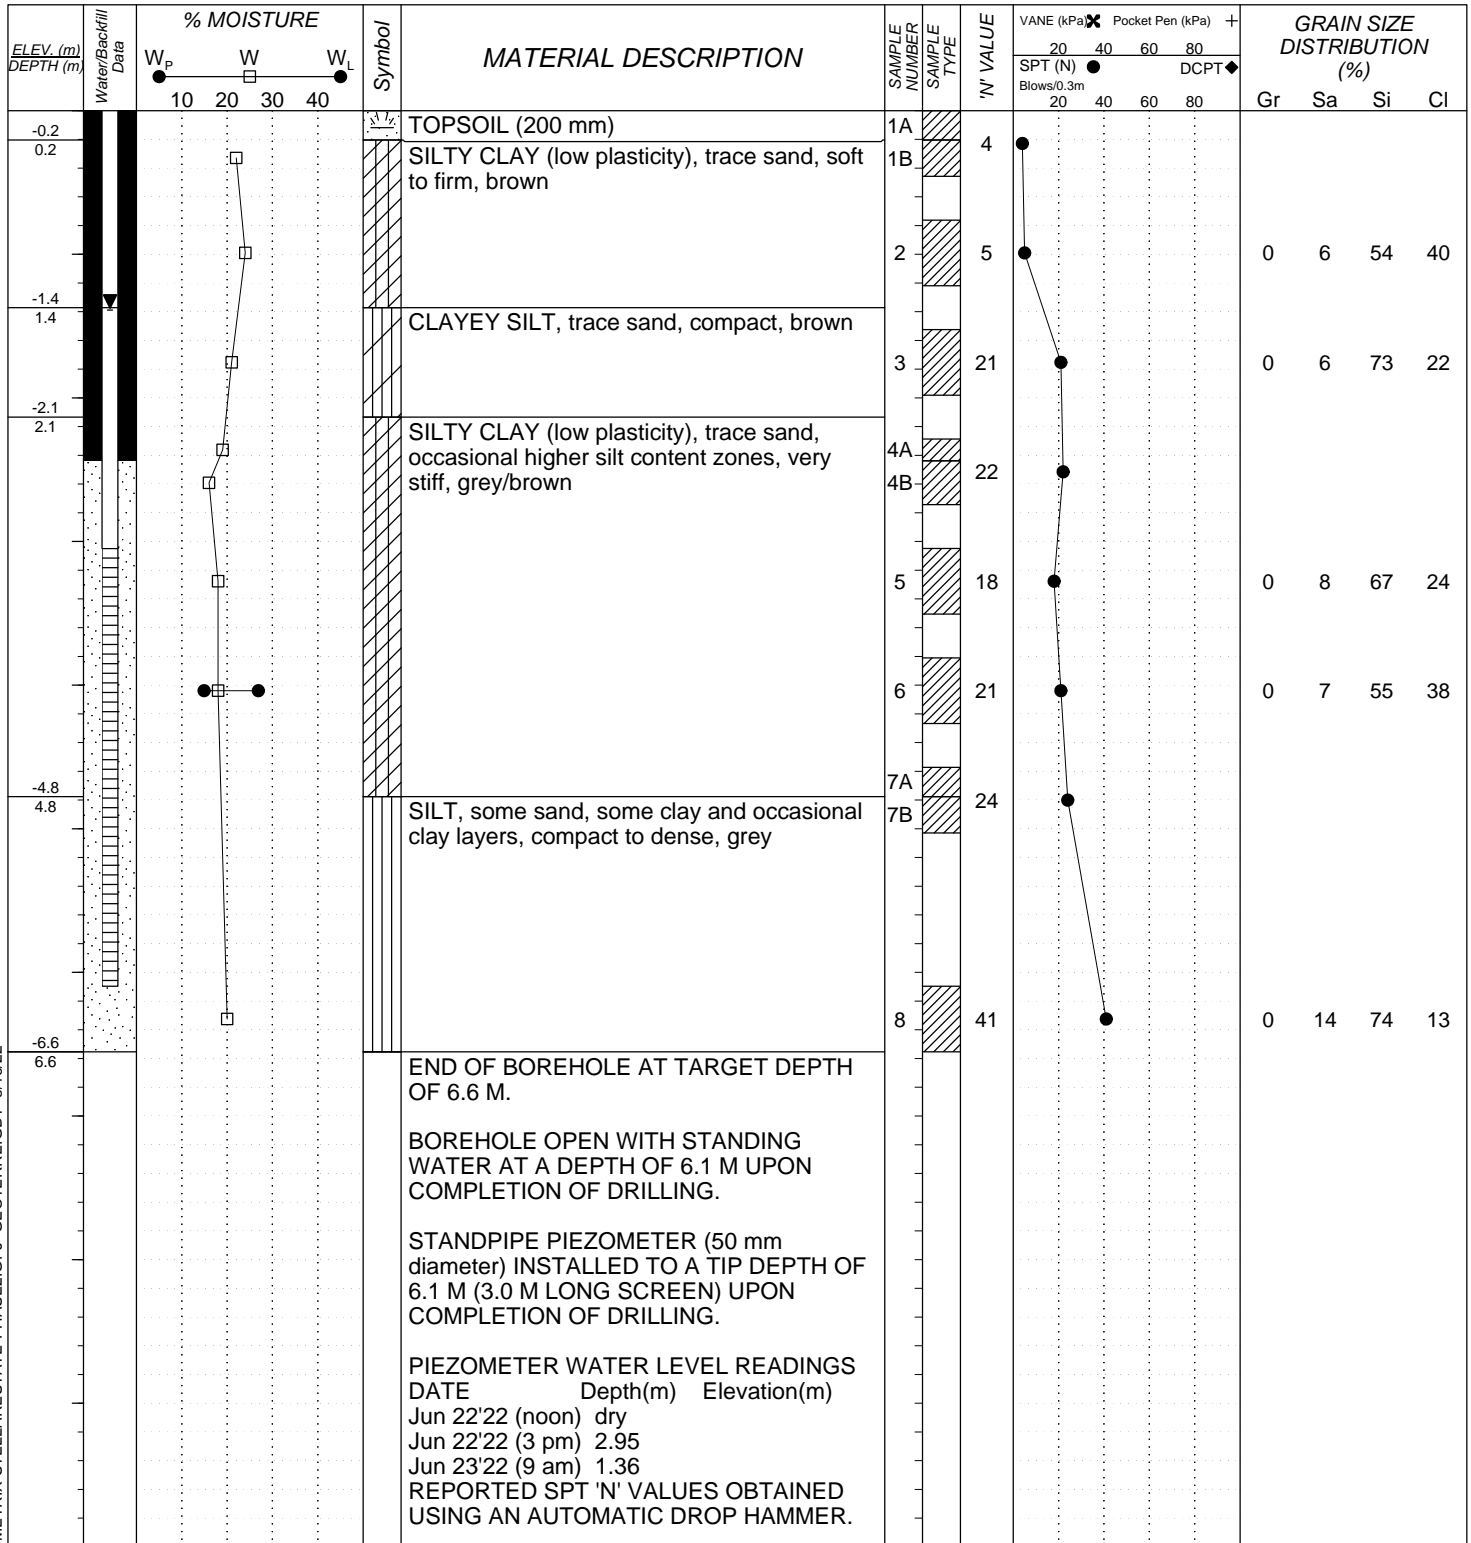
LOG OF BOREHOLE ECOMETRIX-STELLARSTATE-PHASE2.GPJ GEOTERRE.GDT 8/16/22

PROJECT No.: **TG22-033**
 CLIENT: **Ecometrix**
 PROJECT: **Stellar Estates-Phase 2**
 LOCATION: **Ontario**
 SURFACE ELEV.: **0 metres (Geodetic)**

Drilling Data
 METHOD: **Solid Stem Augers**
 DIAMETER: **150 mm**
 PREP. BY: **VTM** APPR. BY: **IC**
 DATE: **June 22 2022**

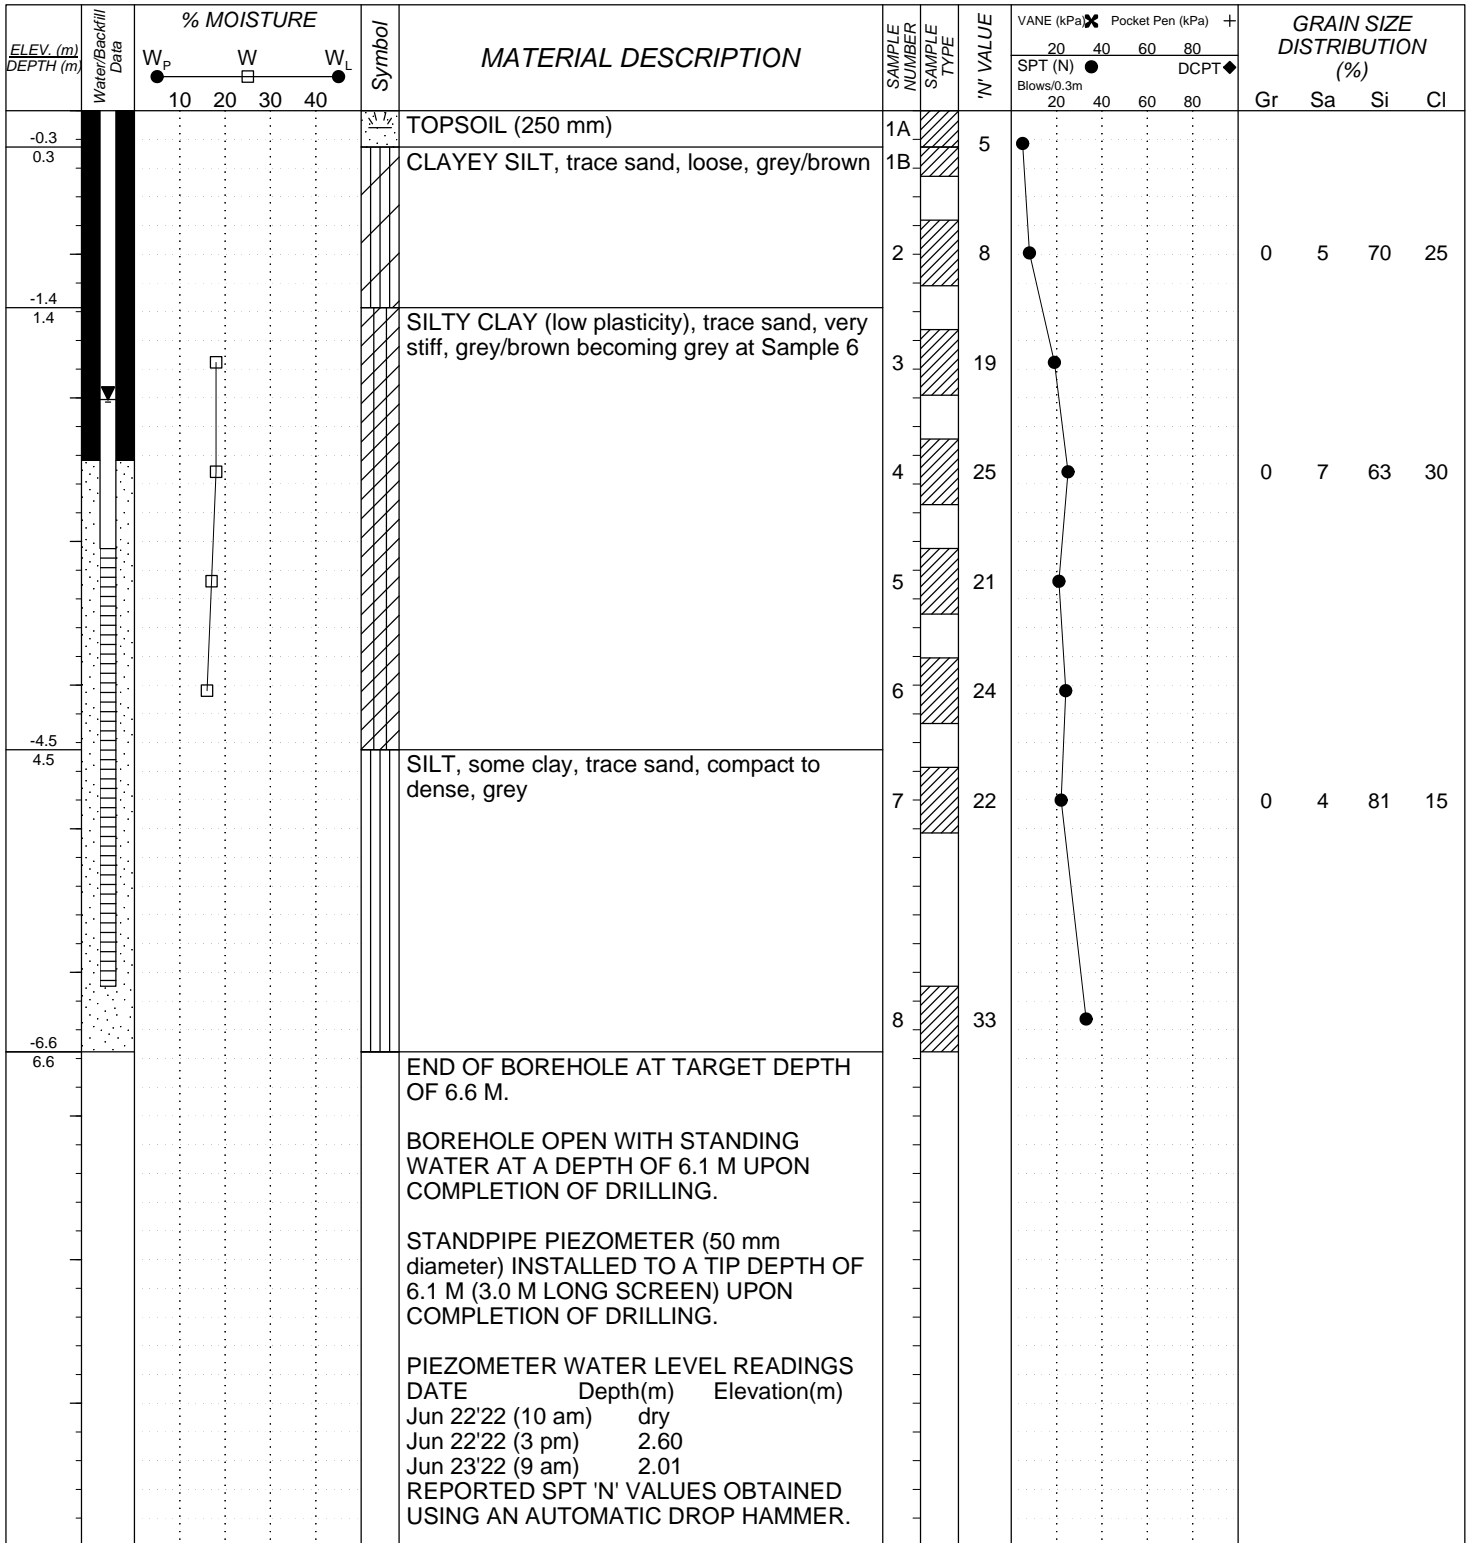
LOG OF BOREHOLE ECOMETRIX-STELLARSTATE-PHASE2.GPJ GEOTERRE.GDT 8/16/22

PROJECT No.: **TG22-033**
 CLIENT: **Ecometrix**
 PROJECT: **Stellar Estates-Phase 2**
 LOCATION: **Ontario**
 SURFACE ELEV.: **0 metres (Geodetic)**

Drilling Data
 METHOD: **Solid Stem Augers**
 DIAMETER: **150 mm**
 PREP. BY: **VTM** APPR. BY: **IC**
 DATE: **June 22 2022**

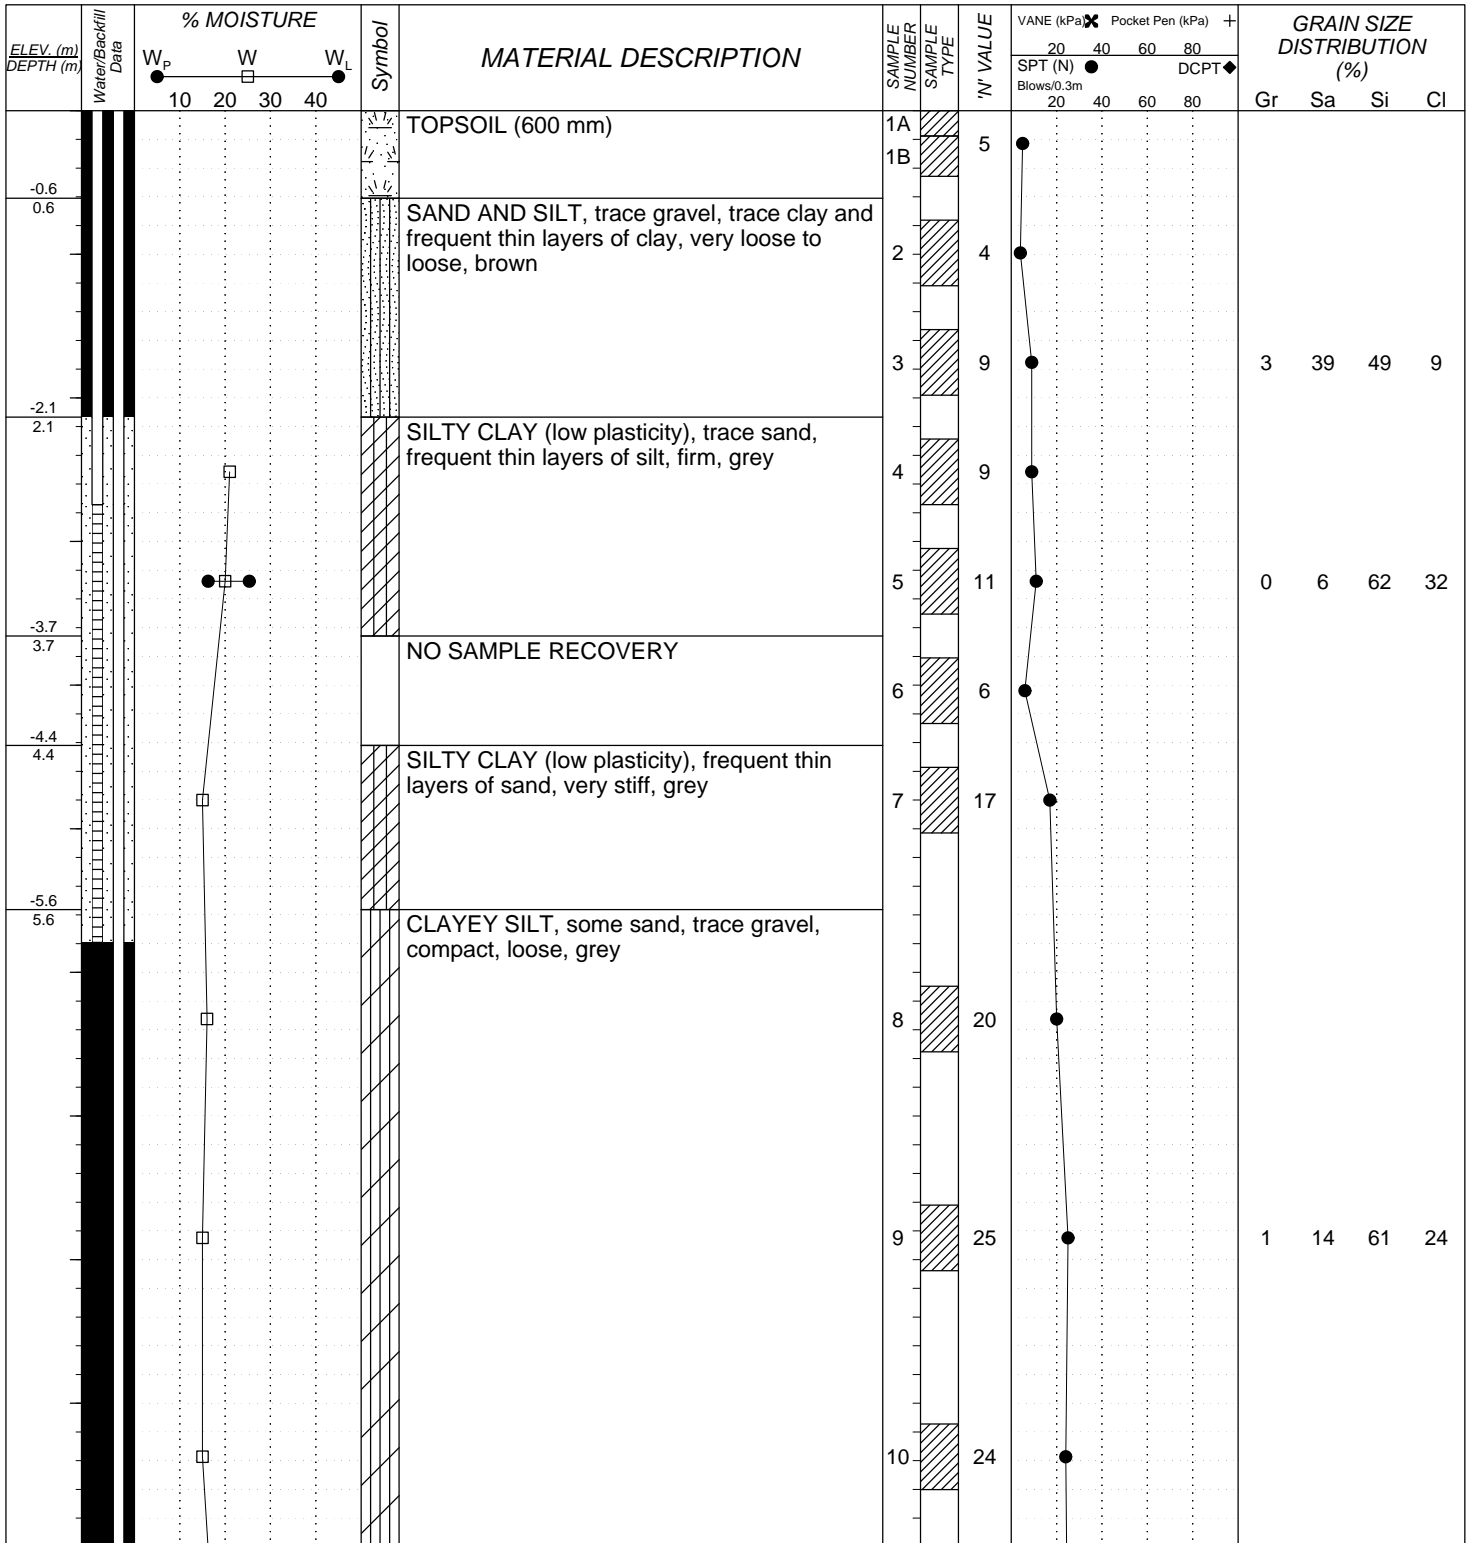
LOG OF BOREHOLE ECOMETRIX-STELLARESTATE-PHASE2.GPJ GEOTERRE.GDT 8/16/22

PROJECT No.: **TG22-033**
 CLIENT: **Ecometrix**
 PROJECT: **Stellar Estates-Phase 2**
 LOCATION: **Ontario**
 SURFACE ELEV.: **0 metres (Geodetic)**

Drilling Data
 METHOD: **See Note 1)**
 DIAMETER:
 PREP. BY: **PSH** APPR. BY: **IC**
 DATE: **June 23 2022**

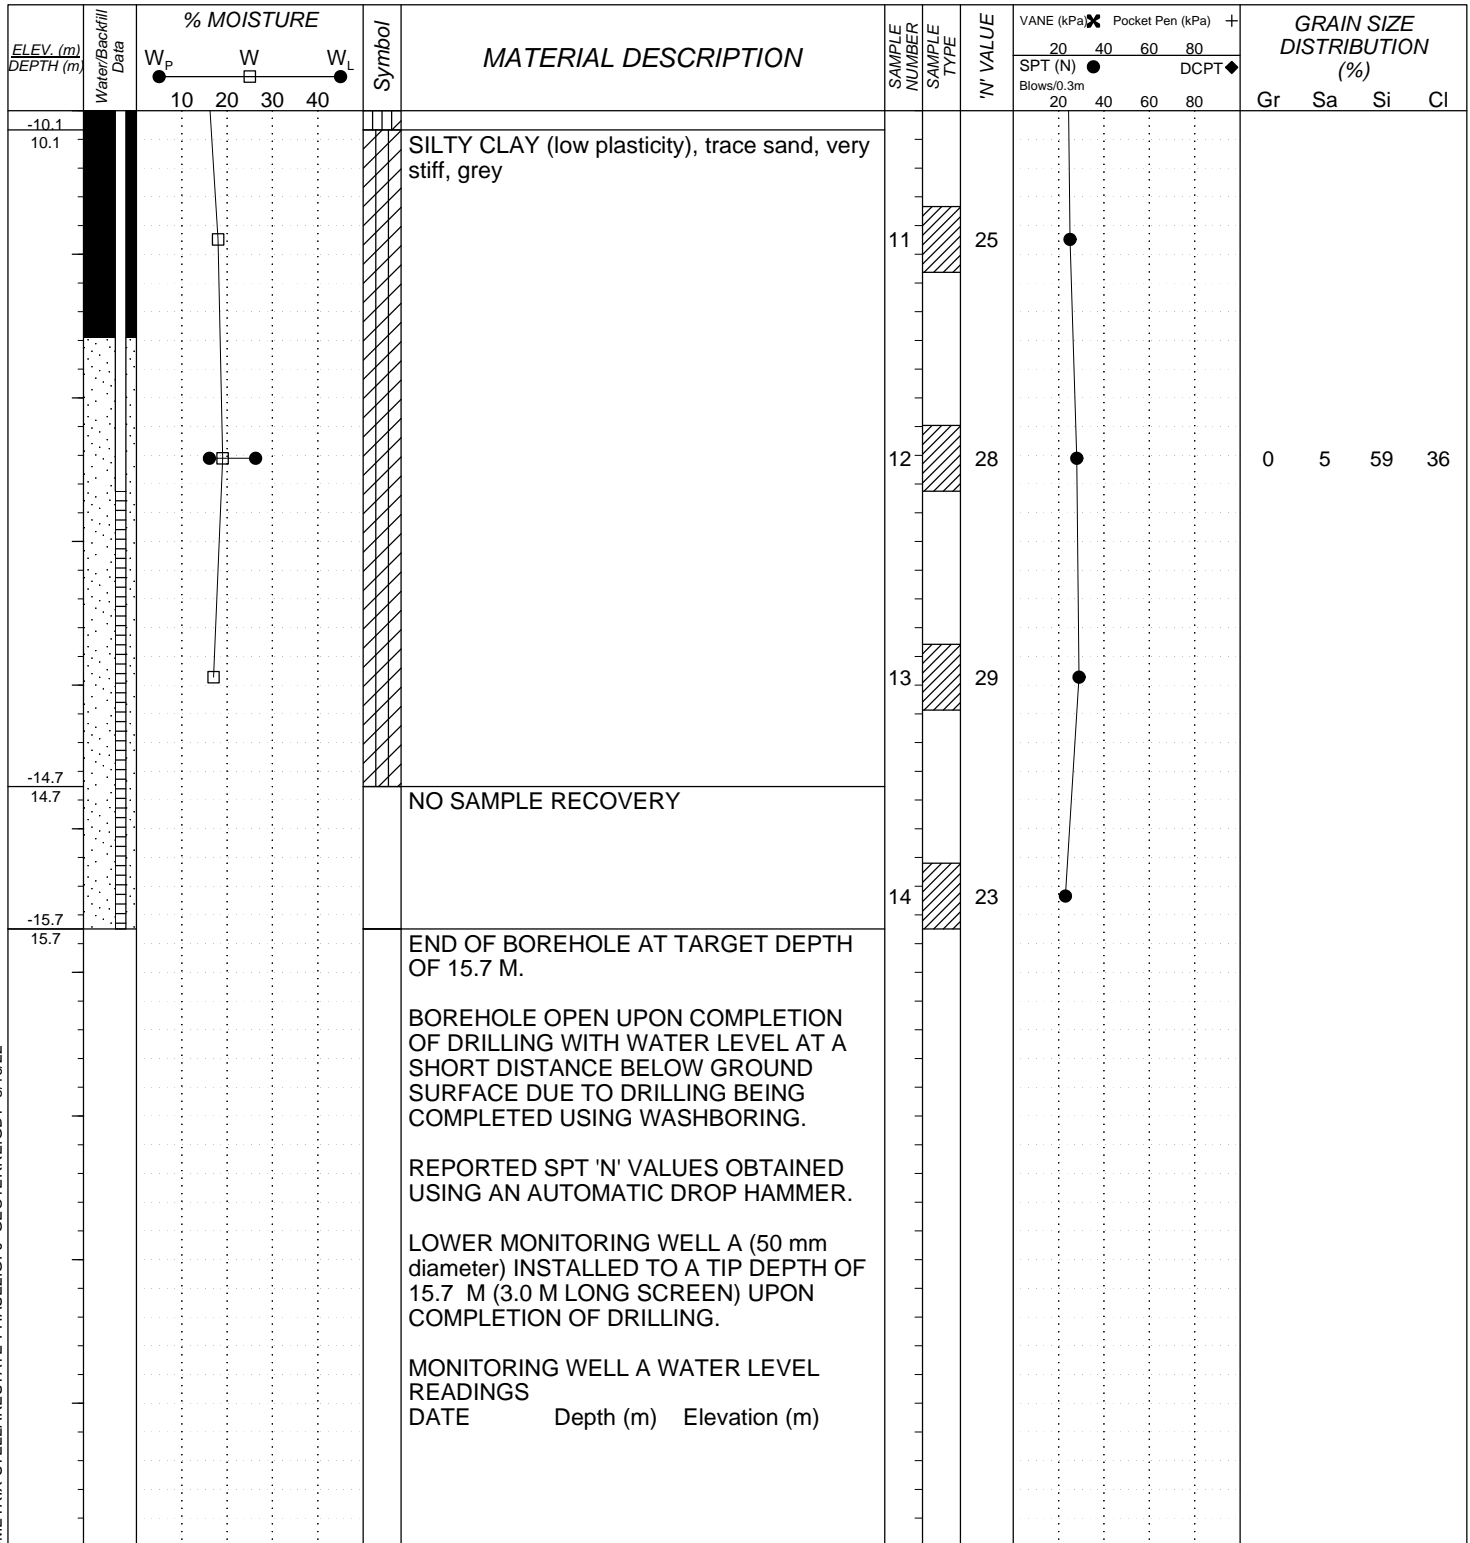
LOG OF BOREHOLE ECOMETRIX-STELLARESTATE-PHASE2.GPJ GEOTERRE_GDT 8/16/22

PROJECT No.: **TG22-033**
 CLIENT: **Ecometrix**
 PROJECT: **Stellar Estates-Phase 2**
 LOCATION: **Ontario**
 SURFACE ELEV.: **0 metres (Geodetic)**

Drilling Data
 METHOD: **See Note 1)**
 DIAMETER:
 PREP. BY: **PSH** APPR. BY: **IC**
 DATE: **June 23 2022**

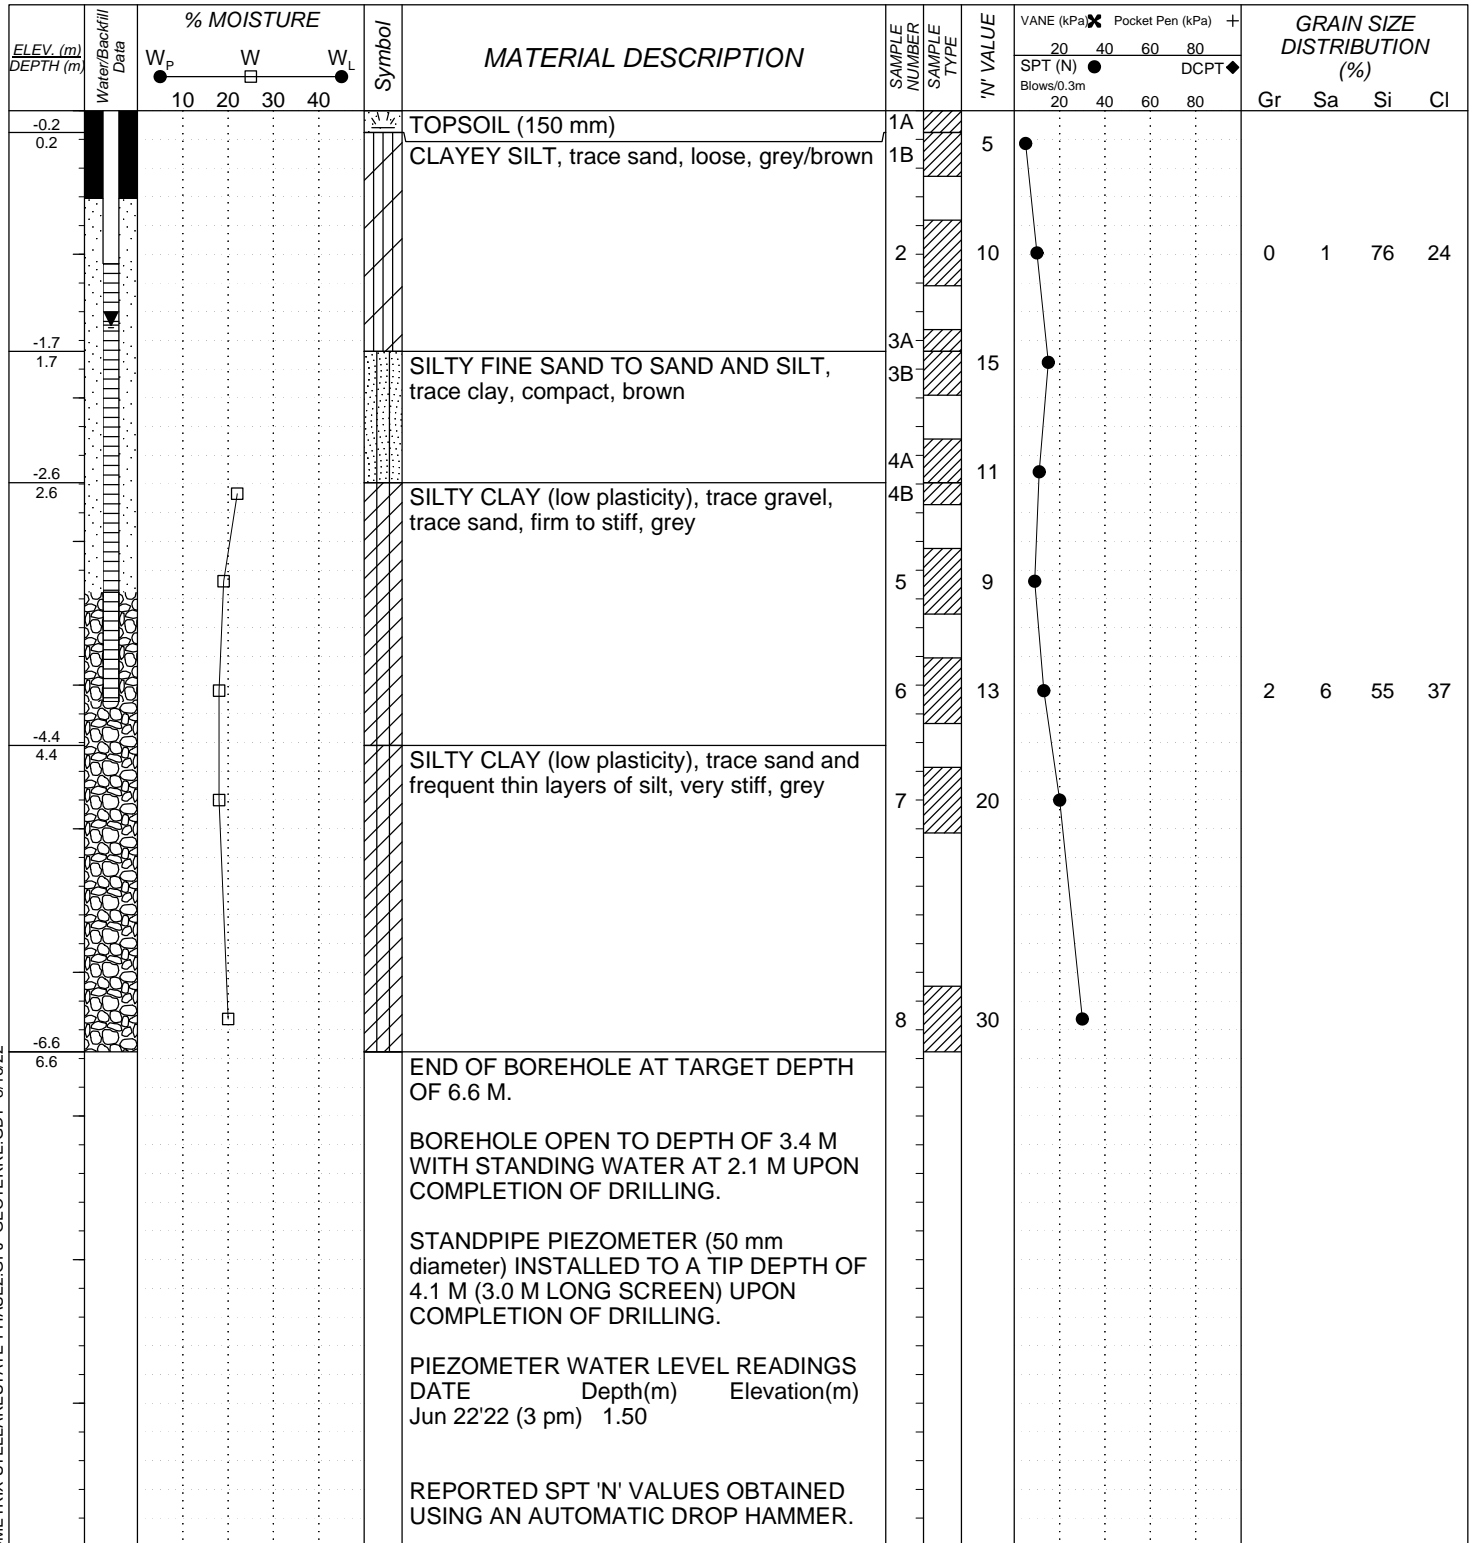
LOG OF BOREHOLE ECOMETRIX-STELLARESTATE-PHASE2.GPJ GEOTERRE.GDT 8/16/22

PROJECT No.: **TG22-033**
 CLIENT: **Ecometrix**
 PROJECT: **Stellar Estates-Phase 2**
 LOCATION: **Ontario**
 SURFACE ELEV.: **0 metres (Geodetic)**

Drilling Data
 METHOD: **Solid Stem Augers**
 DIAMETER: **150 mm**
 PREP. BY: **VTM** APPR. BY: **IC**
 DATE: **June 22 2022**
