HYDROGEOLOGICAL ASSESSMENT FOR STELLAR ESTATES PHASE 2

TOWN OF CALEDON, ONTARIO

Ecometrix Incorporated
www.ecometrix.ca
Mississauga, ON

Ref. 22-3001
17 January 2025

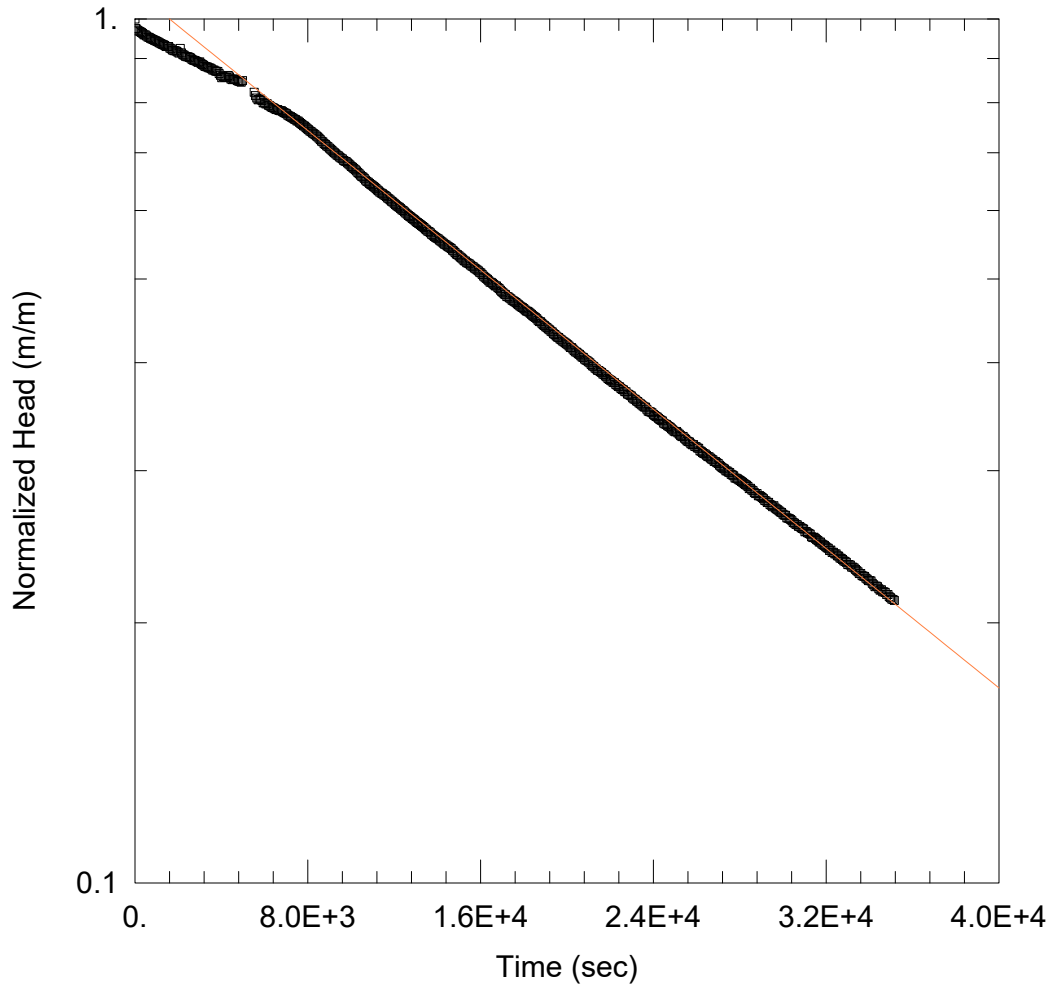
Data Set: W:\...\BH22-15A.aqt
 Date: 08/30/22

Falling head tests were performed at monitoring wells BH22-15A and BH22-15B by inserting a solid slug into the water column, and subsequent monitoring of the lowering of water level in the well over time back to static conditions. A rising head test was performed at monitoring well BH22-16 by removing a volume of water from the well casing and subsequent monitoring of the rise in water level in the well over time back to static conditions. Water levels were recorded manually using a water level tape and through measurements collected automatically in regular intervals using Solinst Levelloggers installed in each well, as described in Section 2.3.4. The test durations ranged from 1.1 to 10.9 hours, and 59% to 96% of the recovery was monitored (Table 2-6). Barometric pressure readings were recorded at the same regular intervals to compensate for atmospheric pressure fluctuations over the course of the test.

Interpretation of the slug test data was completed using version 4.5 of AQTESOLV Aquifer test Analysis Software (HydroSOLVE, 2007), which provides a range of analytical solutions depending on aquifer and well construction conditions. The Bouwer and Rice (1975) model was used to estimate the hydraulic conductivity of BH22-15A, which is installed in silty clay interpreted to represent confined conditions. The model developed by Hyder *et al.* (1994), also known as the KGS Model, was used for the analysis of data from shallow well BH22-15B due to unconfined conditions and slight non-linearity in the response. A saturated thickness of 5 metres was assumed for the analysis of BH22-15A and BH22-15B, approximated based on observed water levels, subsurface stratigraphy reported in borehole logs, and well depths (Appendix A). The Cooper method (Cooper *et al.*, 1967) was used for the interpretation of slug test data from BH22-16, assuming preferential groundwater flow through the 0.9 m thick silty fine sand layer observed between silty clay above and below within the screened interval resulting in a response similar to confined conditions. Inputs and assumptions for the analysis are provided in Appendix C.

The results indicate that the silty clay till observed at the screened depths of deep well BH22-15A has low permeability. Hydraulic conductivity at shallow wells BH22-15B and BH22-16 were higher, and the results are consistent with observations of sand seams at BH22-15B, and a thin confined layer of sand within the screened interval at BH22-16, as reported in borehole logs by GeoTerre (Appendix A). Overall, the results are considered representative of low to moderate permeability of the shallow groundwater system across the southern portion of the Site.
