12197 Hurontario Street, Brampton, Ontario
And
12211, 12213 & 12231 Hurontario Street, Caledon, Ontario

Geotechnical Investigation

Proposed Residential Development (Summer Valley)

BRM-00257876-D0

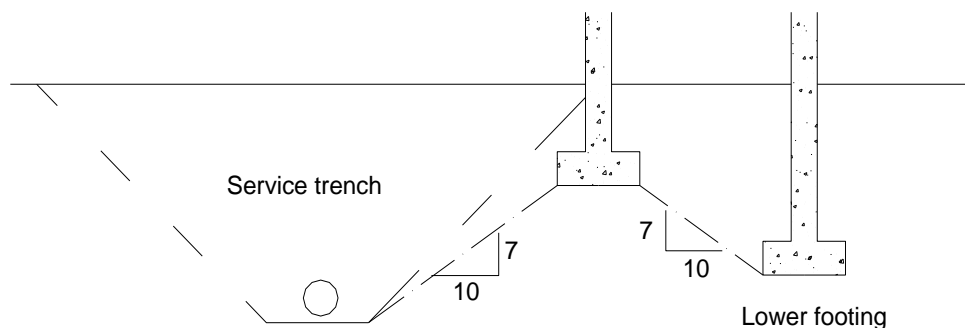
FOOTINGS NEAR SERVICE TRENCHES OR AT DIFFERENT ELEVATIONS

Footings which are to be placed at different elevations should be located such that the higher footings are set below a line drawn up at 10 horizontal to 7 vertical from the near edge of the lower footing. This concept should also be applied to excavations for new foundations in relation to existing footings or underground services. This concept is illustrated in the following sketch:

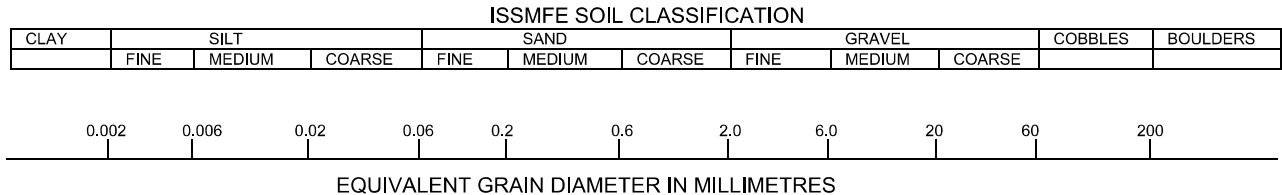
Drawing 1A

1. All sample descriptions included in this report follow the Canadian Foundations Engineering Manual soil classification system. This system follows the standard proposed by the International Society for Soil Mechanics and Foundation Engineering. Laboratory grain size analyses provided by exp Services Inc. also follow the same system. Different classification systems may be used by others; one such system is the Unified Soil Classification. Please note that, with the exception of those samples where a grain size analysis has been made, all samples are classified visually. Visual classification is not sufficiently accurate to provide exact grain sizing or precise differentiation between size classification systems.

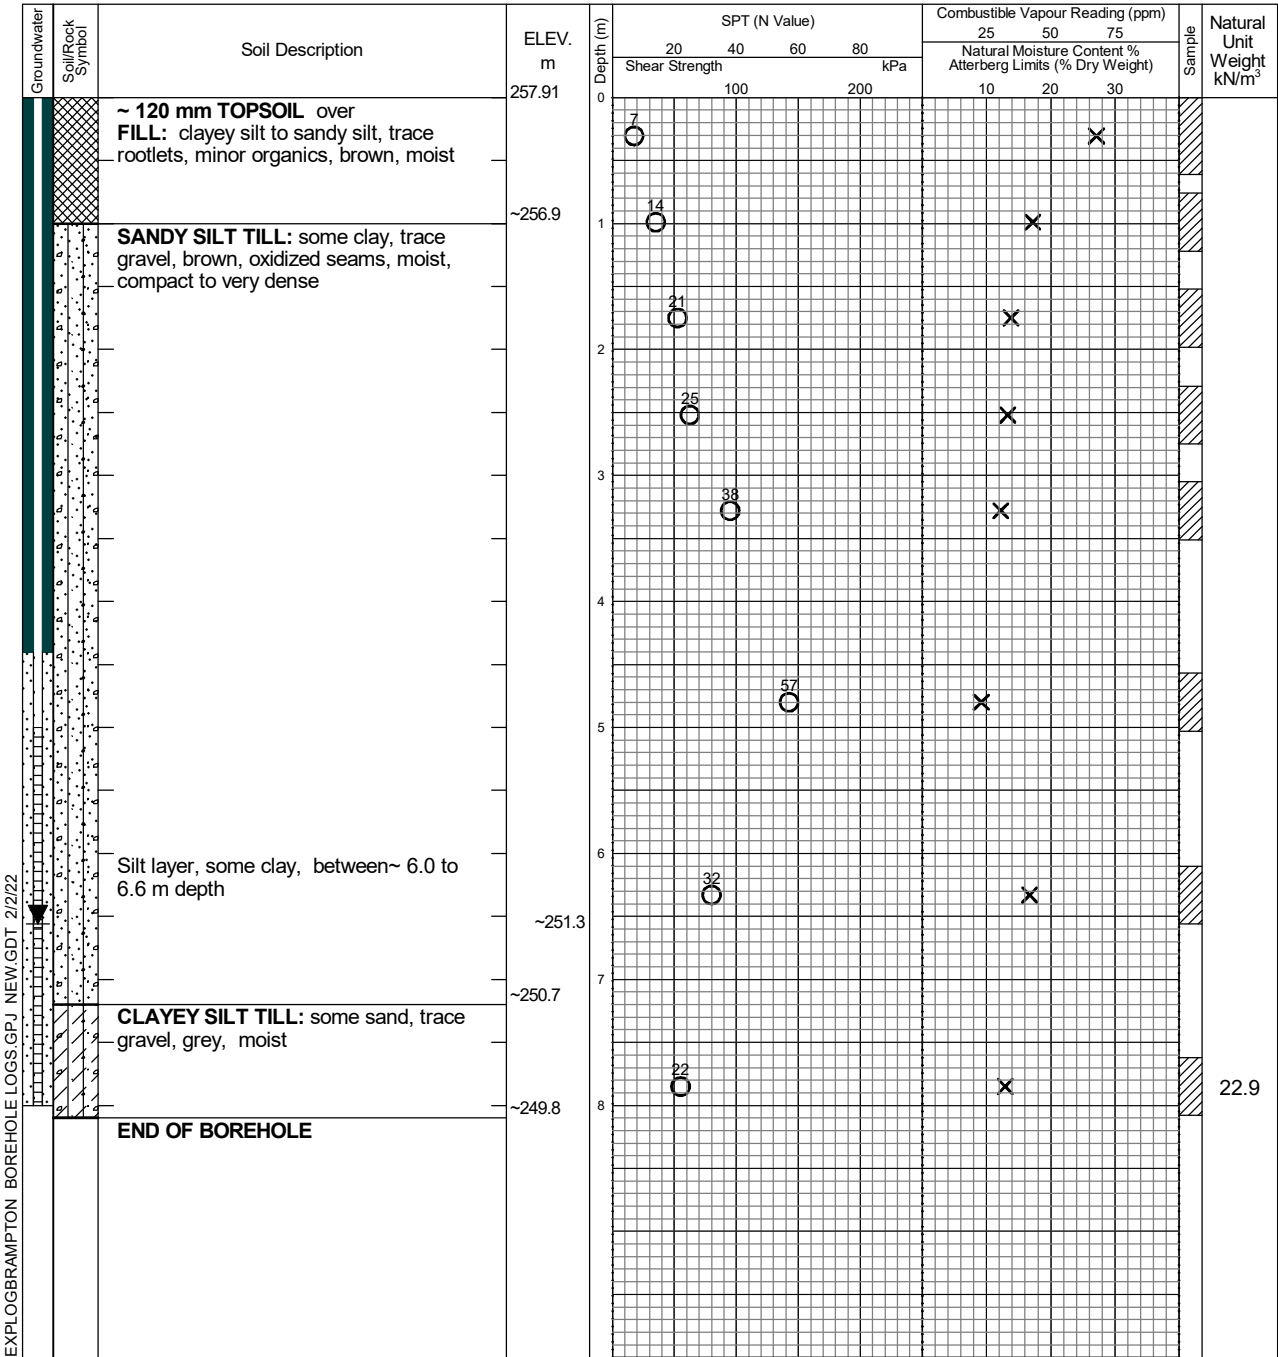
Date	Water Level (m)	Hole Open to (m)
On completion	Dry	
January 5, 2022	6.59	
January 12, 2022	6.49

The detailed soil profiles encountered in each borehole and the results of geotechnical laboratory testing are indicated on the attached borehole logs (Drawing Nos. 2 through 7) and figures in Appendix A. It should be noted that the soil boundaries indicated on the borehole logs are inferred from non-continuous sampling and observations during drilling. These boundaries are intended to reflect approximate transition zones for the purpose of geotechnical design and should not be interpreted as exact planes of geological change.

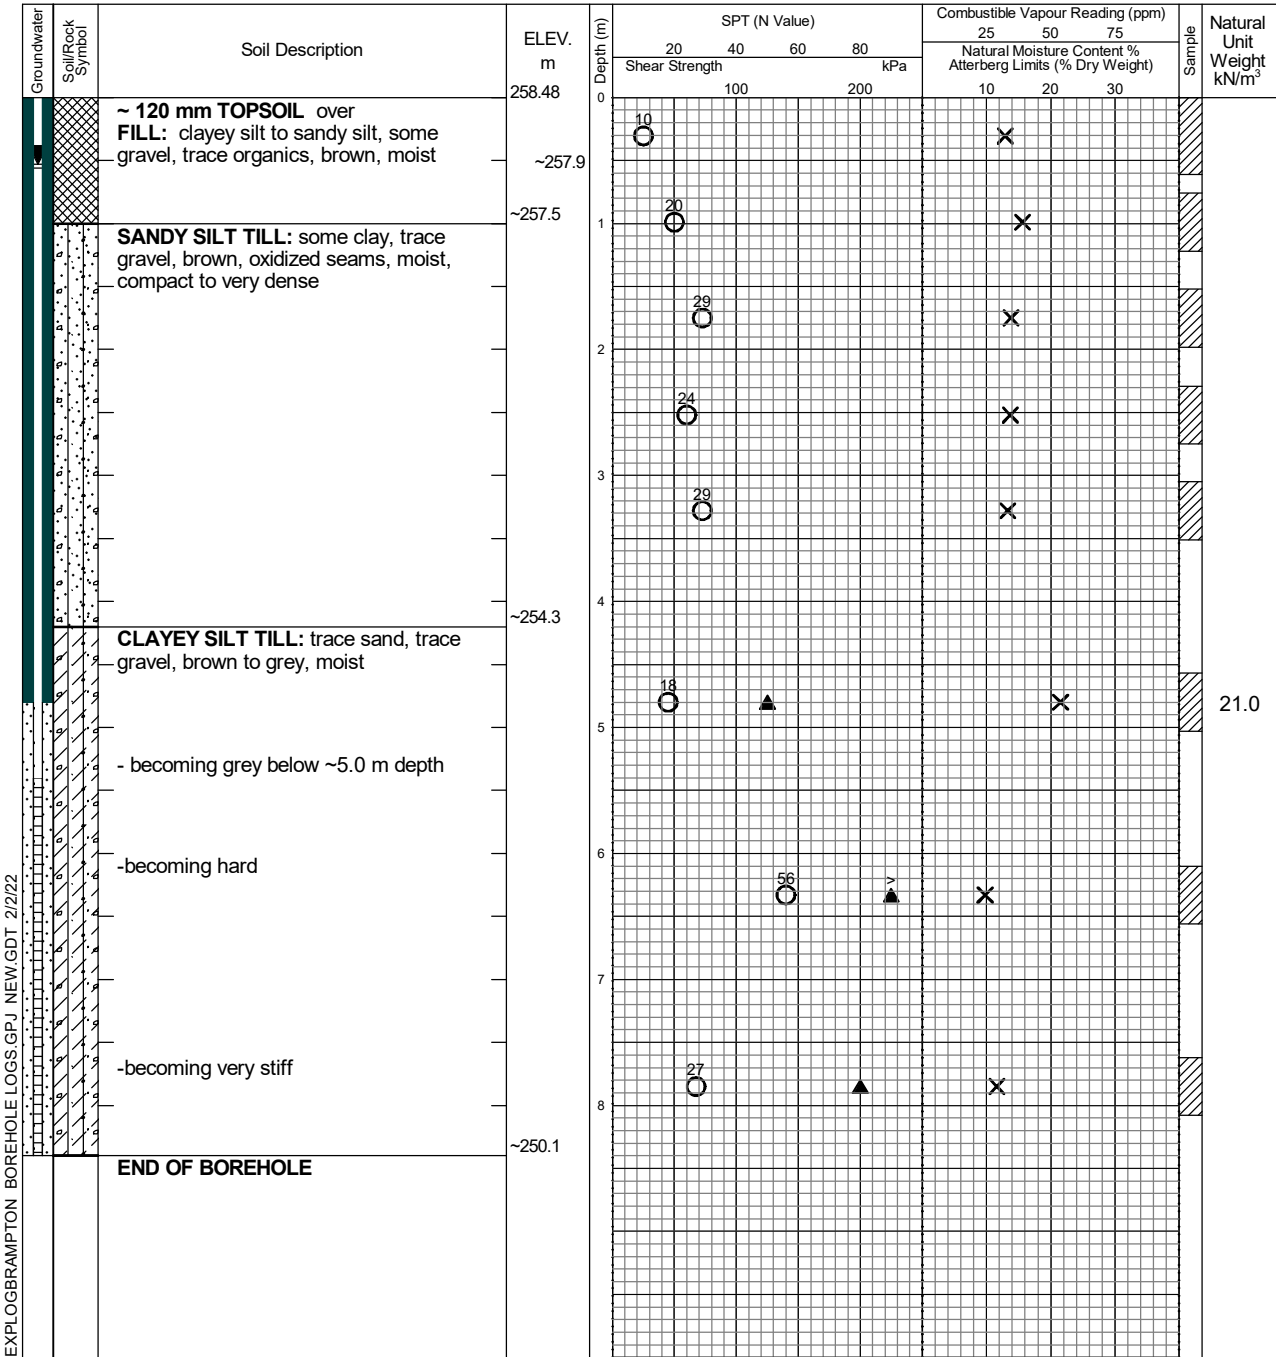
Date	Water Level (m)	Hole Open to (m)
On completion	8.0	
January 5, 2022	0.56	
January 12, 2022	1.72

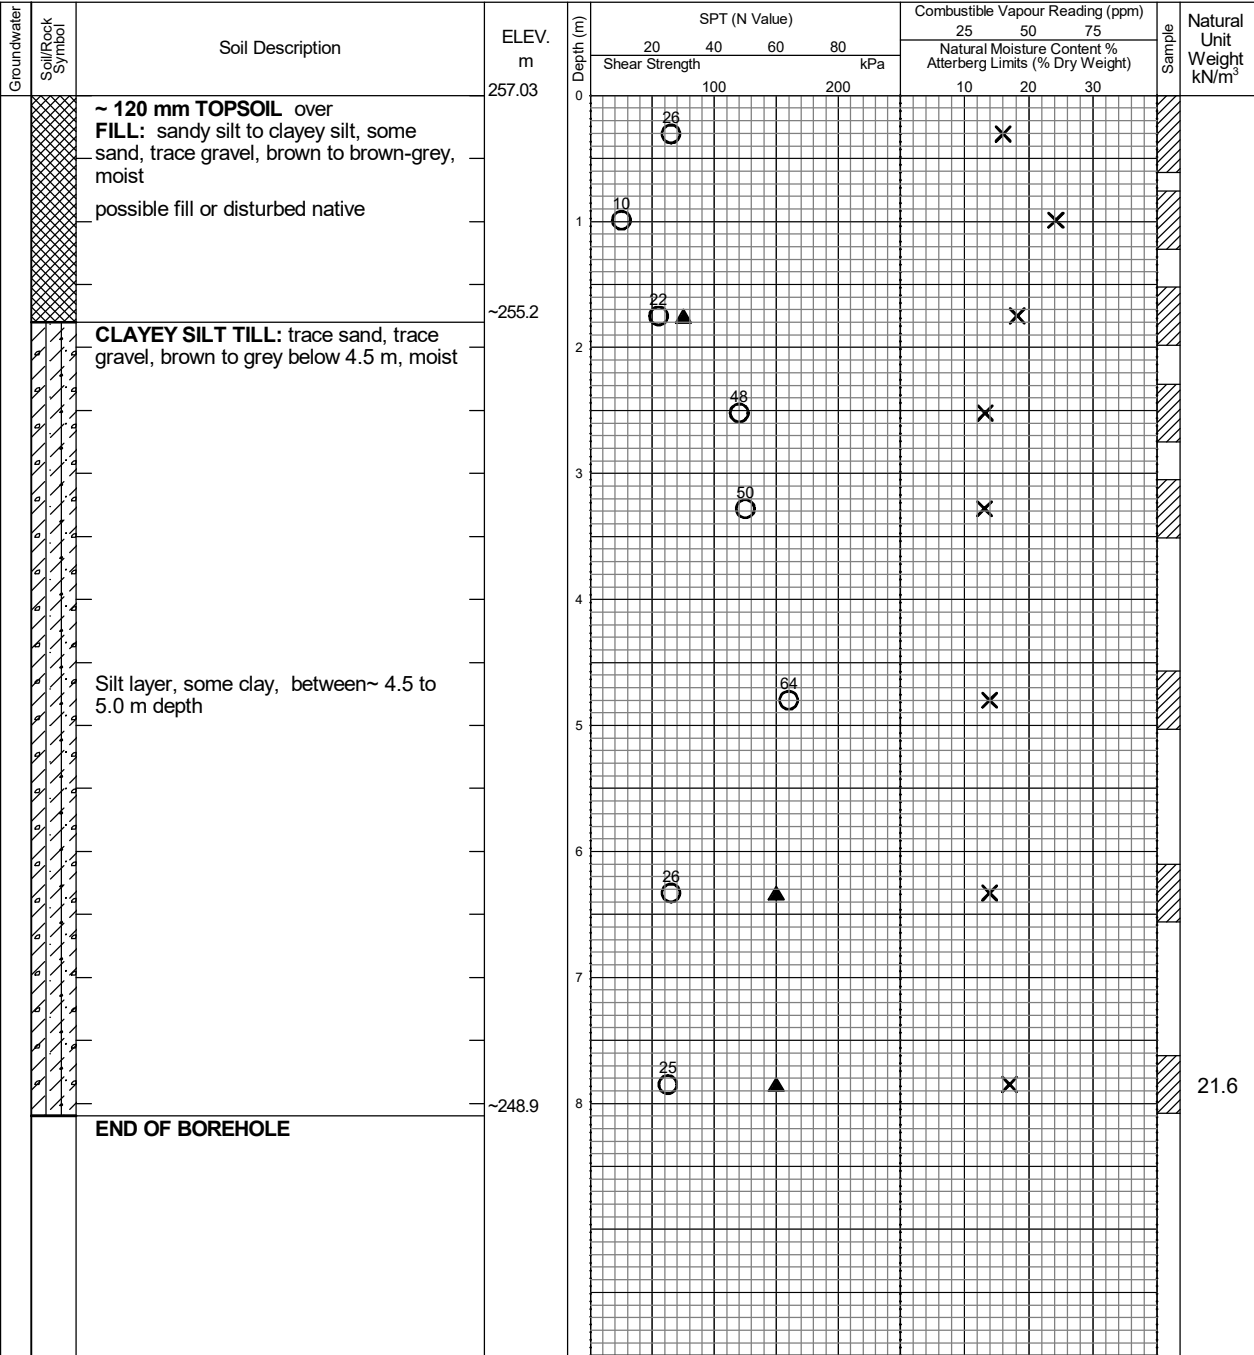
Date	Water Level (m)	Hole Open to (m)
On completion	8.0

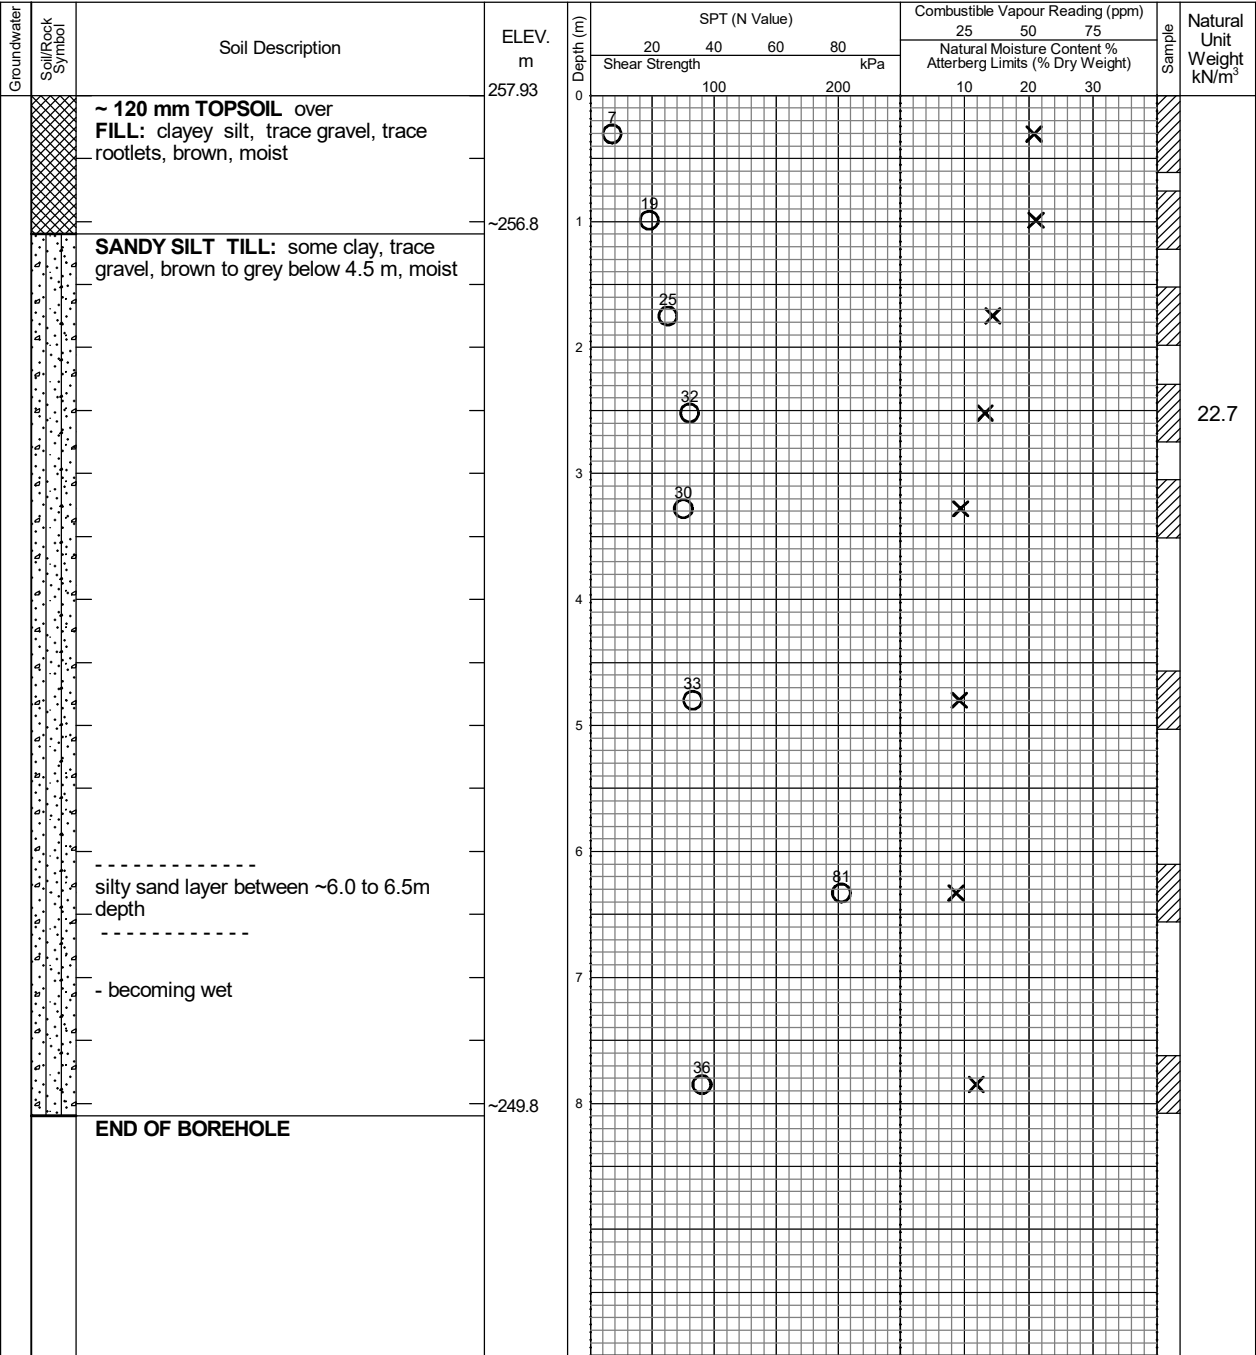
It is recommended that the foundation walls be covered with a bituminous damp-proofing spray and a drainage sheet. In addition, a weeping tile surrounded with 300 mm of 19 mm clear stone and wrapped with a filter cloth should be installed around the perimeter of the basement and connected to a frost-free outlet. The recommended arrangements are shown in Drawing 7.

Date	Water Level (m)	Hole Open to (m)
On completion	7.0

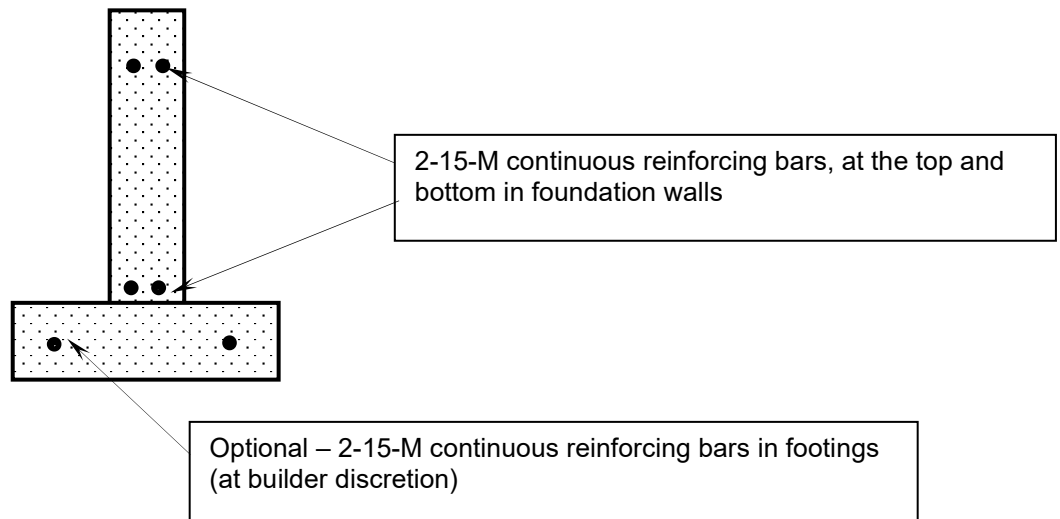
Steel Reinforcement for Footings and Foundation Walls on Engineered Fill

The sketch below outlines the reinforcement required for footings founded on engineered fill.

Note: At windows, reinforcing bars should be placed both above and below the windows.

It is recommended that nominal reinforcing steel be installed in the footings and foundation walls of structures supported on engineered fill to minimize cracking from differential settlement. The basement walls should be reinforced continuously with 2-15M bars above the footings and below the windowsill. If the basement walls are made from concrete blocks, equivalent top and bottom reinforcing should be provided as designed by a structural engineer.

If the dwellings are founded on engineered fill, reinforcement should be provided in the foundation wall as shown in Drawing 8.

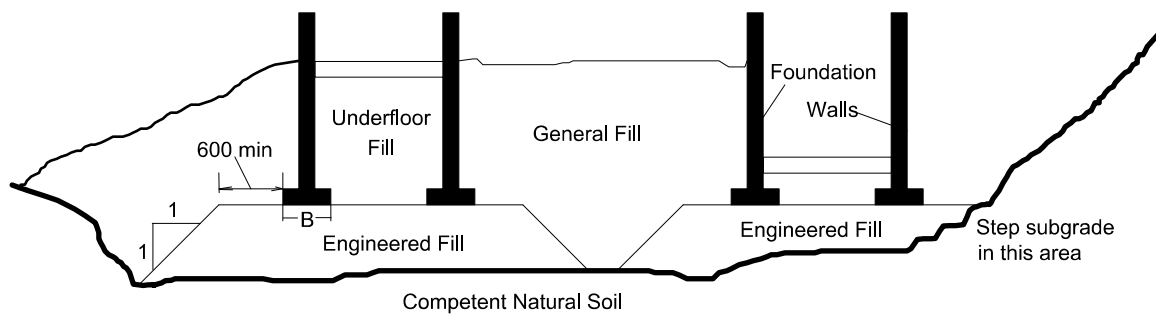
Foundations on Engineered Fill (schematic)

- The area must be stripped of all topsoil, existing fill material or other deleterious material and proof-rolled. Soft spots must be dug out. The stripped native subgrade must be examined and approved by a geotechnical engineer prior to placement of fill.
- The approved engineered fill must be placed in loose lifts not exceeding 200 mm and compacted to 100% Standard Proctor dry density throughout. Granular fill is preferred.
- Full time geotechnical inspection during placement of engineered fill is required.
- The fill must be placed such that the specified geometry is achieved as follows:.

- A minimum footing width of 500 mm (20 inches) is suggested. It is recommended that poured concrete basement walls should be reinforced with 2 – 15M rebars above the footings and below the window sill.
- All excavations must be done in accordance with the Occupational Health and Safety Regulations of Ontario.

The engineered fill should be constructed by removing all topsoil and existing fills in the remediated areas or below the topsoils down to the competent native till deposits. The engineered fill should extend at least 600 mm beyond the outside edge of exterior footings. The required extent of engineered fill should be determined based on a known fixed location for the structures and adherence to the conditions outlined above. The boundaries of the engineered fill should be laid out by a surveyor in consultation with qualified engineering staff.
