Scoped Hydrogeological Assessment

13656 Emil Kolb Parkway Colerain Drive and Harvest Moon Drive Town of Bolton (Caledon), Ontario

Project 10083

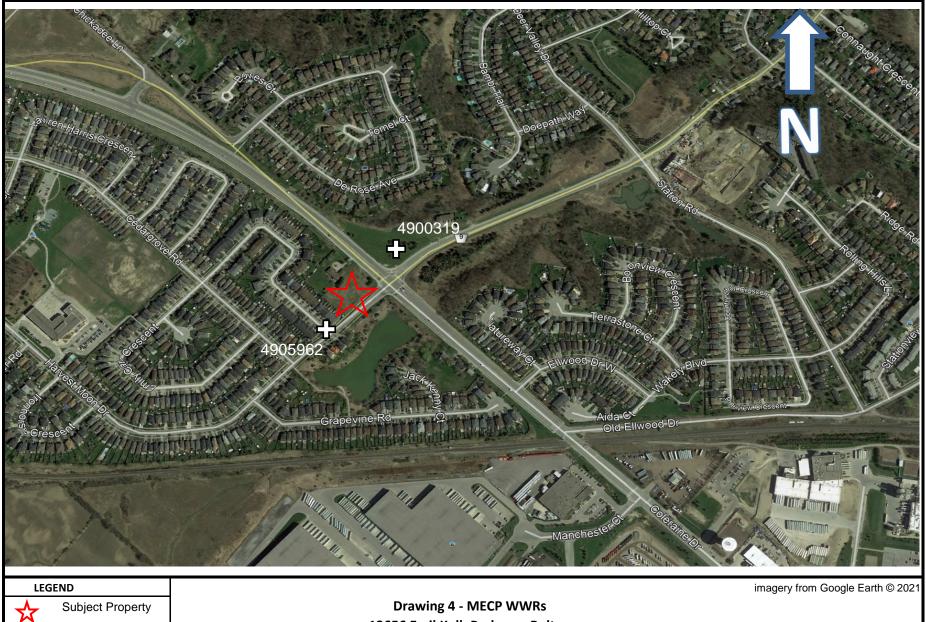
The two remaining domestic use wells are completed in overburden soils at depths of 15.24 and 75.28 mBGS, respectively. A copy of the MECP well records is included in Appendix D, and the two wells are plotted on the appended Drawing 4.

It is noted that some wells plotted on the appended Drawing 4 are located in areas where the actual existence of a well is unlikely (they may be associated with nearby properties), and that some properties shown on the aerial imagery do not have a well associated with them; however, the MECP WWR coordinate data has been used in the absence of more reliable information.
