Visual Impact Assessment Report

Proposed Caledon Pit / Quarry

CBM Aggregates, a division of St. Marys Cement Inc. (Canada)

Golder Associates Ltd.

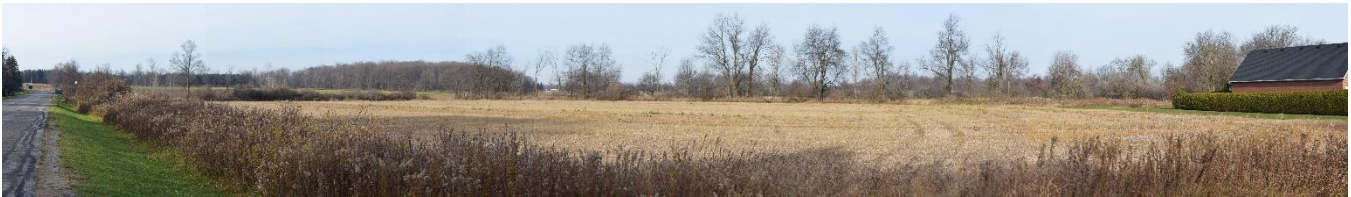
Figure 5.5.1-1: Viewpoint 2 - Existing Conditions

The existing conditions for Viewpoint 2 are shown on Figures 5.5.1-1 to 5.5.1-4.

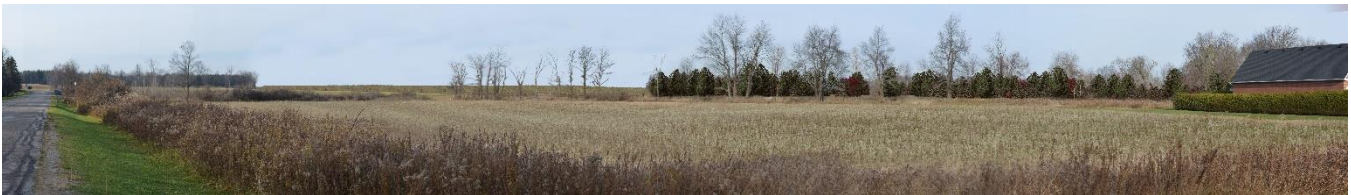
Figure 5.5.1-2: Viewpoint 2 – Site Simulation, Operations Year 6

Visibility: The Woodland Planting Area (to the east) and the Meadow Planting area (to the west) will be planted within 5 years of the licence being issued. At Operations Year 6, extraction in this area will not yet have been initiated. Portions of the grassed water infiltration trench and noise/visual barrier berm set back approximately 400 meters from Cataract Road may be partially visible; however, the Woodland Planting Area will provide effective visual screening. Deciduous trees planted as saplings with 10 m spacing on either side of the water infiltration trench will appear small at Year 6 and will reach maturity at Year 38. At rehabilitation, there will be no visible change from Operations Year 38. (Note: In order to minimize rendering distortion, woodland trees will actually be closer to the viewer than they appear in the 3D simulations).

Visual Contrast: The native vegetation in the Woodland Planting Area to the east and the Meadow Planting Area to the west will be compatible with the existing landscape character. The colour and fine texture of the grasses growing on the water infiltration trench and berm will reduce the contrast within the setting and integrate effectively within the landscape. The Site creates an overall **weak** level of contrast during Operations that may be seen but does not attract attention.

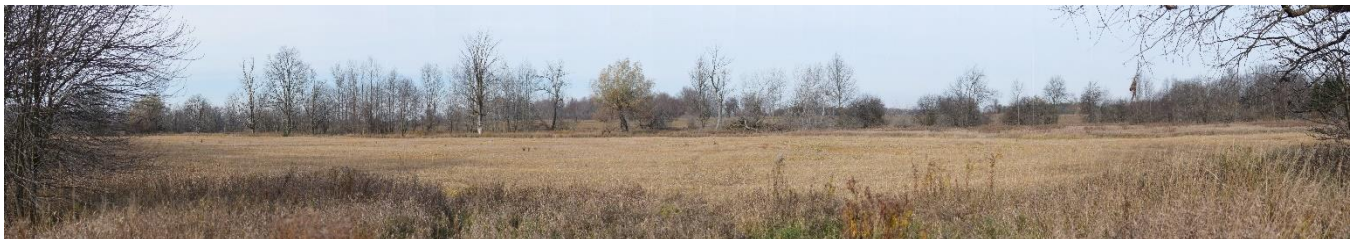
Figure 5.5.2-1: Viewpoint 5 - Existing Conditions

The existing conditions and simulations for Viewpoint 5 are shown on Figures 5.5.2-1 to 5.5.2-3.

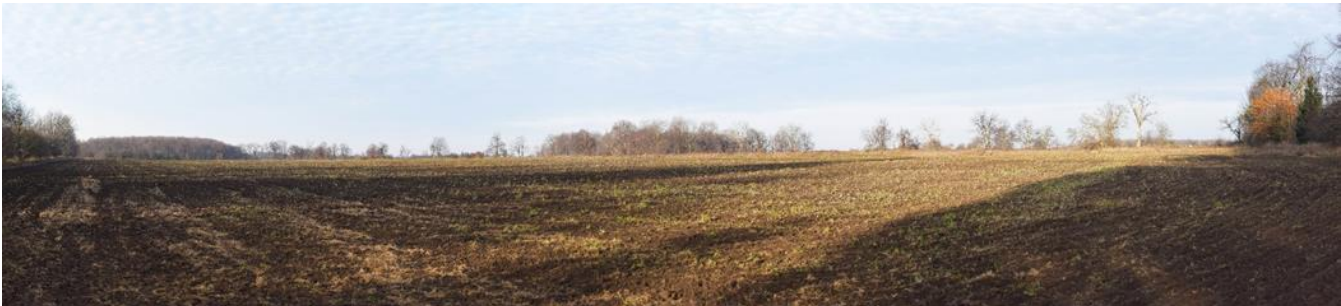
Figure 5.5.3-1: Viewpoint 7 - Existing Conditions

The existing conditions and simulations for Viewpoint 7 are shown on Figures 5.5.3-1 to 5.5.3-3.

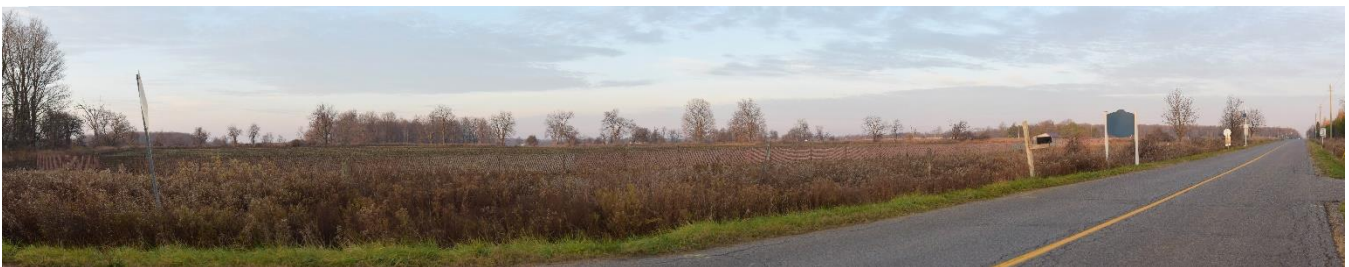
Figure 5.5.4-1: Viewpoint 9 – Existing Conditions

The existing conditions and simulations for Viewpoint 9 are shown on Figures 5.5.4-1 to 5.5.4-3.

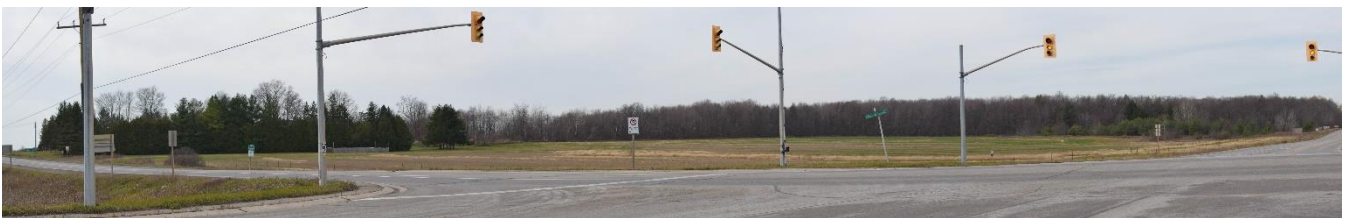
**Figure 5.5.5-1: Viewpoint 10A – Existing Conditions (Viewing NW)**

The existing conditions and simulations for Viewpoint 10A (Viewing NW) are shown on Figures 5.5.5.1 to 5.5.5.4.

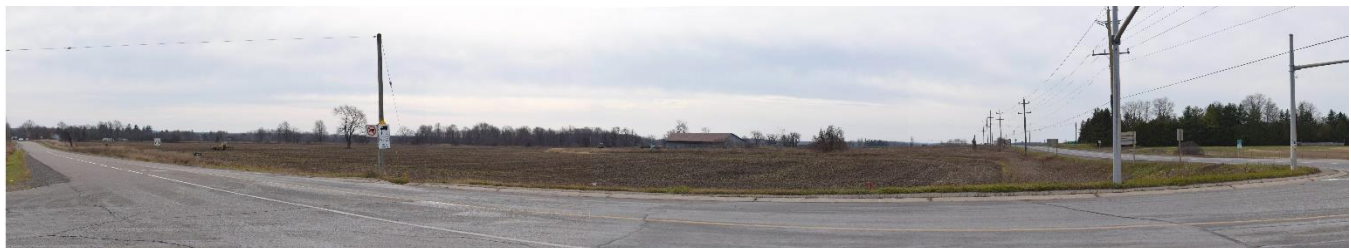
Figure 5.5.5-5: Viewpoint 10B – Existing Conditions (Viewing SW)

The existing conditions and simulations for Viewpoint 10B (Viewing SW) are shown on Figures 5.5.5-5 to 5.5.5-8.

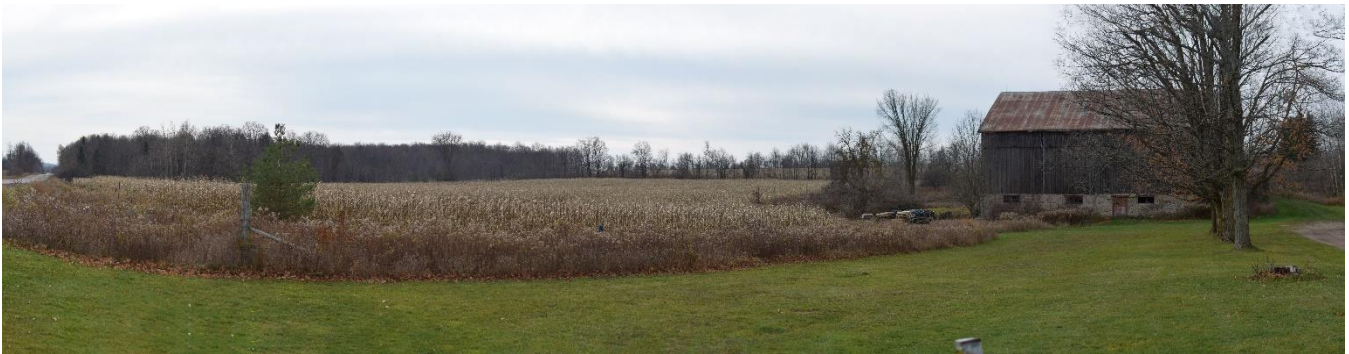
Figure 5.5.6-1: Viewpoint 13 – Existing Conditions

The existing conditions and simulations for Viewpoint 13 are shown on Figures 5.5.6-1 to 5.5.6-3.

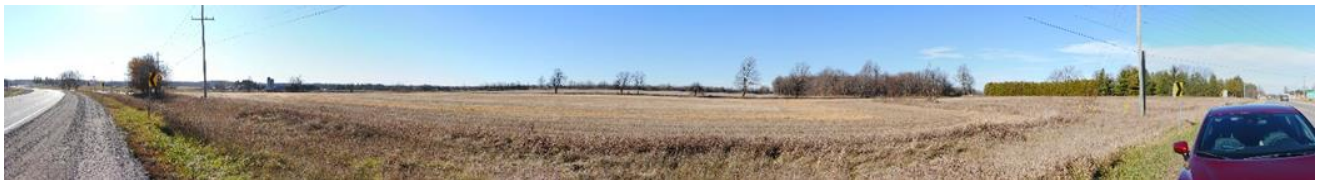
Figure 5.5.7-1: Viewpoint 21A – Existing Conditions (Viewing NW)

The existing conditions and simulations for Viewpoint 21A, from Charleston Side Road, are shown on Figure 5.5.7-1 to Figure 5.5.7-3.

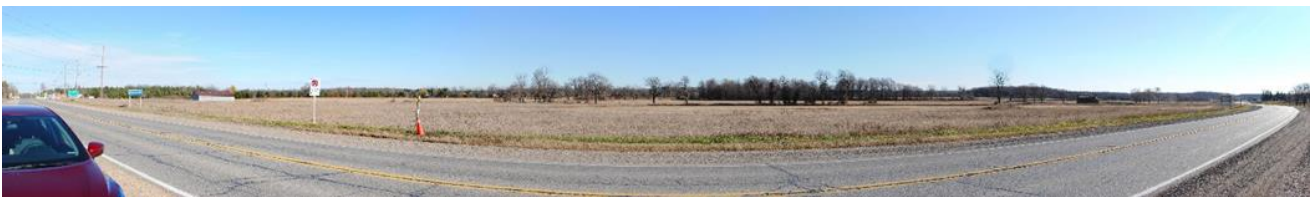
Figure 5.5.7-4: Viewpoint 21B – Existing Conditions (Viewing SE)

The existing conditions and simulation for Viewpoint 21B, from Charleston Side Road, are shown on Figures 5.5.7-4 to 5.5.7-6.

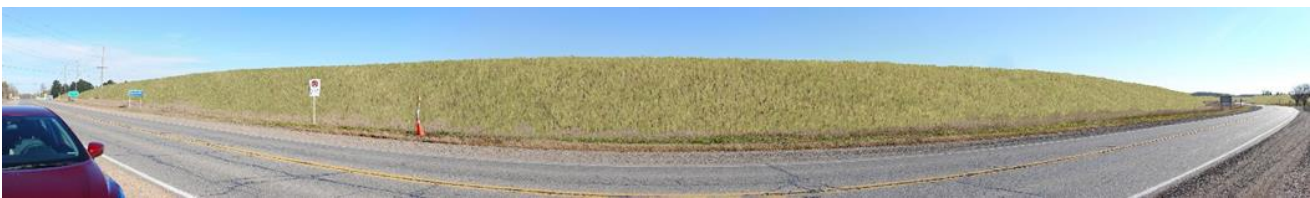
Figure 5.5.7-5: Viewpoint 21B – Site Simulation, Operations Year 38 (Viewing SE)

Visibility: In Operations Year 6, there will be no difference in the view from existing conditions. At Operations Year 38 the grassed noise / visual berm will be in place along Charleston Side Road, visible in the immediate foreground.

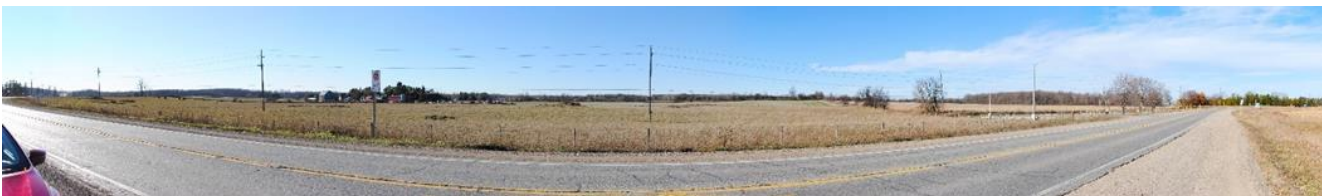
Figure 5.5.8-1: Viewpoint 22A – Existing Conditions (Viewing NW)

The existing conditions and simulations for Viewpoint 22A, from Charleston Side Road, are shown on Figures 5.5.8-1 to 5.5.8.3.

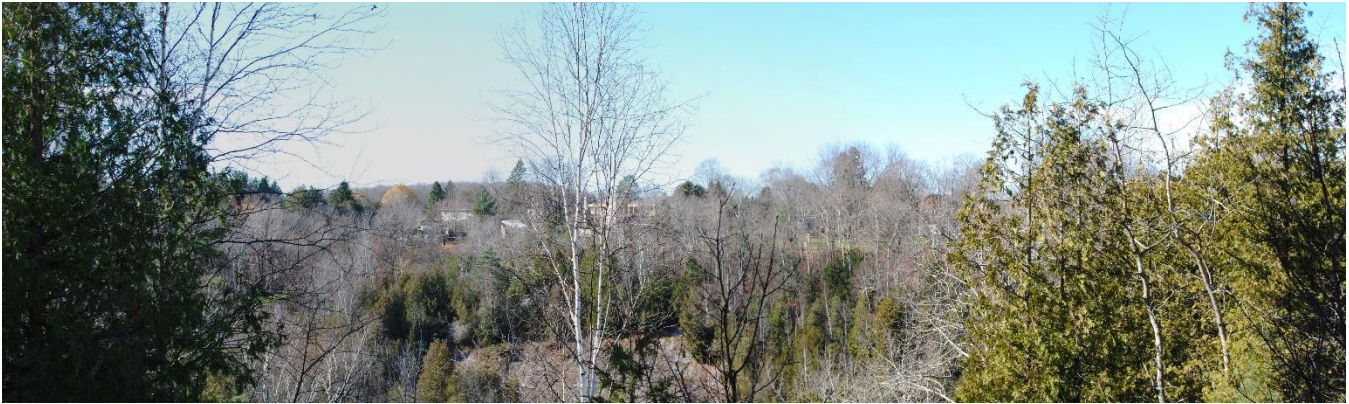
Figure 5.5.9-1: Viewpoint 23 – Existing Conditions

The existing conditions for Viewpoint 23, along the Bruce Trail, is shown on Figure 5.5.9-1.

Receptors: Recreational hikers, local residents.

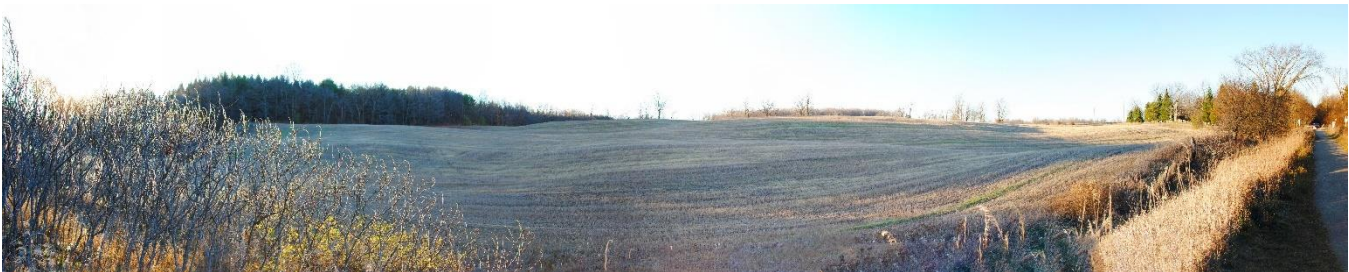
Figure 5.5.10-1: Viewpoint 24 – Existing Conditions

The existing conditions for Viewpoint 24, along the Elora-Cataract Trailway, are shown on Figures 5.5.10-1 to 5.5.10-2. Future conditions have not been simulated since the only visible feature will be a meadow as part of the rehabilitation landscape.

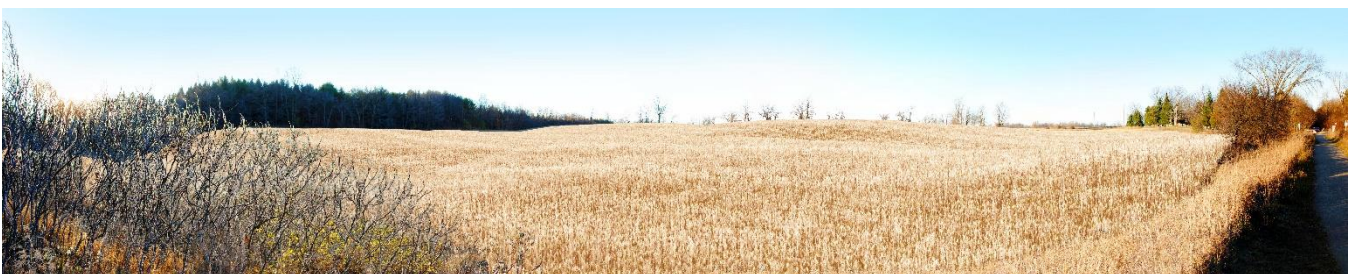
Figure 5.5.10-2: Viewpoint 24 – Site Simulation, Rehabilitation Landscape

Receptors: Recreational hikers, cyclists, local residents.

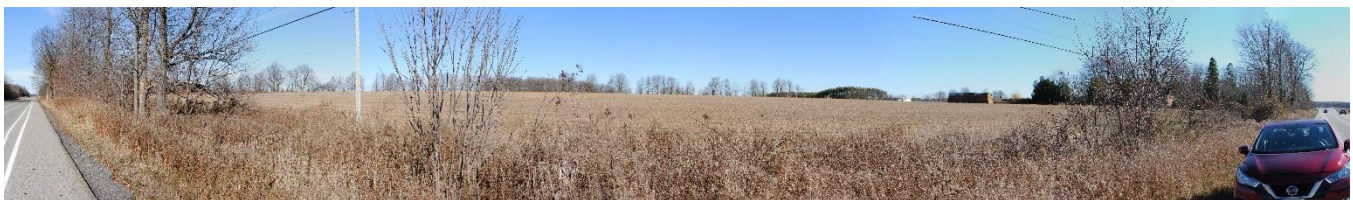
Figure 5.5.11-1: Viewpoint 25A – Existing Conditions (Viewing NE)

The existing conditions and simulations for Viewpoint 25A, from Main Street, are shown on Figures 5.5.11-1 to 5.5.11-4.

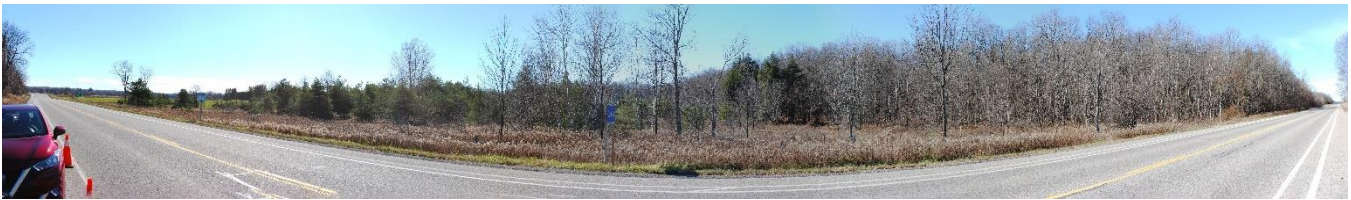
Figure 5.5.11-5: Viewpoint 25B – Existing Conditions (Viewing W)

The existing conditions and simulations for Viewpoint 25B, from Main Street, are shown on Figures 5.5.11-5 to Figure 5.5.11-8.

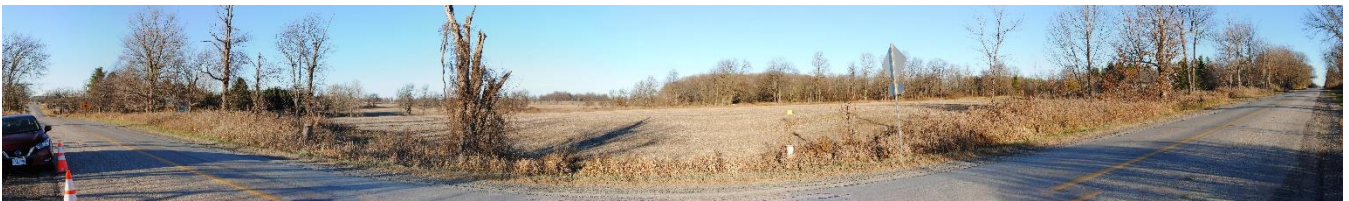
Figure 5.5.12-1: Viewpoint 26 – Existing Conditions

The existing conditions and simulations for Viewpoint 26, from Mississauga Road, are shown on Figures 5.5.12-1 to 5.5.12-3.

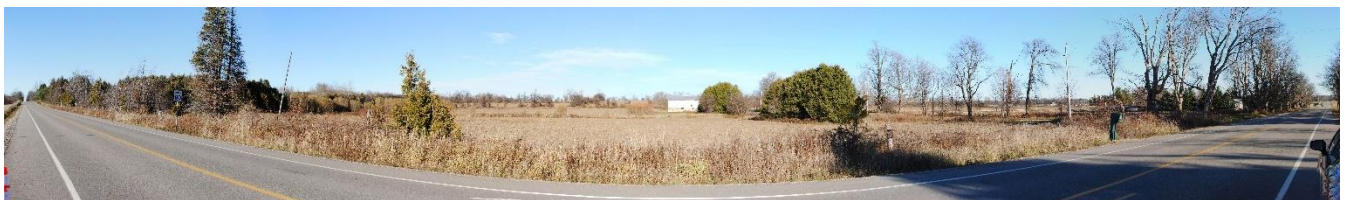
Figure 5.5.13-1: Viewpoint 27 – Existing Conditions

The existing conditions and simulations for Viewpoint 27, from Mississauga Road, are shown on Figures 5.5.13-1 to 5.5.13-3.

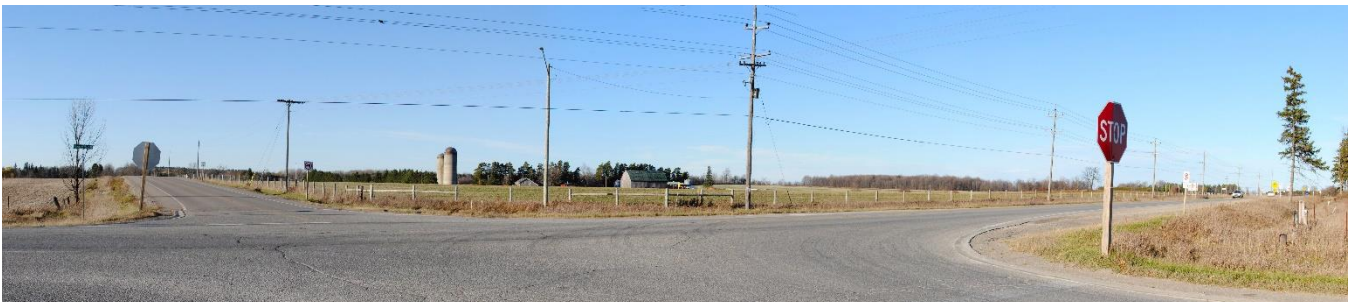
Figure 5.5.14-1: Viewpoint 28A – Existing Conditions

The existing conditions and simulations for Viewpoint 28A, from the intersection of Mississauga Road and Charleston Sideroad, are shown on Figures 5.5.14-1 and 5.5.14-4.

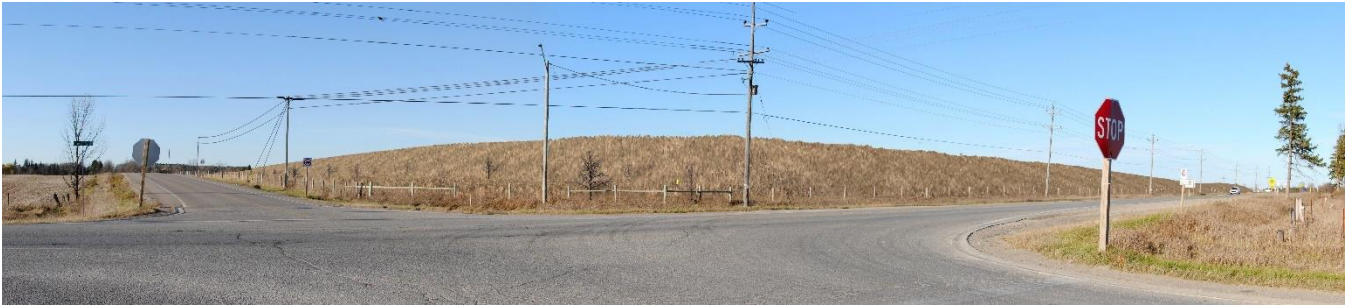
**Figure 5.5.14-2: Viewpoint 28A – Site Simulation, Operations Year 6 (Viewing N)**

Visibility: Deciduous trees, planted as saplings with 10 m spacing on either side of the water infiltration trench, will appear small at Year 6 (Figure 5.5.14-2) and will reach maturity at Year 38 (Figure 5.5.14-3). In Year 38, other than the growth of more mature grasses and trees, there will be no difference in the view of the berm from Year 6, as the berm will already be constructed. Prominent features include the, planted trees and the grassed area over the water infiltration trench; and the noise/visual barrier berm in the immediate foreground adjacent to the intersection of Mississauga Road and Charleston Sideroad.

Visual Contrast: The duration of the view for motorists is brief but sustained while the viewer is stopped at the intersection. The colour and fine texture of the grass over the water infiltration trench and berm integrates with the landscape adjacent to the intersection. The predominately horizontal orientation of the landscape is somewhat maintained with the addition of the linear berm. The steeper berm slope contrasts with the generally level plane of

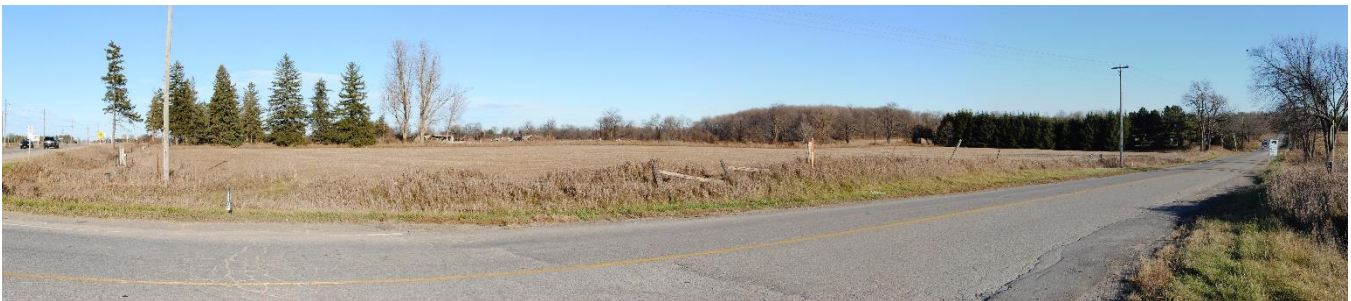
Figure 5.5.14-5: Viewpoint 28B – Existing Conditions (Viewing SE)

The existing conditions and simulations for Viewpoint 28B, from the intersection of Mississauga Road and Charleston Sideroad, are shown on Figures 5.5.14-5 to 5.5.14-8. There is no mining activity at Year 6 so from this viewpoint the view will not change from existing conditions.

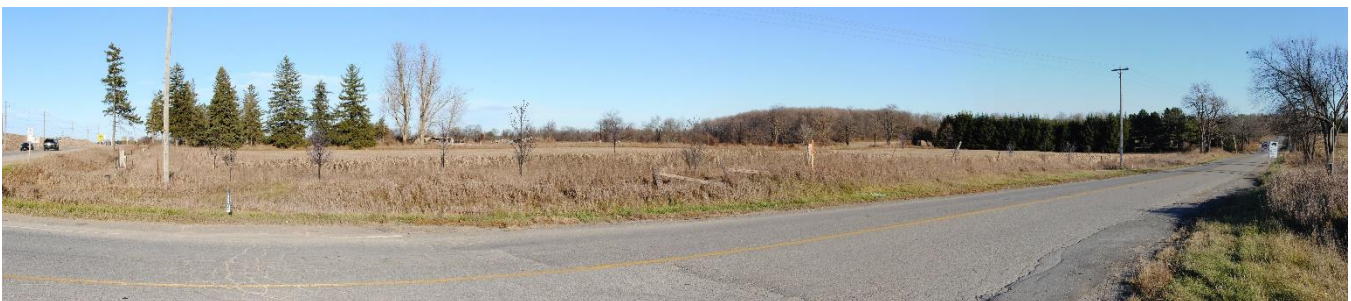
Figure 5.5.14-6: Viewpoint 28B – Year 6 (Viewing SE)

Visibility: The visibility at existing conditions and Operations Year 6 is the same, as the berm will not be constructed at this time. Deciduous trees planted as saplings with 10 m spacing on either side of the water infiltration trench will appear small at Year 6 and will reach maturity at Year 38. At Operations Year 38, prominent features include the tree plantings and the grassed noise/visual barrier berm in the immediate foreground adjacent to the intersection and extending along the roads (Figure 5.5.14-7).

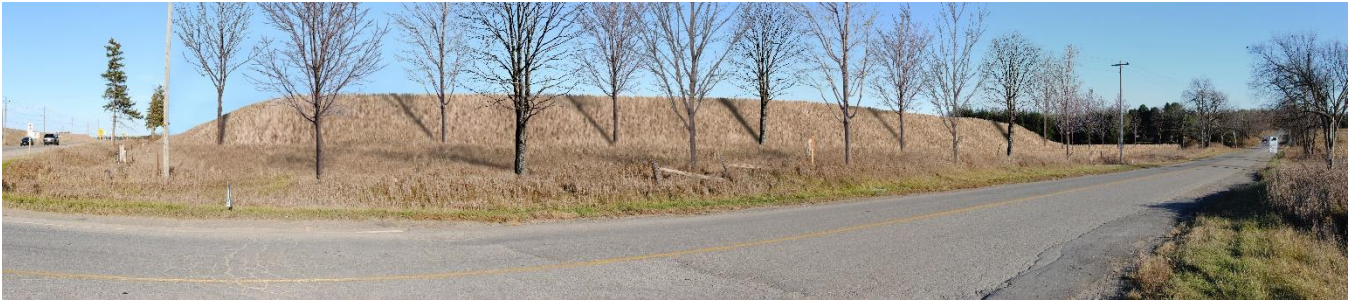
Figure 5.5.14-7: Viewpoint 28B – Site Simulation, Operations Year 38 (Viewing SE)

Visual Contrast: At Operations Year 38, the existing view is altered by the proposed berm (shown in cross-section 28B – 28B' Year 38 Mine Plan). During the initial berm and water infiltration trench construction, visual contrast will be strong temporarily; however once the berm and trench are vegetated and the plants begin to grow the berm grasses reduce the contrast within the setting and integrate effectively within the landscape. The steeper berm slope contrasts with the generally level plane of the existing landscape; however, the berm setback of approximately 28 metres from the licence limit helps to reduce visual contrast. The tree rows will be planted with a mixture of sugar maple (*Acer saccharum*) and red oak (*Quercus rubra*) which are native to the Great Lakes – St. Lawrence Forest Region and will fit well with existing trees along the roadside and surrounding woodlots. The Site creates an overall **weak** level of contrast during Operations that will initially attract attention but will not entirely dominate the viewing opportunity of the existing landscape character.
