# PHASE I ENVIRONMENTAL SITE ASSESSMENT

12563, 12585 AND 12599 HIGHWAY 50 AND 2 INDUSTRIAL ROAD BOLTON, ONTARIO

#### 12599 HWY 50 LTD.

WATTERS ENVIRONMENTAL GROUP INC.

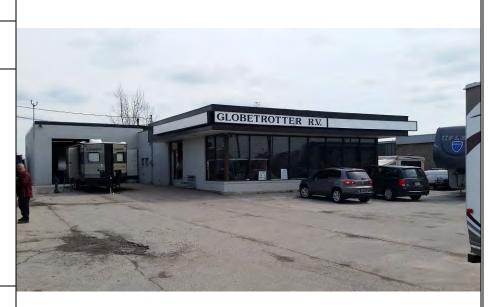
Façade of Site building 1, occupied by Globetrotter R.V.

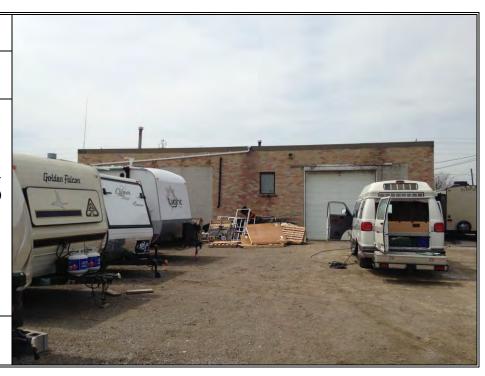
View of the eastern exterior portion of Site building 3, including the unpaved area where minor Recreational Vehicle (RV) maintenance and detailing activities are conducted.

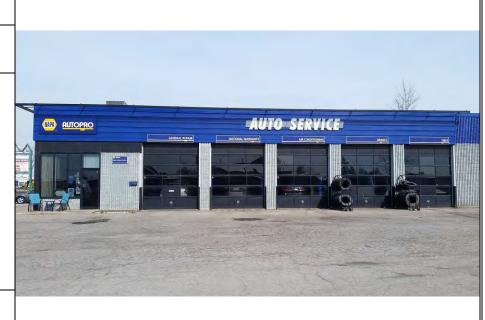
The southern face of Site building 2, occupied by NAPA Autopro, showing the five (5) bay doors and the access to the reception/sales area.

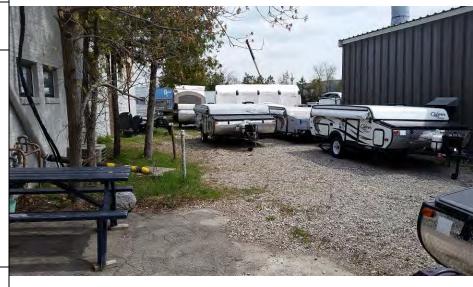
Overview of the eastern portion of the Site, used as an RV parking and storage area.

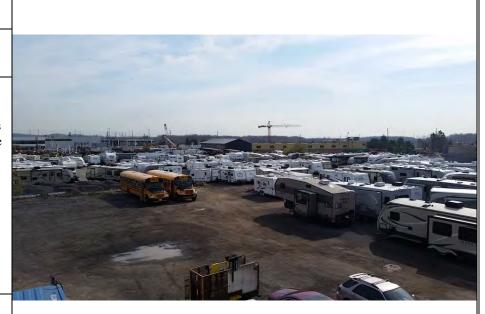
Western exterior portion of the Site between Site Buildings 3 and 2, which is used as an access lane and RV parking/storage area

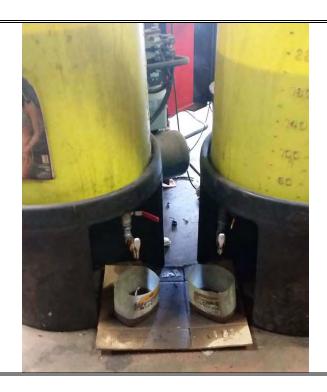
Storage of automotive maintenance fluids, cans of paint, a propane cylinder and other RV maintenance chemicals, observed in the service area of Site Building 3.

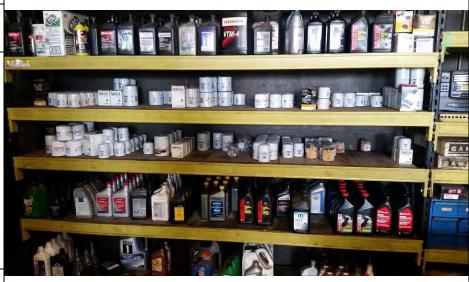
Storage of small to medium containers of automotive maintenance chemicals (i.e., motor oil, refrigerants, etc.), located in the northern portion of the service area of Site Building 2.

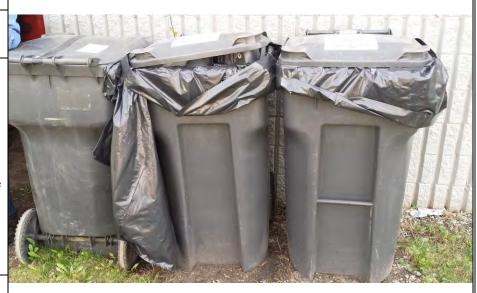
One tote containing nonhazardous solid waste (i.e. oil filters) and two bins containing empty automotive chemical containers located in the northeastern portion of Site Building 2.

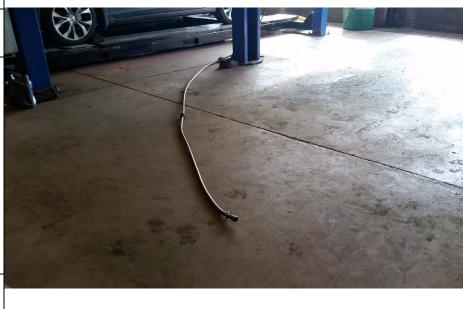
Minor staining observed on the concrete floors in the service area of Site Building 2.

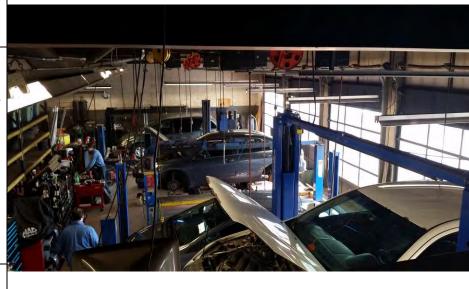
Five automotive service bays within Site building 2, each with an aboveground hydraulic hoist.

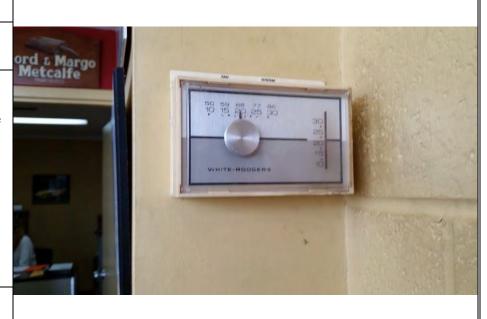
Mercury-containing thermostat observed in the reception area of Site

building 2.

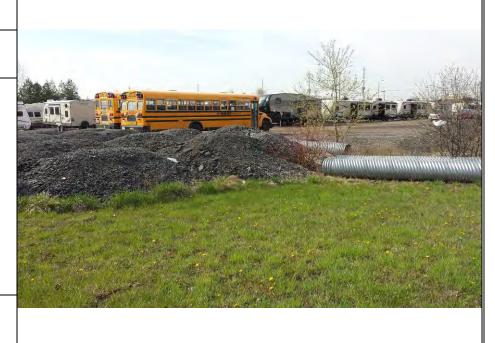
Stockpile observed in the central portion of the Site on an unpaved area.

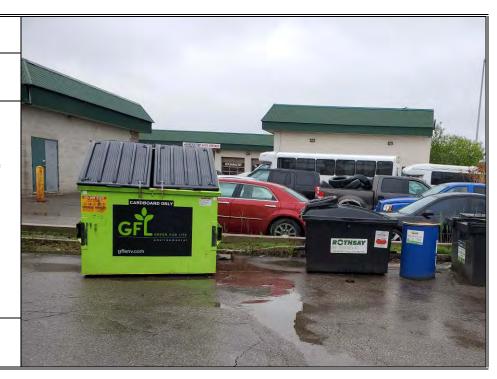
View of the recycling, waste, and waste grease containers located on the northeast portion of the Site building 1.

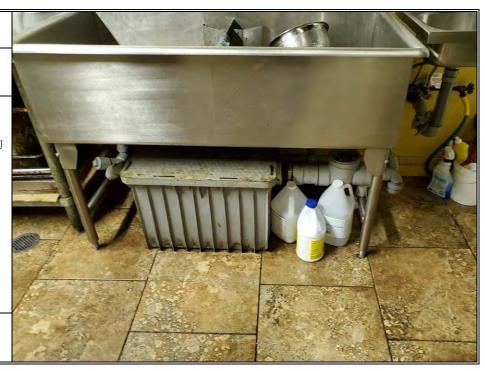
View of the above ground grease trap located in CRU

5B.

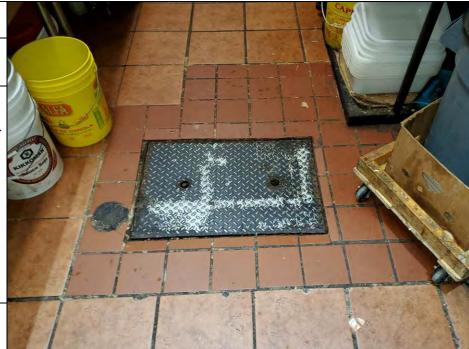
View of the in-floor grease trap resent in the kitchen of CRU 2.

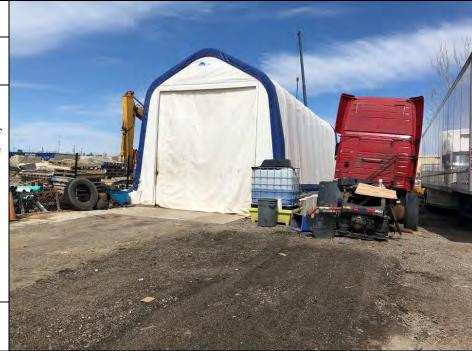
Truck maintenance tent in the north-central portion of the Site building 4 (i.e., the northwest corner of the J-Line Truck.

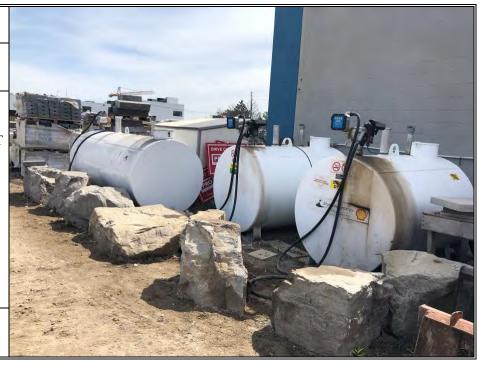
Two diesel ASTs (right side) and one gasoline AST (left side) outside the north end of the Site building 4.

- Three fuel ASTs were observed outdoors and adjacent to the northeast end of Site building 4. The fuel ASTs are used to store and supply diesel and gasoline to on-Site vehicles and equipment of one of the tenants, Pro-Land. All three ASTs were observed to be in good condition and no staining was observed on the ground surface below or around the ASTs. Based on the condition of the ASTs, Watters Environmental does not anticipate any significant environmental impacts (if any) to the subsurface due to the presence of the ASTs;

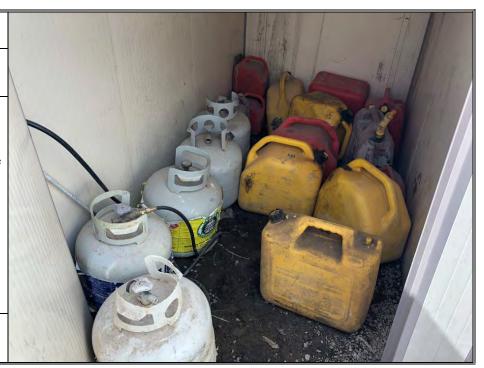
Propane tanks and jerry cans inside a storage shed outside the north end of the Site building 4 (behind the larger, gasoline, AST in Photograph 3)

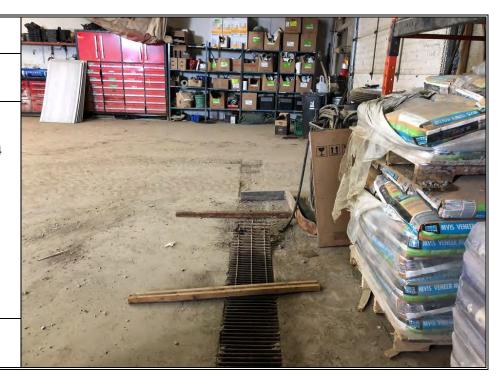
Partially covered steelgrated trench in Unit 104 of the Site building 4.

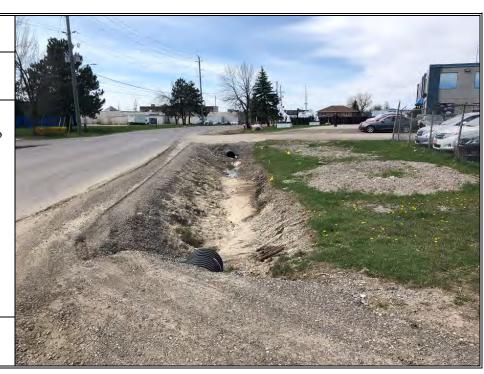
Drainage ditch adjacent to the south property line of the Site building 4, along Industrial Road.
