Palmer Project #

170163

Zancor Homes (Bolton) Inc.

Re: Hydrogeological Investigation – Chickadee Lane Rounding Out Area B
Project #: 170163

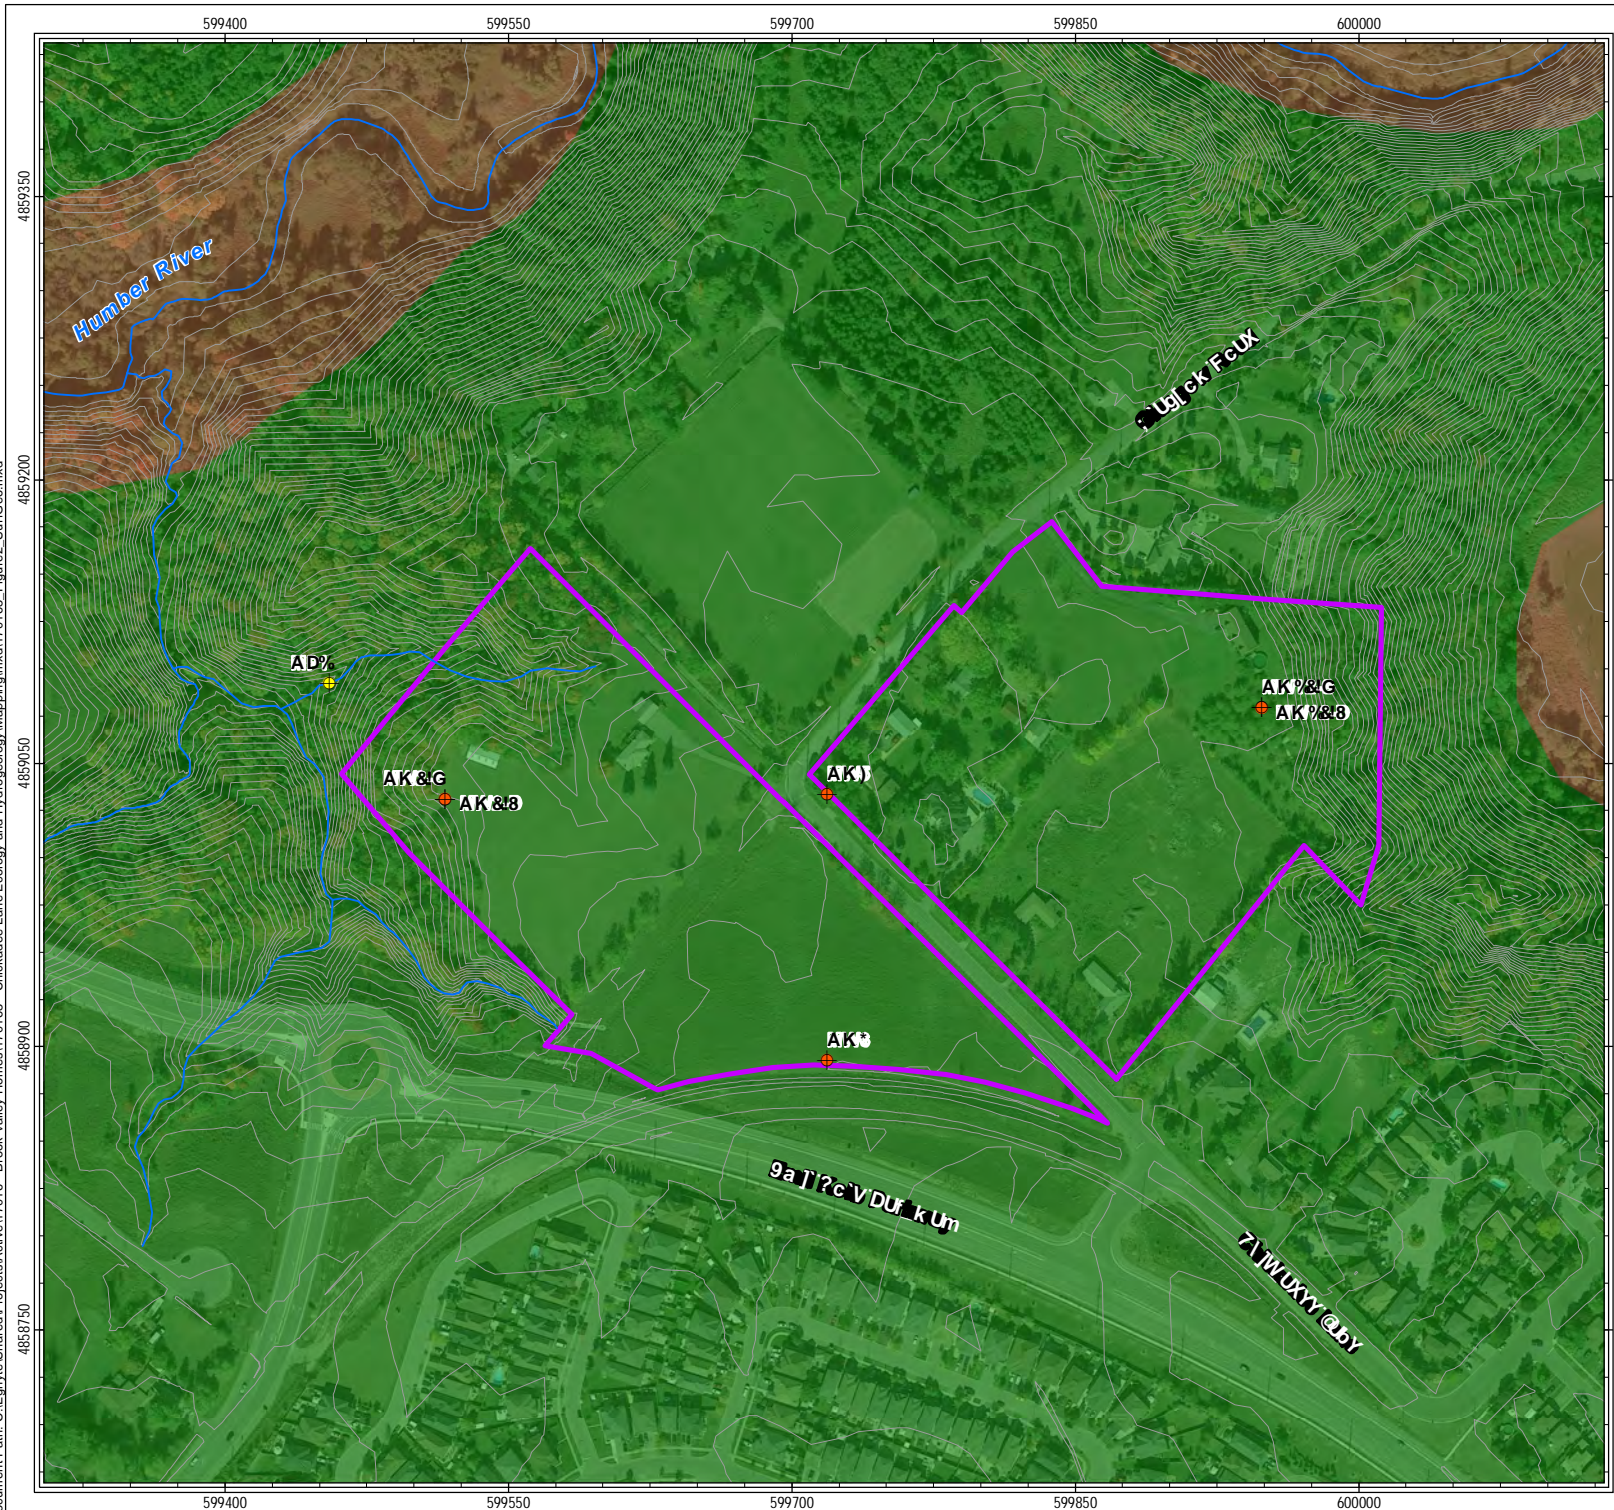
Figure 3

Based on an updated search of the MECP water well database, 34 water well records were identified within a 500 m radius of the site (**Figure 3**). A roadside water well screening identified up to 14 properties within 500 m of the site that have the potential to still rely on potable groundwater rather than municipal supply, although the municipal water is known to be available along Glasgow Road, Chickadee Lane, Emil Kolb Parkway and King Street. A detailed door-to-door water well survey will be completed at detailed design to document existing potable groundwater use near the site and to collect baseline data on groundwater quality and quantity.

- ⊕ Mini Piezometer
- ⊕ Monitoring Well
- Watercourse
- Contour (1 m)
- Study Area
