Fluvial Geomorphology Assessment and Conceptual Natural Corridor Design

Mount Hope West Secondary Plan Area Local Subwatershed Study Town of Caledon, Ontario

GEO Morphix Project No. 25026

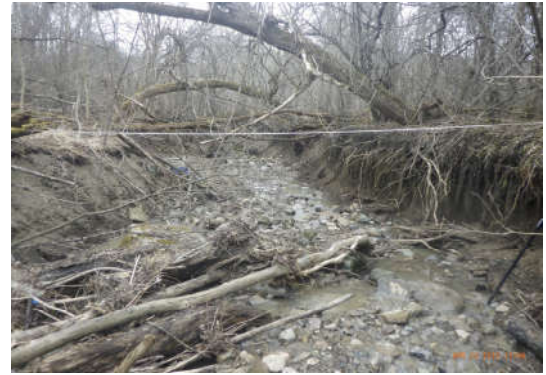
Representative Cross-Section 4

Photograph at cross section 4 (looking downstream)

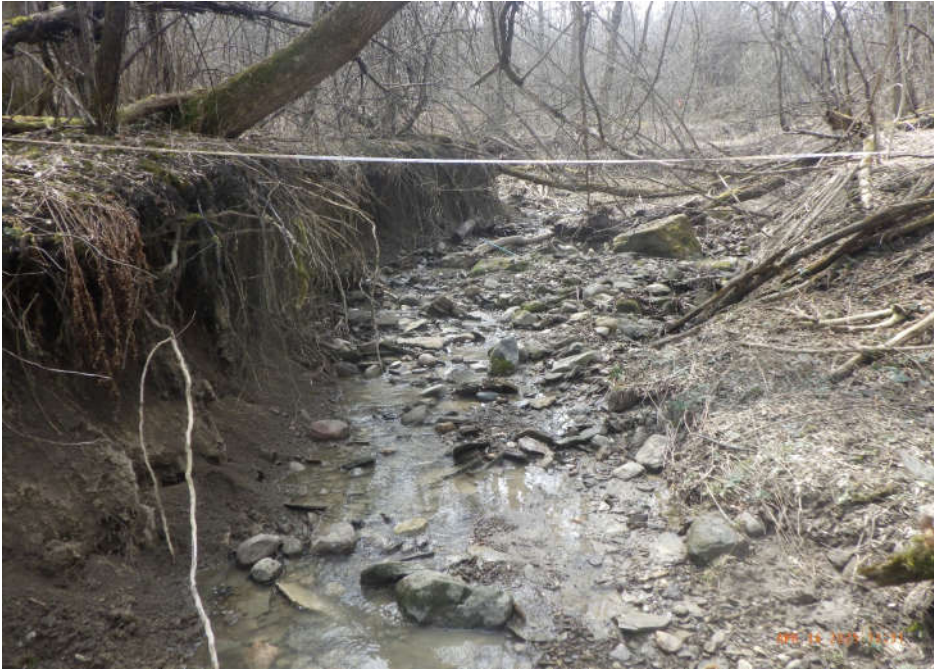
General Field Observations
<p style="text-align: center;">Channel Description</p> <p>The subject reach was characterized by a channel with a low sinuosity set within a confined, wooded valley. Agricultural fields bordered the forest on either side of the channel. Instream vegetation was predominantly absent for the full extent of the reach. Channel bed morphology was characterized by occasional riffle-pool sequences and had a moderate gradient. The channel exhibited evidence of systematic widening. Bank soil was additionally loose and exposed to flow, with bank erosion being visible throughout the reach. Flow in the channel was minimal, and was largely only observed in riffles. Bank substrate was primarily consisted of sand, silt, and clay materials, while bed substrate was defined by sand, gravel, cobble, and boulders. Notably, a rooted knickpoint was observed at the downstream extent of the reach.</p> <p style="text-align: center;">Cross Section 3 - Facing Upstream</p>

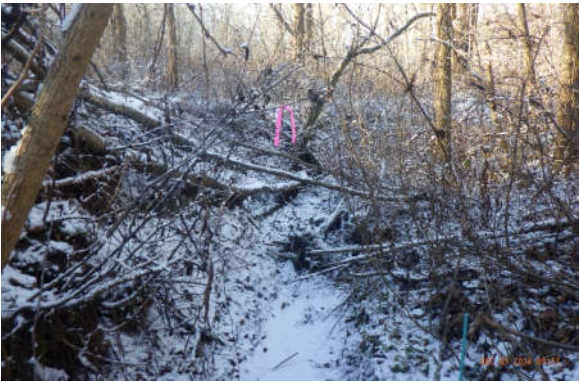
Representative Cross-Section #2

Photograph at cross-section 2

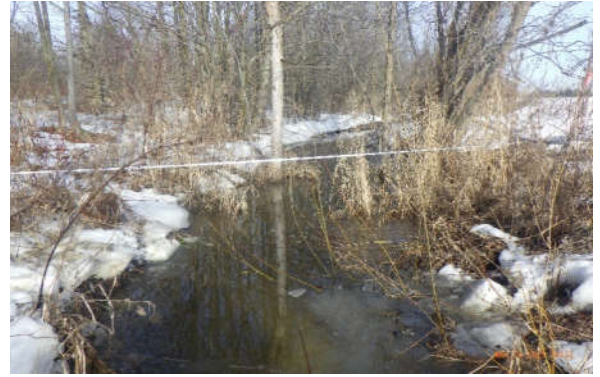
Representative Cross-Section 1

Photograph at cross section 1 (looking upstream)

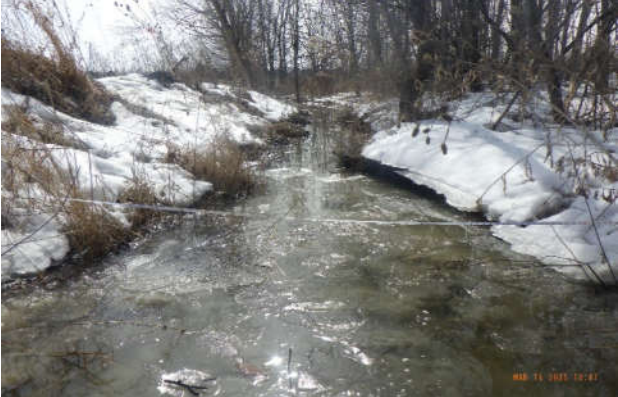
General Field Observations
<p style="text-align: center;">Channel Description</p> <p>The subject reach was characterized by a generally straight channel set within an unconfined forested area between two agricultural fields. Dominant riparian vegetation consisted of trees and shrubs, which provided good cover over the channel. Instream vegetation covered approximately 15% of the channel, generally consisting of rooted emergent vegetation. Channel bed morphology was relatively planar, primarily dominated by one habitat type, and one depth and velocity condition. Generally, no flow was observed. The water level appeared high at the time of observation as inundated riparian vegetation was common. Bed substrate was primarily silt and clay, with organics. Woody debris was noted more frequently at the upstream extent. Bank angles generally ranged from 30 to 60 degrees and bank erosion was observed along less than 30% of the reach.</p> <p style="text-align: center;">Cross Section 4 - Facing Downstream</p>
