# HERITAGE IMPACT ASSESSMENT

18667 MISSISSAUGA ROAD, TOWN OF CALEDON,  
REGIONAL MUNICIPALITY OF PEEL, ONTARIO

CBM AGGREGATES

PROJECT NO.: OCUL2216  
DATE: JULY 28, 2023

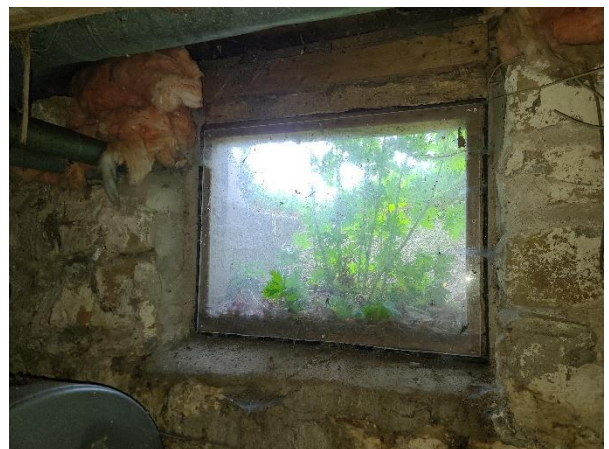
The basement is an open, rectangular room that encompasses the footprint of the original main block (Plate 30 and Plate 31). The entrance to the basement is via a stairwell located in the hallway on the west side of the main block. The floor is poured concrete and the random rubble walls of the foundation have been parged (Plate 32 and Plate 33). The floor joists are visible and consists primarily of logs which were hand-hewn on the top and bottom to provide a flat surface but otherwise left in the round, some with the bark still intact (Plate 34). There are ten hand-hewn log joists spanning the entirety of the main block, with five on each side of the staircase. A singular log joist has been squared on all sides and cut to accommodate the staircase (Plate 35). Later, metal floor joist jacks were added to support the framing. The main block's plank subflooring is visible between the log joists (Plate 36). There is a single basement window on the south elevation. The window has sawn wooden frames and is set into the parged stone foundation. Concrete has been hand applied between the window frames and stone foundation. The window has a hand-hewn timber lintel. A sawn piece of wood sits atop the lintel and plexiglass has been attached on the interior. (Plate 37).

**Plate 37: Basement window**

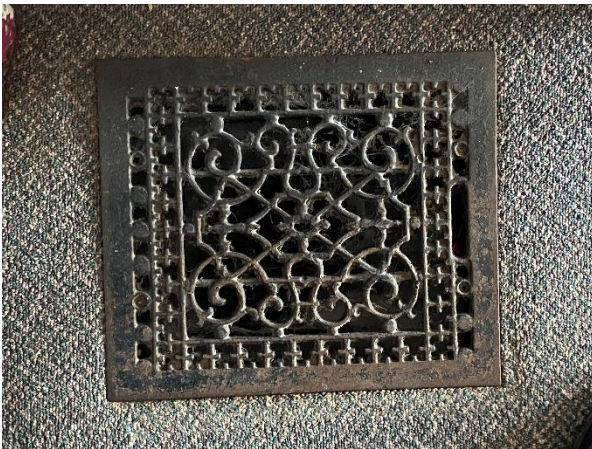
The kitchen is located in the north half of the main block (Plate 38 and Plate 39). Wood doors and trim appear to be original and are in good condition. Cast floor grates are also likely original to the house or very early additions (Plate 40). Carpet covers the floor. The frame for an original window opening on what would have been the original west elevation has been converted into a nook, likely at the time the west addition was constructed (Plate 41). Two one-over-one sash windows are located on the east wall of the kitchen on what would have been the original front elevation of the house (Plate 42 and Plate 43).

**Plate 40: Cast floor grate**

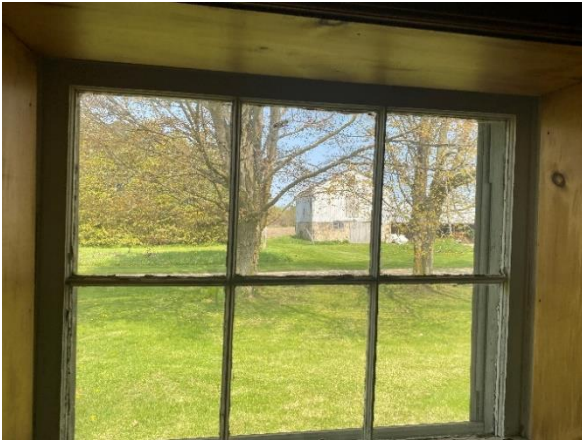
The living room has a tiled drop ceiling, faux wood panelling on the walls, and carpeted flooring (Plate 68 to Plate 70). There is a six-over-six sash window on the west wall (Plate 70). The window has a wood frame and glazing bar that appear to be original. A new wood door provides exterior access on the south wall (Plate 69).

**Plate 70: West elevation window**

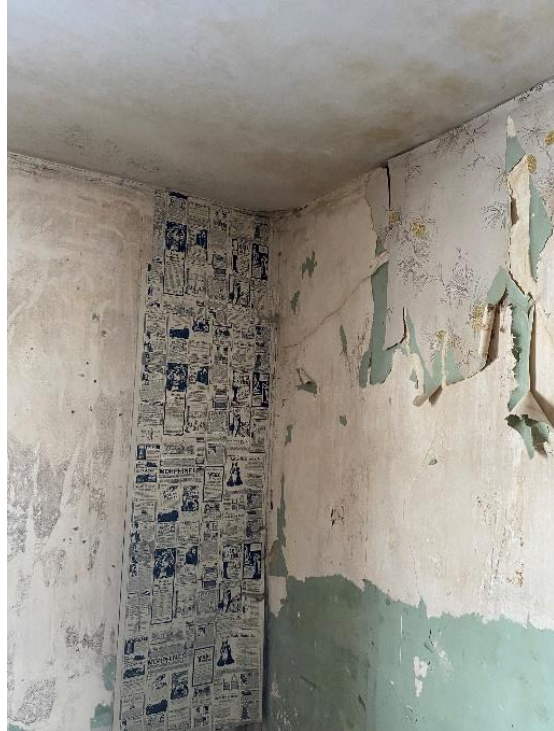
The storage room has painted wood floors, plaster walls (covered in wallpaper), and built in wood cabinets on the east wall (Plate 71 and Plate 72). One six-over-six hung and one one-over-one sash window are located on the west wall, both with wood frames (Plate 73). There is one six-over-six wood sash window on the north wall, looking into the north addition (Plate 74). There is a boarded-up window in the kitchen that acts as a nook on the west elevation of the original main block (Plate 75).

**Plate 71: Side addition storage room**

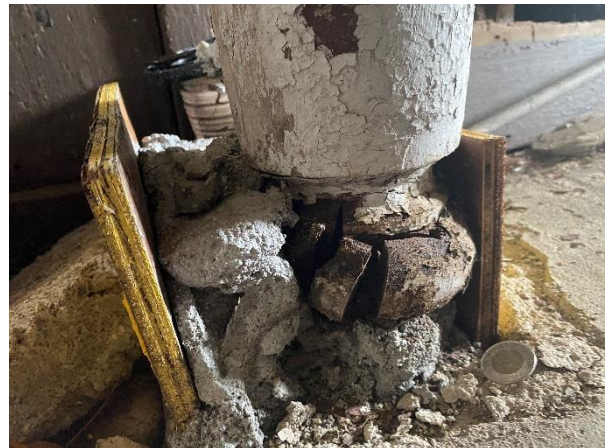
**Plate 79: Base of the original veranda pillar**

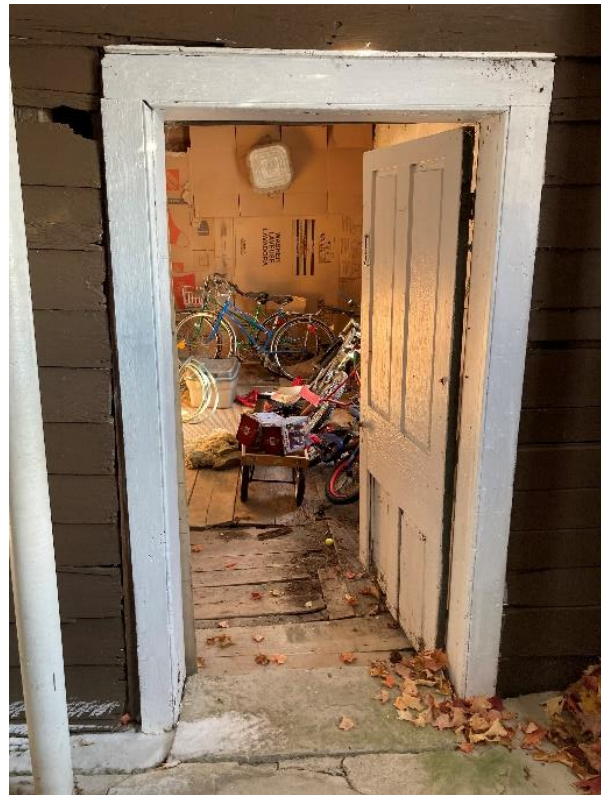
**Plate 81: Doorway from frame and plywood addition to east storage room/summer kitchen**

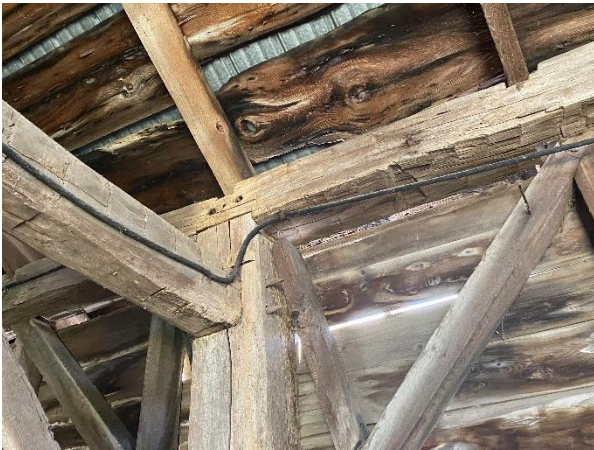
**Plate 85: Mortise and tenon timber joints with wood trenails/dowels**

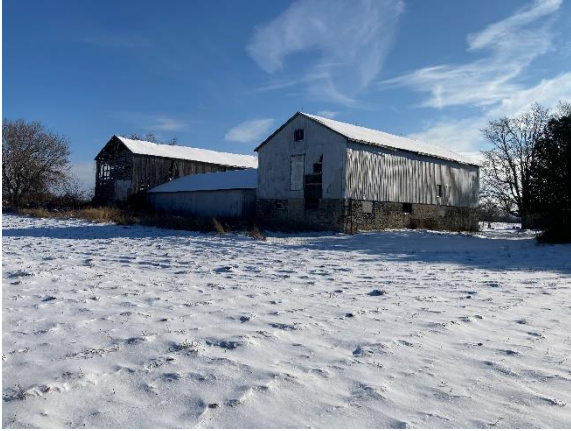
**Plate 87: South and west elevations of the H-shaped barn complex**

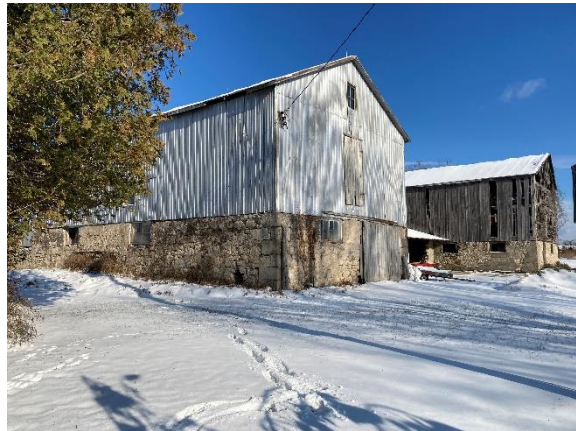
**Plate 88: South and east elevations of the H-shaped barn complex**

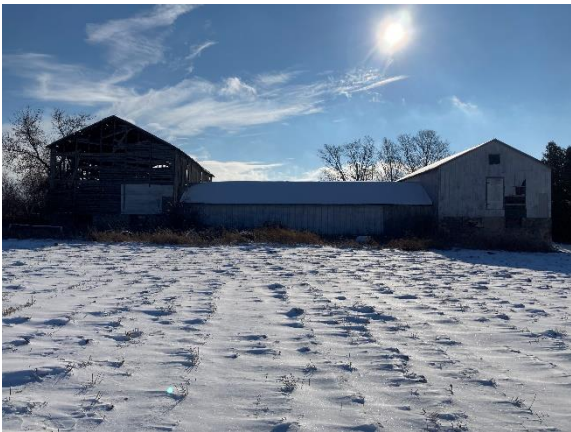
**Plate 89: West elevation of complex showing connecting shed**

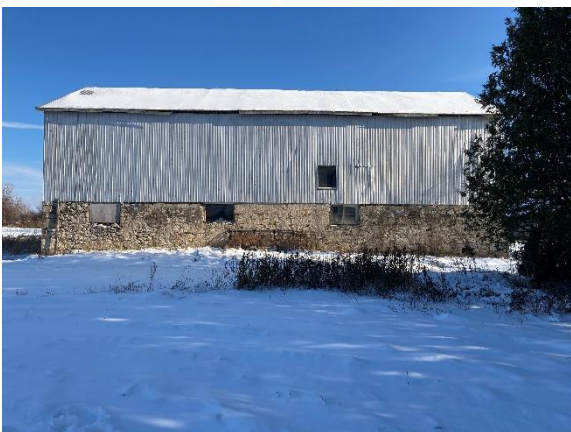
**Plate 91: South elevation of south barn**

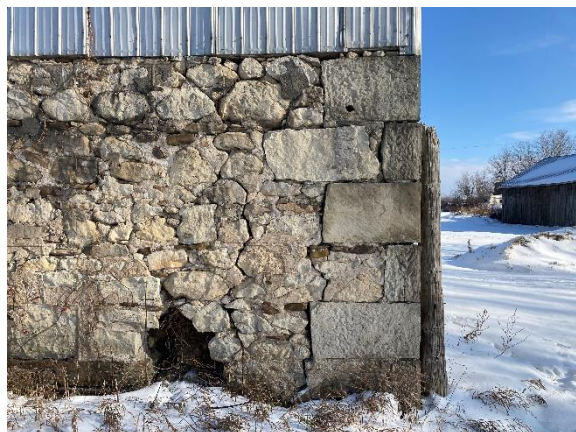
**Plate 92: Foundation and cut stone cornerstones of south barn**

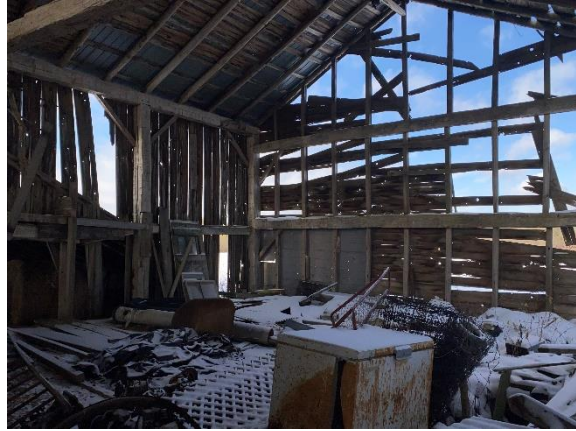
**Plate 94: North barn interior showing hand hewn beams**

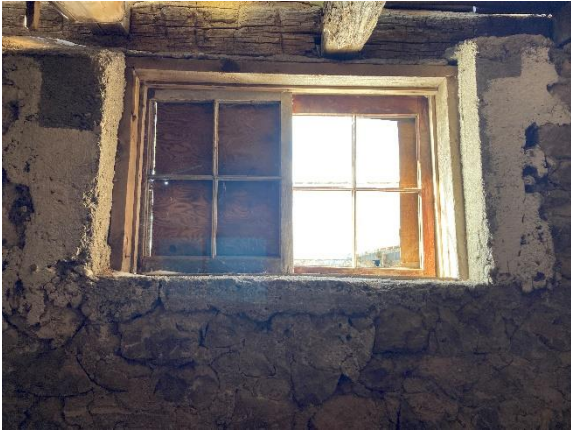
**Plate 95: North barn window**

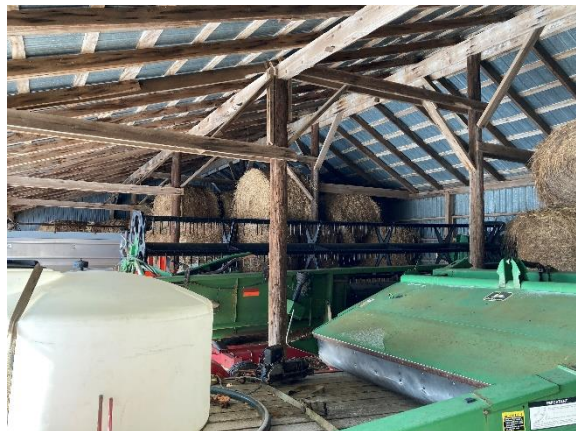
**Plate 98: Barn complex connecting shed**

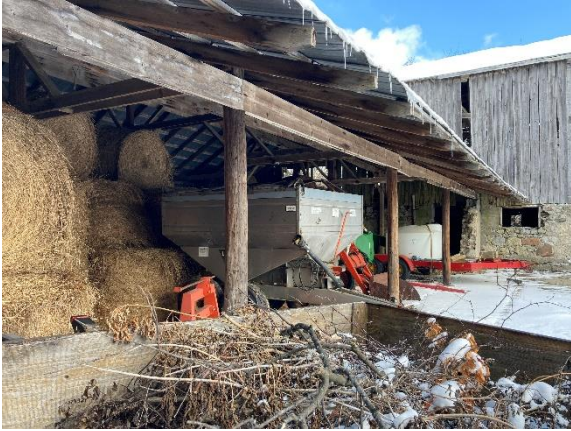
**Plate 99: Junction between connecting shed and north barn**

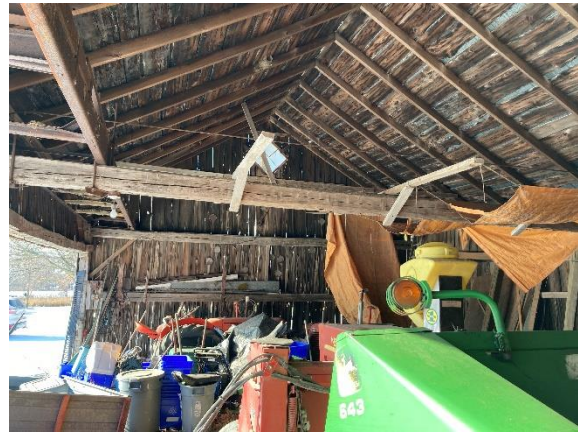
Two outbuildings are located to the north (rear) of the house. Outbuilding No. 1 is a timber-framed drive shed with a metal gable roof (Plate 100). Wide plank sheathing on the rafters have been covered in corrugated sheet metal (Plate 101 and Plate 102). The drive shed roofing has undergone similar upgrades to the rafters as the summer kitchen. While the rafters appear to have been replaced, the plank sheathing seems to have been reused. This structure features a diamond shaped gable window on the south elevation and a diamond cross owl hole within the gable of the north elevation (Plate 103 and Plate 104). The outline of the original opening to the drive shed is visible on the west elevation and was closed using the same board and batten wood siding as the rest of the structure (Plate 105). The current opening is a modification to the original structure and is located on the east elevation.

**Plate 102: Interior of Outbuilding No. 1**

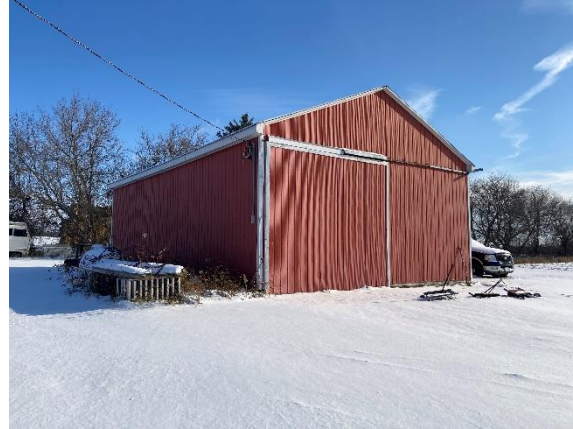
Outbuilding No. 2 has a rectangular floor plan, metal siding, and a metal gable roof (Plate 106). This outbuilding is the most recent addition to the property and dates to between the 1950s and 1970s (Plate 1 and Plate 2).

**Plate 106: Outbuilding No. 2**
