DETAILED CONDITION SURVEY REPORT

Site No. B26030042, Main Street, Alton
Caledon, ON

Prepared for: GHD Limited

BCC Project No.: BCC19012
Report Date: May 31, 2019

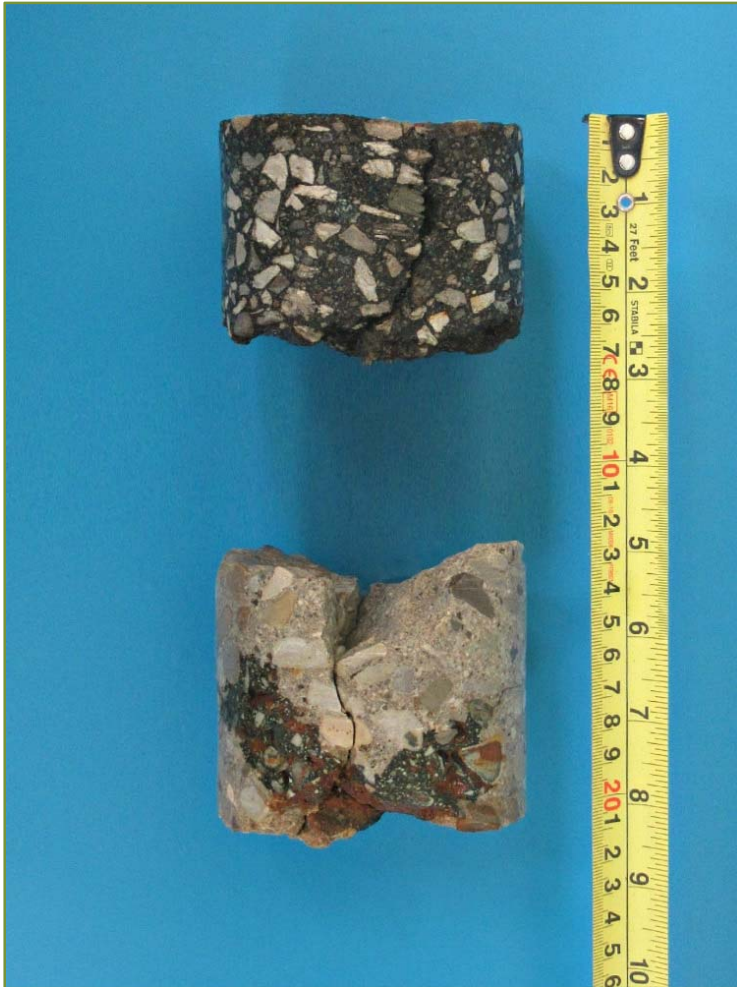
Core C9

Concrete cover on the upper rebar layer was found to range from 100 to 125 mm with an average cover of 115 mm. Light rusting of the reinforcement steel was found in cores C3, C5, C6, C7, C8, C12. Severe rusting of the reinforcement was noted in core C9.

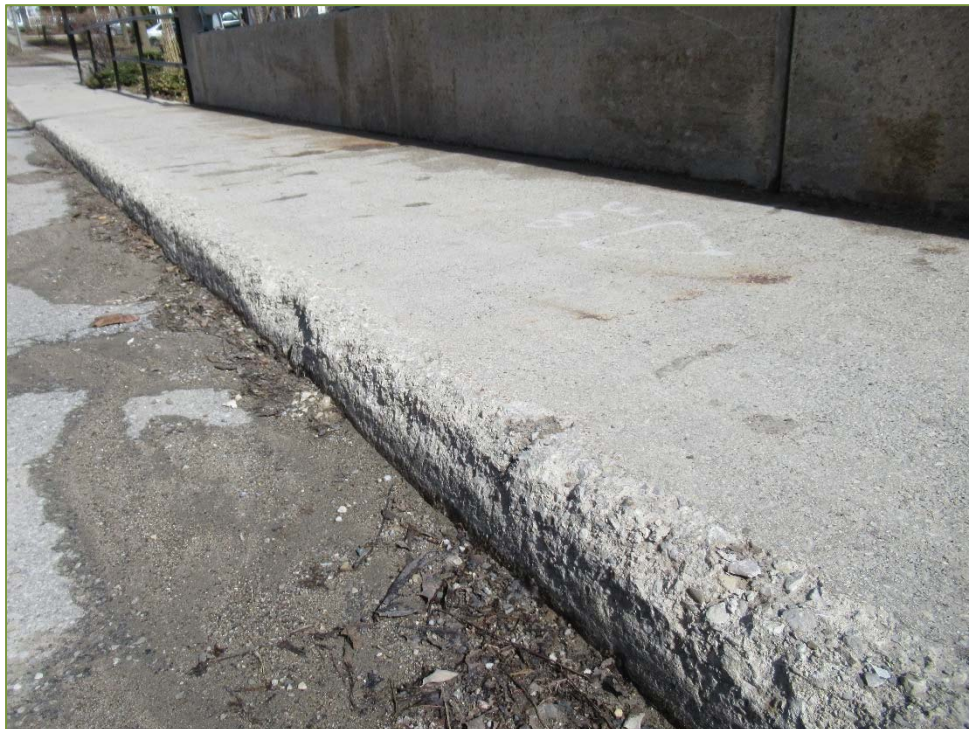
Photo P26 – East Sidewalk (medium scaling)
